Technical Service Bulletin

Topic	Headlamp operation issues
Market area	Bentley: worldwide (2WBE),Hongkong-Macau (5HK)
Brand	Bentley
Transaction No.	2054599/4
Level	EH
Status	Released for publishing
Release date	Dec 16, 2019

New Continental GT and New Continental GTC

Headlamp operation issues

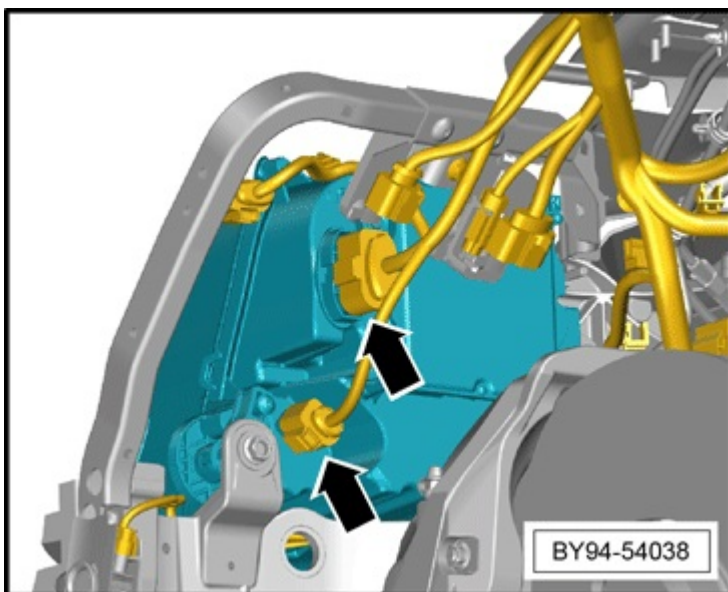
- 1) Remove the applicable front wheel arch liner – Refer to Repair manual Rep.Gr 66
- 2) Referring to Figure 1 - Disconnect the applicable headlamp plugs (right and/or left hand side) - During disconnection look out for any abnormalities for example a plug which is loose/broken or can easily be disconnected

- 3) Check the condition of the headlamp plug and terminals
- 4) Check the condition of the headlamp assembly connection pins
- 5) Using the applicable Elsa pro wiring diagrams – Check the electrical integrity of the complete headlamp circuit

- Should NO concerns be identified – Carry out the remaining instructions
- 6) Reconnect the headlamp plugs NOTE: An audible click will be heard once the plug is refitted/connected correctly

- 7) Carry out a pull check to confirm correct fitment
- 8) Erase any related DTC's using offboard Diagnostic Information System (ODIS)
 - Carry out a road test (maximum of 50 time units) to confirm the headlamps are fully functional
