Technical Service Bulletin

Topic	TPMS Warning light - DTC U012700 evident
Market area	Bentley: worldwide (2WBE),Hongkong-Macau (5HK)
Brand	Bentley
Transaction No.	2057947/2
Level	EH
Status	Released for publishing
Release date	Dec 18, 2019

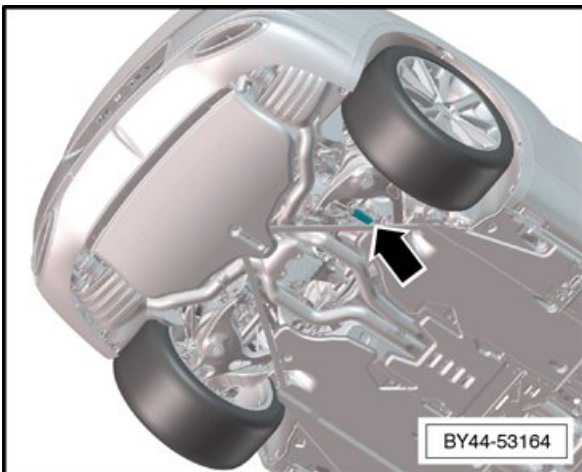
NOTE: For clarity Figure 1 shows the fitting location for the New Continental GT, New Continental GTC and New Flying Spur, Figure 2 shows the fitting location for Bentleyga

1) Replace the Tyre pressure control module and bracket (Figure 1) - Refer to Rep.Gr 44

The control module and bracket should be returned back to Bentley Motors Crewe as a complete assembly using the normal parts return procedure
