# SERVICE BULLETIN

Classification:	Reference:	Date:
EC18-015a	NTB18-047a	December 3, 2019

## 2018-2019 ROGUE SPORT; MIL ON WITH A/F SENSOR DTC(S)

**APPLIED VEHICLES:** 2018-2019 Rogue Sport (J11)  
**APPLIED ENGINE:** MR20DD

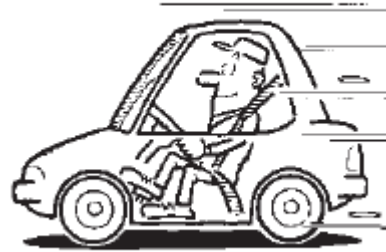
Figure A

- Connect a battery maintainer or smart charger set to reflash mode or a similar setting. If the vehicle battery voltage goes below 12.0V or above 15.5V during reprogramming, the ECM may be damaged.
- Be sure to turn OFF all vehicle electrical loads. If a vehicle electrical load remains ON, the ECM may be damaged.
- Be sure to connect the AC Adapter. If the CONSULT PC battery voltage drops during reprogramming, the process will be interrupted and the ECM may be damaged.
- Turn OFF all external Bluetooth® devices (e.g., cell phones, printers, etc.) within range of the CONSULT PC and the plus VI. If Bluetooth® signal waves are within range of the CONSULT PC and plus VI during reprogramming, reprogramming may be interrupted and the ECM may be damaged.

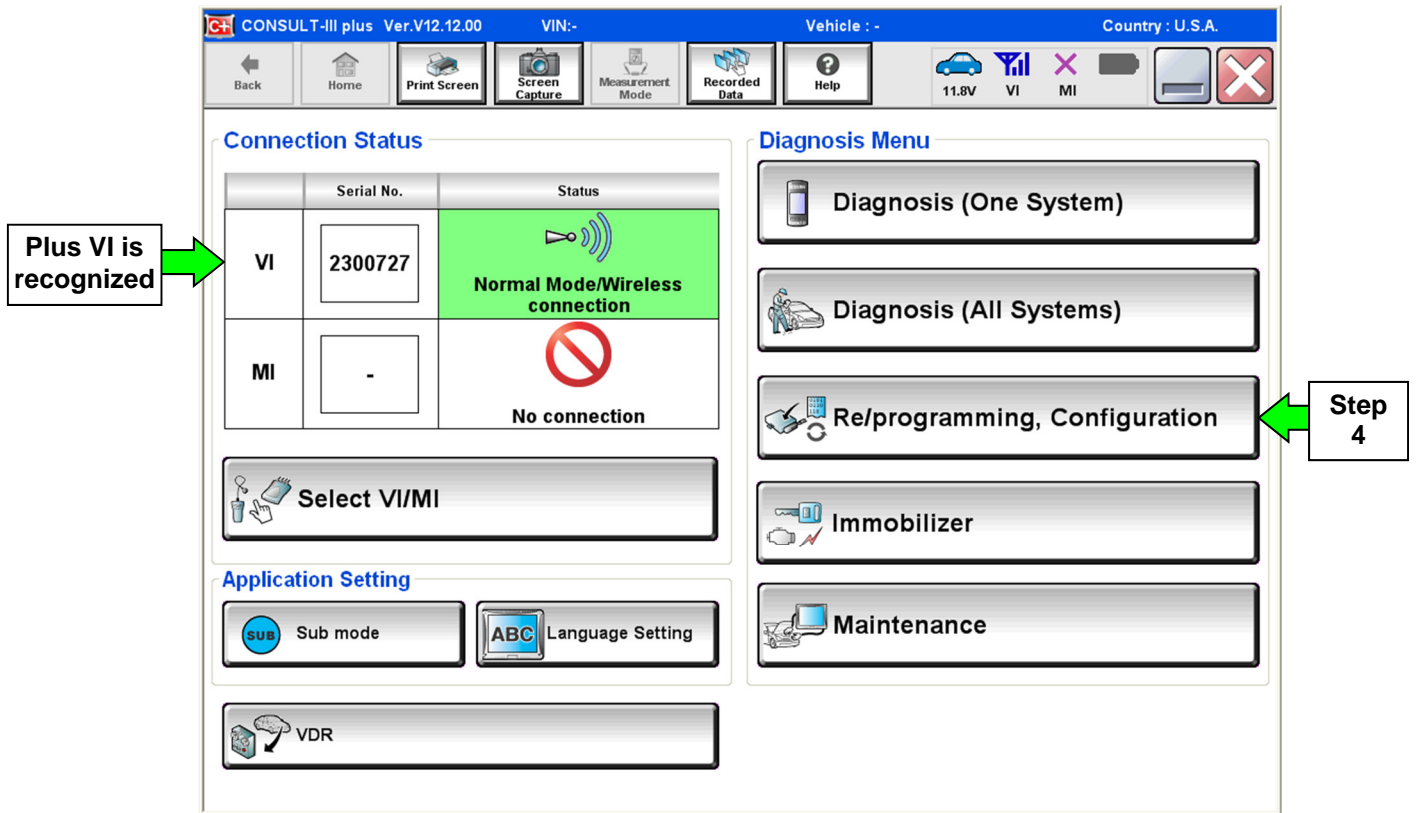
Figure 1

1. Connect the CONSULT PC to the vehicle to begin the reprogramming procedure.
2. Start C-III plus.
3. Wait for the plus VI to be recognized / connected.
  - The serial number will display when the plus VI is recognized / connected.
4. Select **Re/programming, Configuration**.

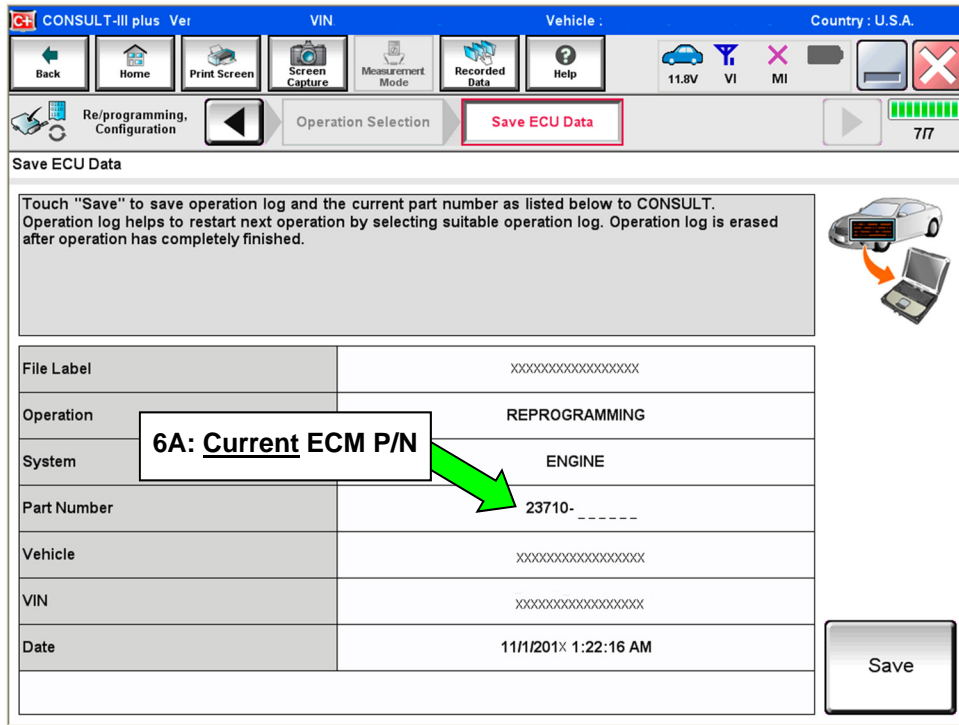
6. When the screen in Figure 2 displays, confirm this bulletin applies as follows.

A. Find the ECM **Part Number** and write it on the repair order.

**NOTE:** This is the current ECM Part Number (P/N).

B. Compare the P/N you wrote down to the numbers in the **Current ECM PART NUMBER** column in **Table A**, on the next page.

- If there is a match, this bulletin applies. Continue with the reprogramming procedure.
- If there is not a match, reprogramming does not apply. Refer to ASIST for further diagnosis.

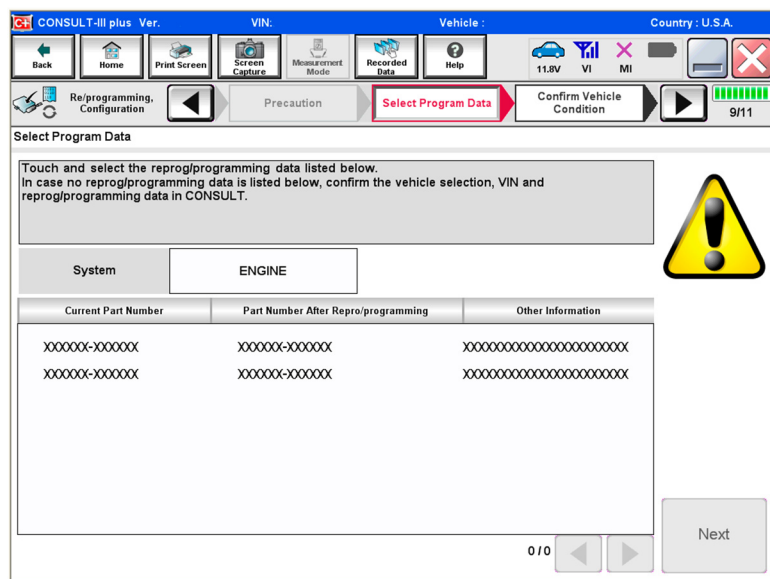
**Figure 3**

- In some cases, more than one new P/N for reprogramming is available.
  - In this case, the screen in Figure 3 displays.
  - Select and use the reprogramming option that **does not** have the message “Caution! Use ONLY with NTBXX-XXX”.
- If you get this screen and it is blank (no reprogramming listed), it means there is no reprogramming available for this vehicle. Close C-III plus and refer back to ASIST for further diagnosis.

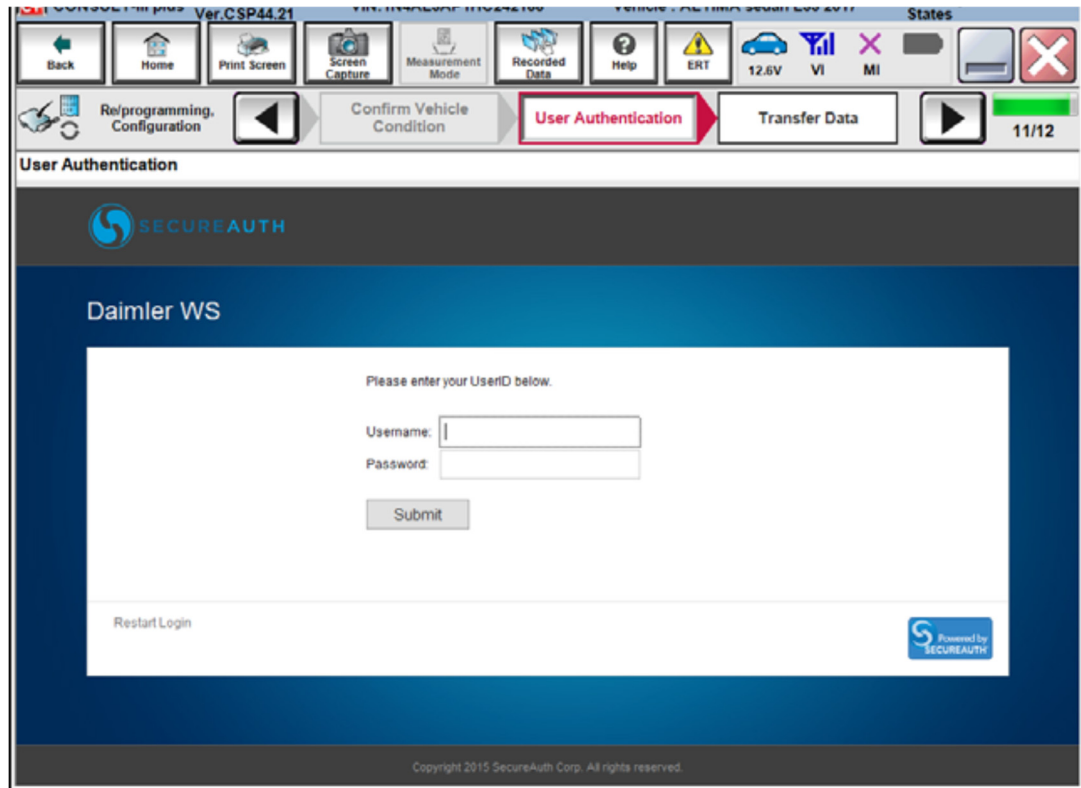
Figure 4

- Before reprogramming will start, you will be required to enter your User Name and Password.
  - The CONSULT PC must be connected to the Internet (Wi-Fi or cable).
  - If you do not know your **Username** and **Password**, contact your service manager.

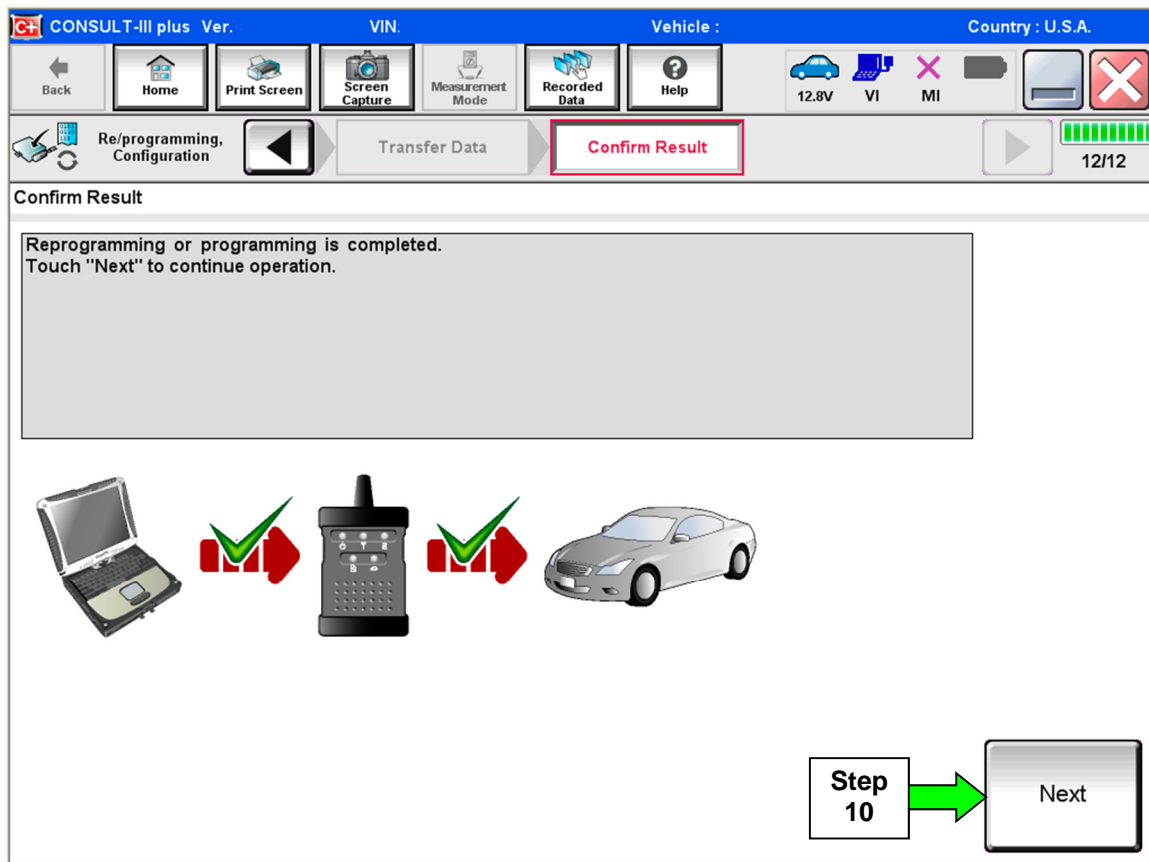
8. When the screen in Figure 5 displays, reprogramming is complete.

**NOTE:** If the screen in Figure 5 does not display (reprogramming does not complete), refer to the information on page 8.

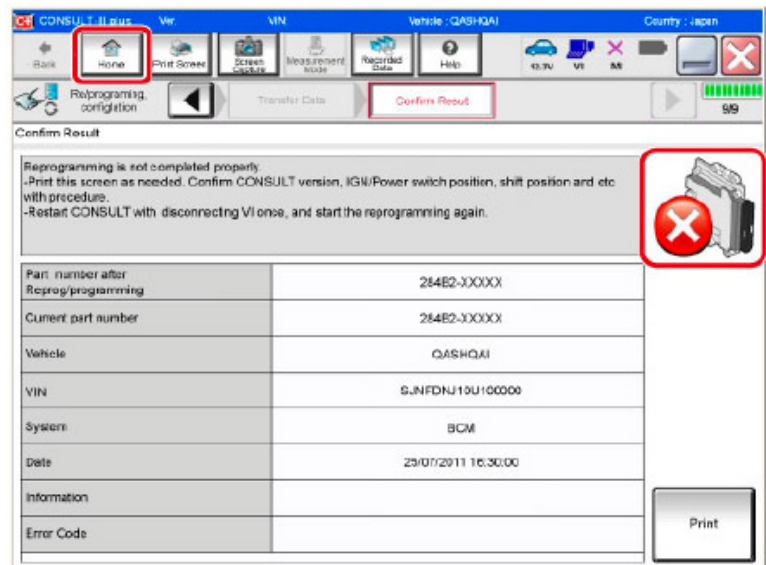
Figure 7

If reprogramming does not complete and the “X” icon displays as shown in Figure 7:

- Check battery voltage (12.0 – 15.5 V).
- CONSULT A/C adapter is plugged in.
- Ignition is ON, engine OFF.
- Transmission is in Park.
- All C-III plus / VI cables are securely connected.
- All C-III plus updates are installed.
- **Select Home, and restart the reprogram procedure from the beginning.**

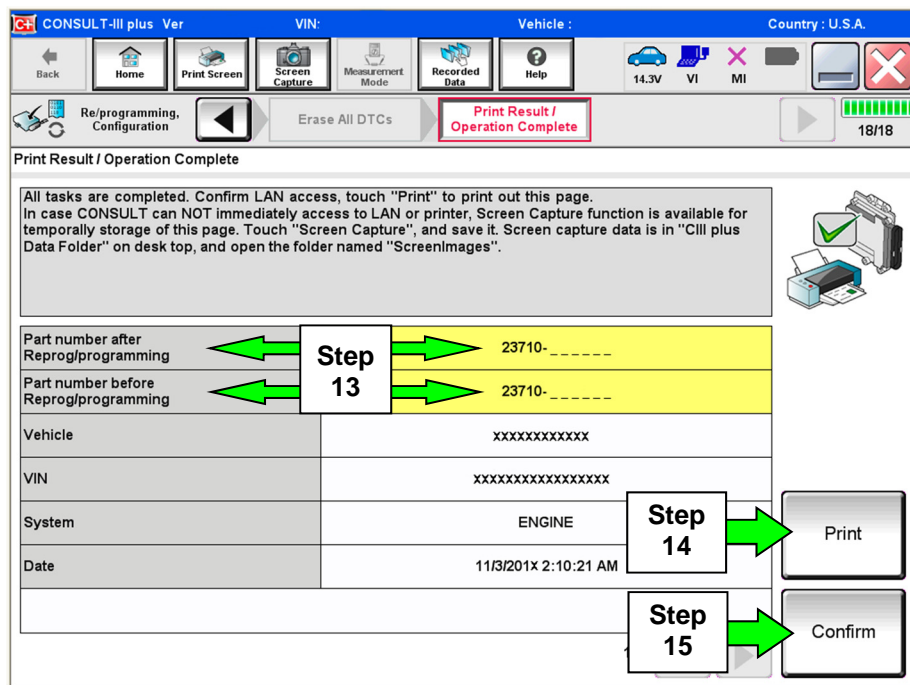
12. When the entire reprogramming process is complete, the screen in Figure 8 will display.
13. Verify the before and after part numbers are different.
14. Print a copy of this screen (Figure 8) and attach it to the repair order for warranty documentation.
15. Select **Confirm**.
