CAMPAIGN BULLETIN

VCR Engine Inspection

Reference: PC724

PC724 - 2020 ALTIMA VCR ENGINE INSPECTION

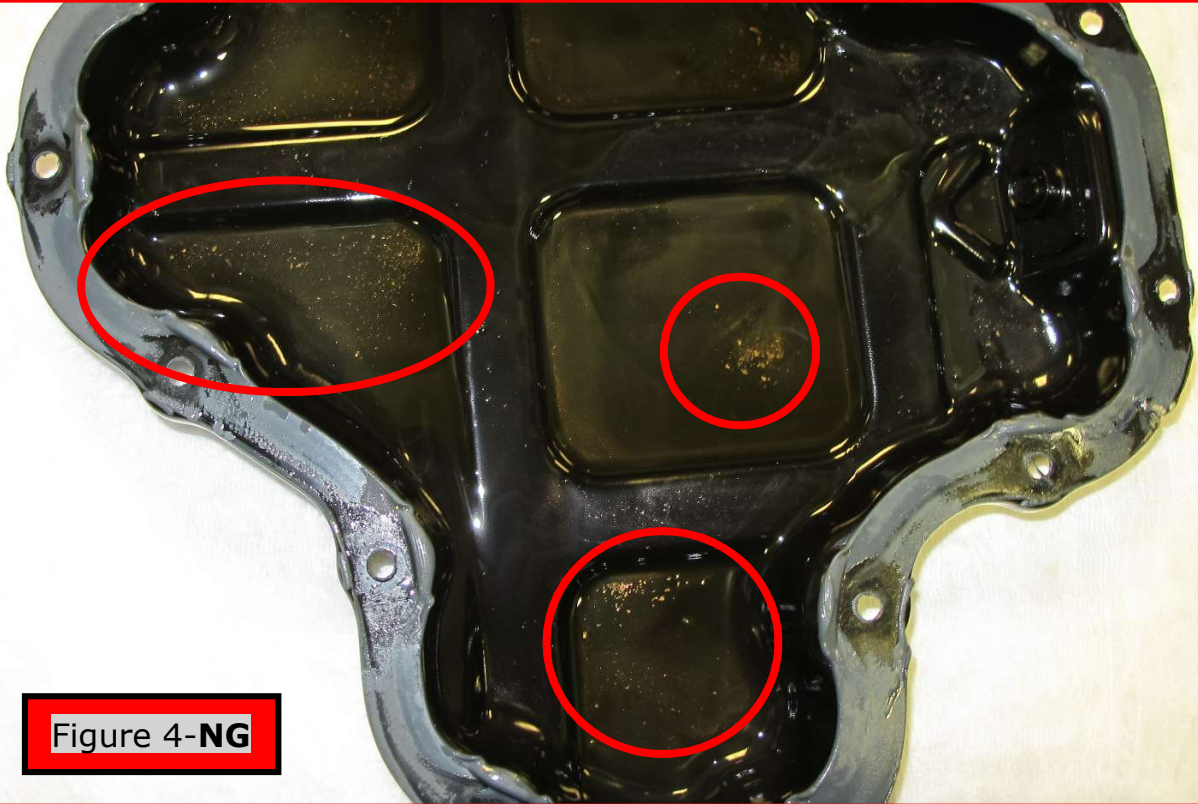
Figure 4-NG

5. Inspect the lower engine oil pan for gold colored debris.
- Any amount of **gold** colored debris in engine oil pan is **NG (Figure 4)**
 - **No debris or black and silver debris** in the engine oil pan for this inspection is considered **OK (Figure 5)**

7. If **NG condition**, provide a video to FQA using the information below and **HOLD** the vehicle until further notice.

- Take a short video starting at the lower engine oil pan to show debris and move to the VIN certification label
- Video needs to be less than 8mb in size
- Email video to nnafqasupport@nissan-usa.com
 - Make sure to include the below information:
 - E-Mail Subject Line: PC724 Altima VCR Engine Inspection
 - Dealer Name:
 - Dealer Code:
 - Dealer Address:
 - VIN:
 - Contact Person Name:
 - Contact Person Phone Number:
