## **Service Bulletin**

**Bulletin No.:** 2019-0039

World Trans E-series, 2016MY thru 2018MY

To repair assembly of second unit body front hood to vehicle chassis over driver door and windshield on the passenger side.

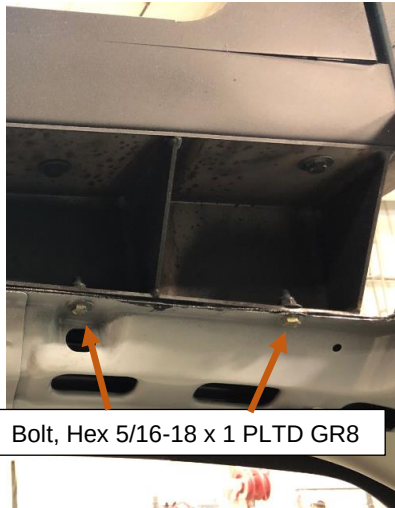
Photo #5  
Location 1,  
Above driver side A-pillar

4. Inspect the following areas:
  - a. Location 1, above driver side A-pillar; reference Photo 5.
  - b. Location 2; above driver side B-pillar; reference Photo 6.
  - c. Location 3; above passenger side A-pillar; reference Photo 7.

5. If damage to any of these three areas is realized, proceed with the appropriate Repair Procedure outlined in this Bulletin.
6. If no damage to any of these three areas is realized, no further action is required. Proceed to the **Finish** section beginning at Step 61.

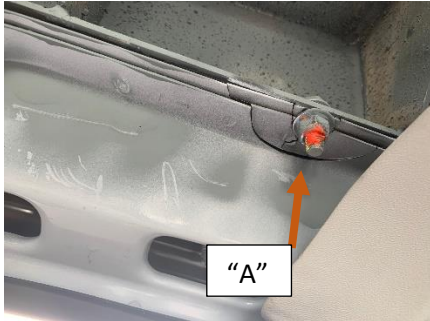
3. Locate fasteners securing the second unit body bracket/hood to the vehicle chassis over the driver door that shows fracture to the vehicle chassis. Reference Photos #13, #10, #11, and #12.

4. If there is a fracture in the sheet metal at Location 1 "A" or "B", proceed to Step #6. Reference Photos #5 and #13.
5. If there is no fracture in the sheet metal at Location 1 "A" or "B", proceed to Step #10.
6. Mark a location 2.00 inches rearward of fastener "A", and 0.50 inches outward from the edge of the bracket. Drill a 0.38-inch diameter hole from the underside of the chassis door frame thru the second unit body bracket. Reference Photos #10 and #13.

29. Weld the vehicle chassis fractured parts to the vehicle chassis door frame. Reference Photo #10 and #11, as appropriate.
30. Spray paint the welded areas using a corrosion inhibitor paint.

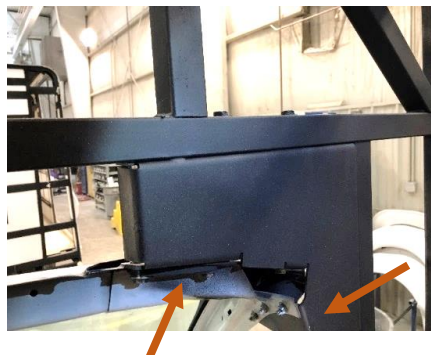
Photo #17

34. Locate the second unit body bracket above the windshield on the passenger side.  
Reference Photo #7 and #17.
35. Inspect for fractures in the vehicle chassis above the windshield or on the second unit body bracket. Reference Photo #17.

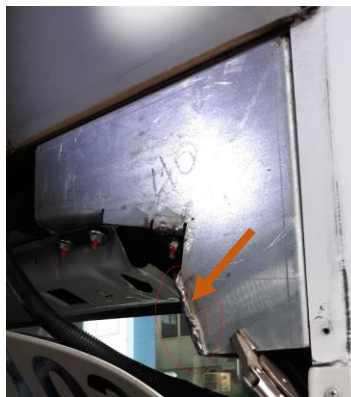
Photo #20

37. If a fracture in the bracket is not realized, then proceed to Step 41.
38. If a fracture in the bracket is realized, prep the area for weld by grinding the area to be welded on each bracket piece. Reference Photo #20.

39. Weld the bracket pieces together. Reference Photo #20.
40. Spray paint the welded area using a corrosion inhibitor paint.
41. Measure distance between the top of the bracket over the driver door to the bottom of the second unit body hood at each fastener location. Reference Photo #21.

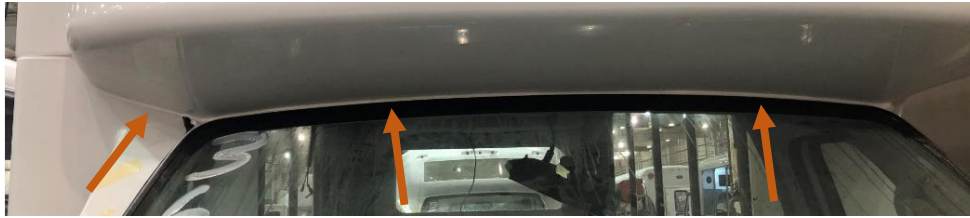
Photo #23

61. Re-install the ABS Trim Cover over the windshield, reversing task(s) of Step 3.
62. Re-install the ABS Trim Cover over the driver door and bulkhead, reversing task(s) of Step 2.
63. Re-install the ABS Trim Cover on the passenger A-pillar, reversing task(s) of Step 1.
64. Inspect the caulking on the exterior of the vehicle sealing the joint between the front cap and vehicle chassis over the windshield. Reference Photo #23.

65. IF cracking of the caulking is realized, remove carefully the caulking between the front cap and vehicle chassis over the windshield. Reference Photo #23.  
Proceed to Step 65.
66. IF no cracking of the caulking is realized, then no further action is required.
67. Clean the surfaces on the front cap and vehicle chassis where the caulking was removed using paint reducer.
68. Apply new caulking/sealant at the joint of the front cap and vehicle chassis over the windshield. Reference Photo #23.
