Title Assembled Camshaft - Injector Lobe Rotation Inspection For Possible Spun Camshaft Lobe; Diagnostic Trouble Codes (DTC) P0257-00, P2A17-00, Or P2A1F-00, Possible Lack Of Power – **US17+OBD16 and Newer Emissions**

Mack Models

Volvo Models

Engine family 11L Engine , 13L Engine , MP7 , MP8

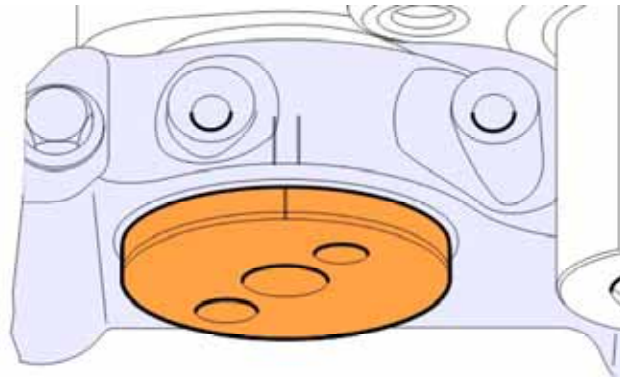
1. Rotate the engine with the turning tool in the normal direction of rotation until the timing marks are aligned for the Injector Pump(s). While the engine is being rotated, confirm each

injector lobe is rotating with the camshaft and does not slip.

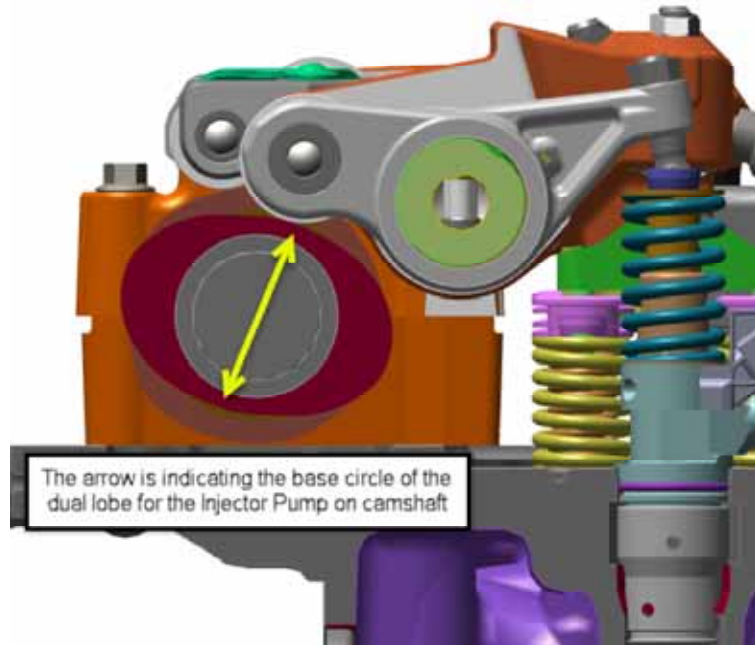
2. Once the timing marks are aligned for a specific Injector Pump, verify the injector rocker roller is on the base circle of the injector lobe. Refer to the illustration below.

Note: If an injector lobe rotates on the camshaft, the rotation is normally by 60 degrees. It takes approximately 15 degrees of rotation before potentially causing the faults codes listed previously or a fault for a pumping injector during the Common Rail Fuel System Test.
