# Technical Journal

TITLE:  
**Software download not possible, Vehicle in "Driving" mode**

<b>REF NO:</b> TJ 35290.1.0	<b>ISSUING DEPARTMENT:</b> Technical Service	<b>CAR MARKET:</b> United States and Canada	
<b>PARTNER:</b> 3 US 7510 Volvo Car USA		<b>ISSUE DATE:</b> 2019-11-25	<b>STATUS DATE:</b> 2019-12-06
<b>FUNC GROUP:</b> 3018	<b>FUNC DESC:</b> Software	Page 1 of 3

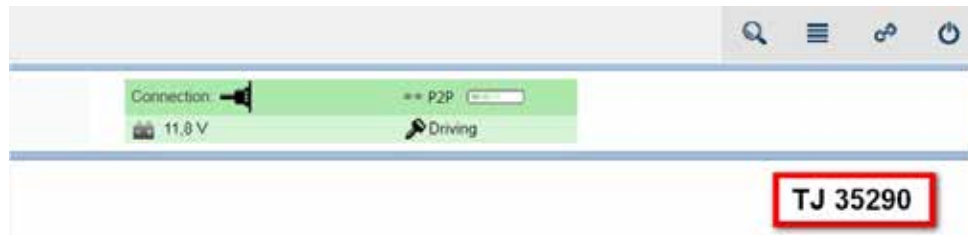
File Name	File Size
TJ 35290.jpg	0.0270 MB

If a software download fails for any reason, the vehicle may get stuck in usage mode “Driving” even if the engine is not running, and it’s not possible to change the usage mode by turning the start knob. When the vehicle is in usage mode “Driving” it will not be possible to download any software, see attachment TJ “35290.jpg”.

Follow below procedure to change the usage mode from “Driving” to a lower state.

1. Remove fuse for VCU1 (fuse *BF18* in Engine Junction Box).
2. Turn and keep the start knob at start position for at least 5 seconds, until the vehicle’s usage mode changes.
3. Re-install the fuse for VCU1.
4. Continue with the intended software download.
