TITLE:
PAC 360 side camera, intermittent no image

REF NO: TJ 32892.2.0	ISSUING DEPARTMENT: Technical Service	CAR MARKET: United States and Canada	
PARTNER: 3 US 7510 Volvo Car USA		ISSUE DATE: 2019-12-05	STATUS DATE: 2019-12-10
FUNC GROUP: 3871	FUNC DESC: Parking assistance	Page 1 of 4

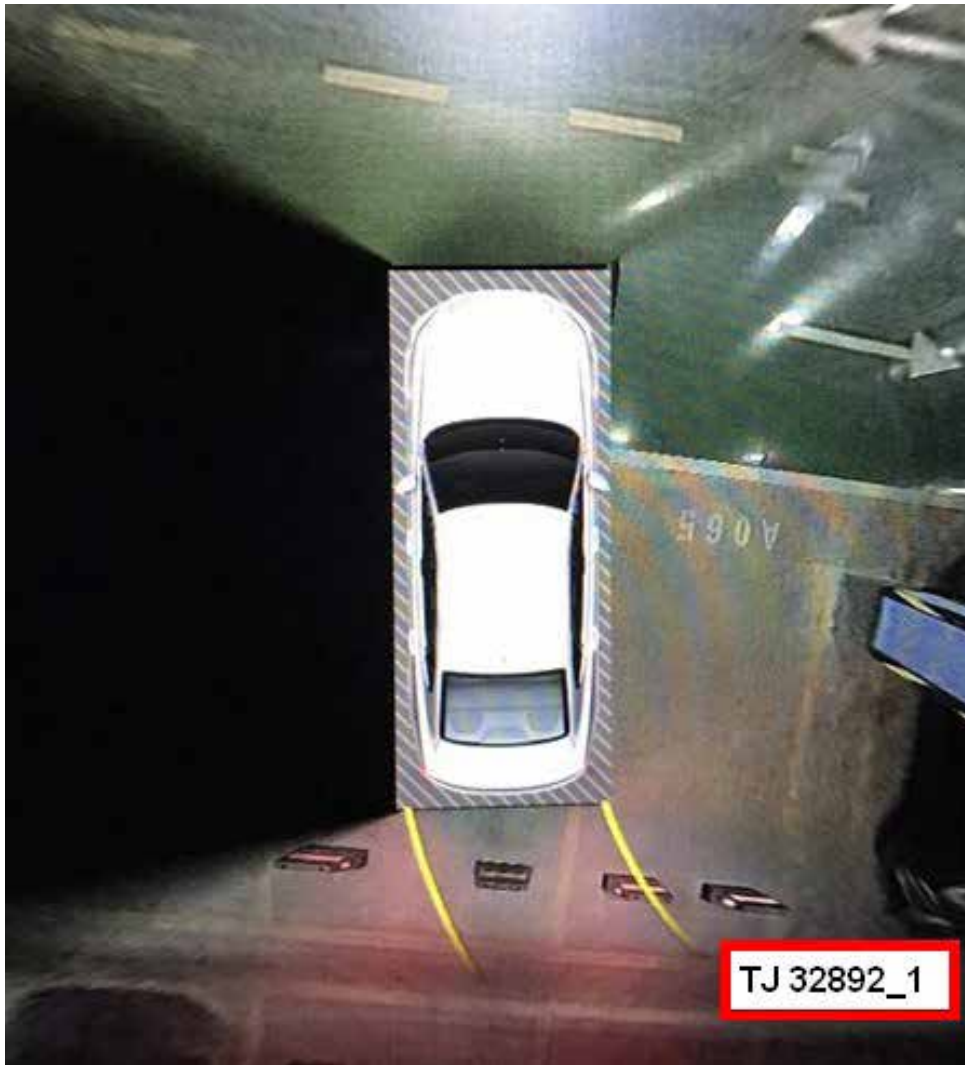
If there is no camera image intermittently for left/right side PAC (PAC 360) without any DTCs (see picture TJ 32892_1.jpg) please follow instructions under “Service”.

Check that all doors are closed and side mirrors are unfolded.

If there is no/black image, try to recover image by pressing the “fold/unfold mirror” buttons on driver door controls. If still not shown, repeat the operation a few times.

If still not successful, do not replace any parts for this symptom:

If the above described symptom still occurs, the DDM/PDM need to be upgraded with improved software.

The software can be downloaded in accordance with TJ 31543. (The improved DDM/PDM software is included in software products such as Service 2.0, PDS, Total Upgrade)

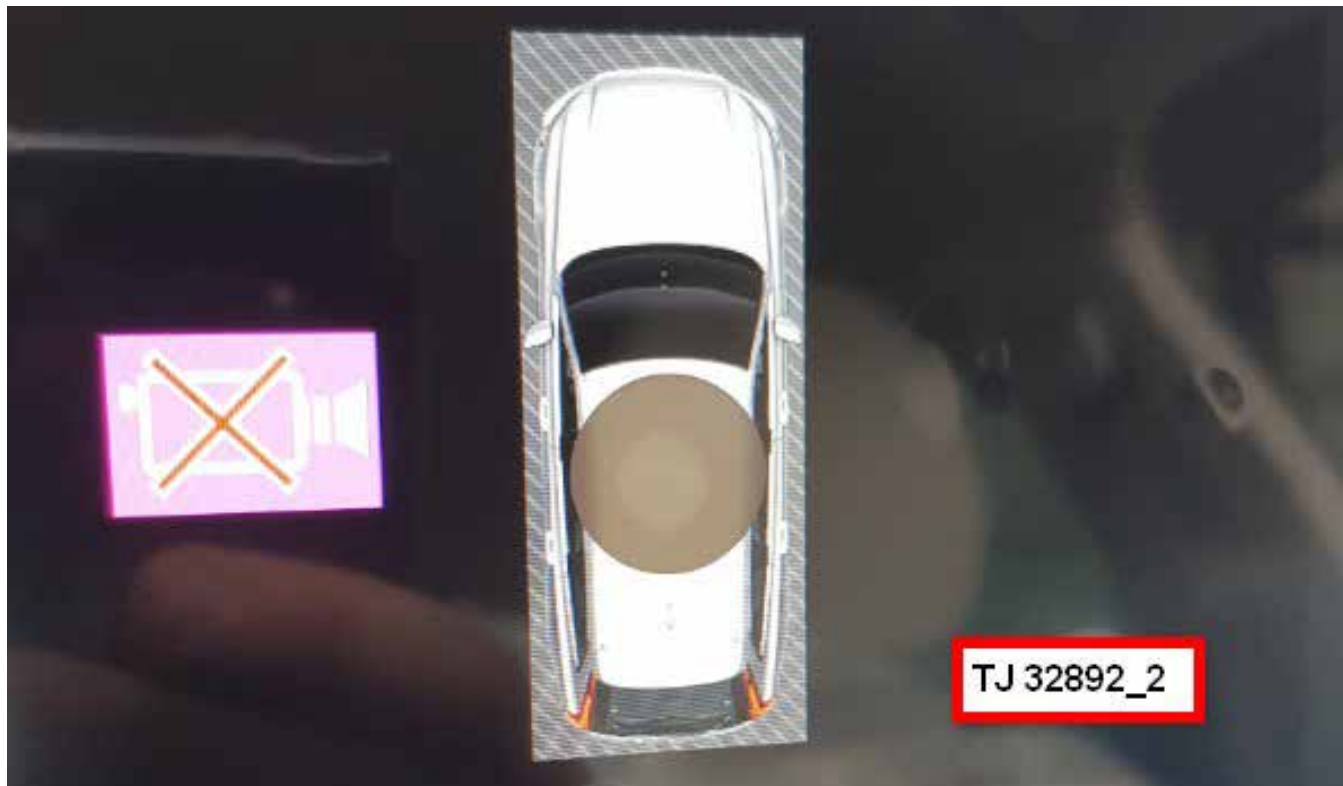
If a DTC is present in the WAM, CEM, DDM/PDM or there is a hardware/harness problem related to the PAC camera, a pink crossed camera image will be shown see picture (TJ 32892_2.jpg), then fault trace according to VIDA for the present DTC.
