Hesitation On Acceleration From a Slow Roll or Rolling Stop

Service Category Engine/Hybrid System

YEAR(S)	MODEL(S)	ADDITIONAL INFORMATION
2019	RAV4

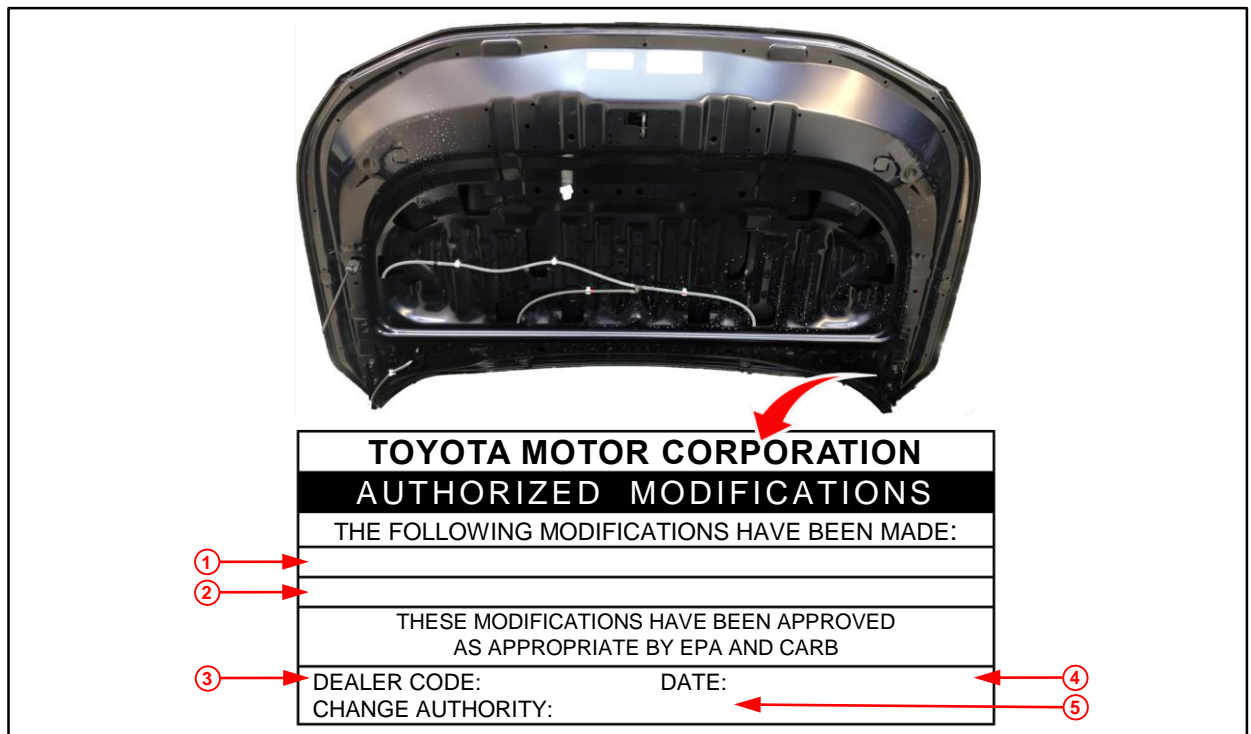
Figure 1. Location of Authorized Modifications Label on 2019 RAV4

- Use Techstream to confirm if the ECM (PCM) calibration has been updated and check for the Authorized Modifications Label affixed to the vehicle in the location shown below.

4. Prepare and install the Authorized Modifications Label.
 - A. Using a permanent marker, enter the following information on the label:
 - ECM (PCM) part number [*Refer to the **Parts Information** section for the **NEW PART NUMBER***]
 - Calibration ID(s) [*Refer to the **Calibration Information** section for the **NEW CALIBRATION ID***]
 - Dealer Code
 - Repair Date
 - Change Authority [***This bulletin number***]
 - B. Install the Authorized Modifications Label onto the vehicle at the location shown in Figure 1. The Authorized Modifications Label is available through the MDC, P/N 00451-00001-LBL.
