NUMBER: 23-033-19

DATE: December 4, 2019

Hood Bezel is Warped and Hood Paint is Damaged or Chipped

2018 (LA) Dodge Challenger (Demon)

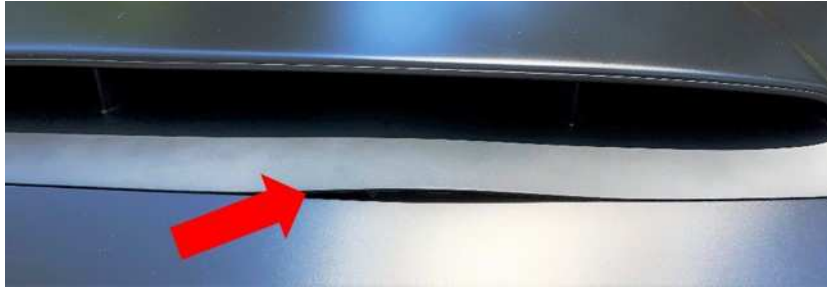
Fig. 1

1. Inspect the hood bezel for a warped condition (Fig. 1) and the hood for chipped or damaged paint (Fig. 2) around the hood bezel opening.

Example Of A Warped Hood Bezel (Bezel May Be Warped In More Than One Location)

1. Replace the hood bezel, discarding the old bezel. Refer to the detailed service procedure available in: <https://www.fcamastertech.com/content/eLearning/MT1908-Master-Tech/index.html> .

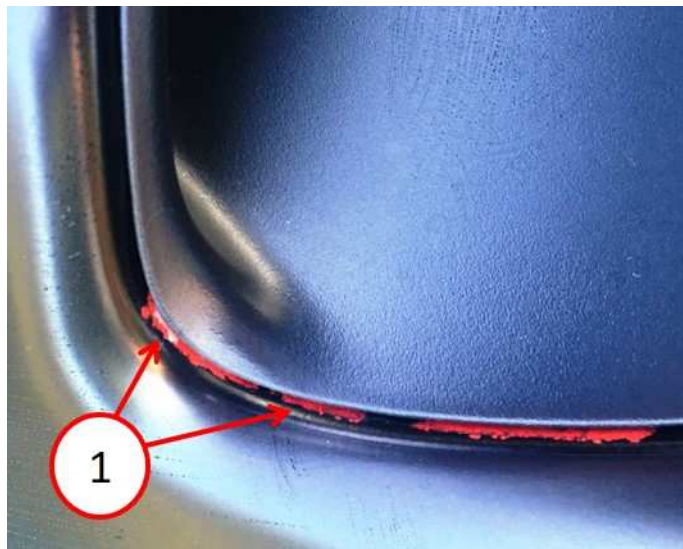
Fig. 2

Example Of Damaged Hood Paint

1 - Chipped Hood Paint (Requires Photos Of Damaged Paint)

2. Remove and discard the hood bezel. Refer to the detailed service procedure available in: <https://www.fcamastertech.com/content/eLearning/MT1809-Master-Tech/index.html>.
3. Refinish the hood per the Axalta refinish process.
4. Feather sand the surface area with P500 sandpaper.
5. Which type of basecoat will be used?
 - Solvent Basecoat >>> Proceed to **Step 1** of the Solvent Basecoat Procedure.
 - Waterborne Basecoat >>> Proceed to **Step 1** of the Waterborne Basecoat Procedure.
