NUMBER: 08-120-19

GROUP: 08 - Electrical

DATE: December 4, 2019

UGQ Radio Enhancements

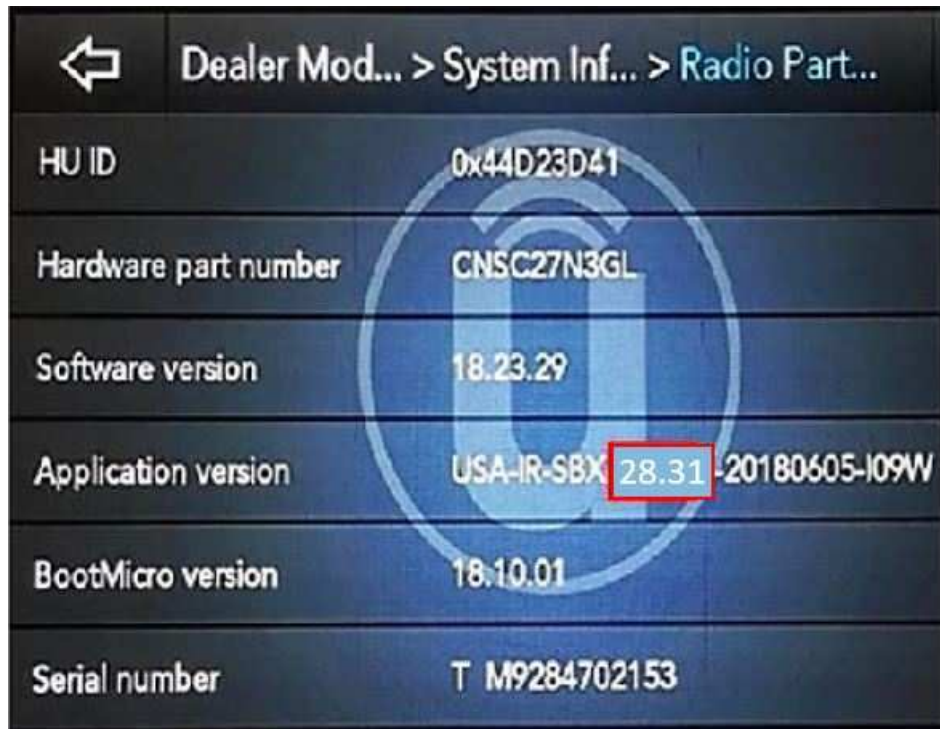
Fig. 1

Radio Software Level Screen

1. Verify the radio software version. Radio must be in Dealer Mode to verify by following these steps:
 - a. Push and hold the front defrost, driver temperature up and temperature down buttons simultaneously until the 'Dealer Mode' screen appears (approximately seven seconds). Release buttons.
 - b. Select "Radio Part Information". The software version will be listed next to "Application Version" (Fig. 1) .

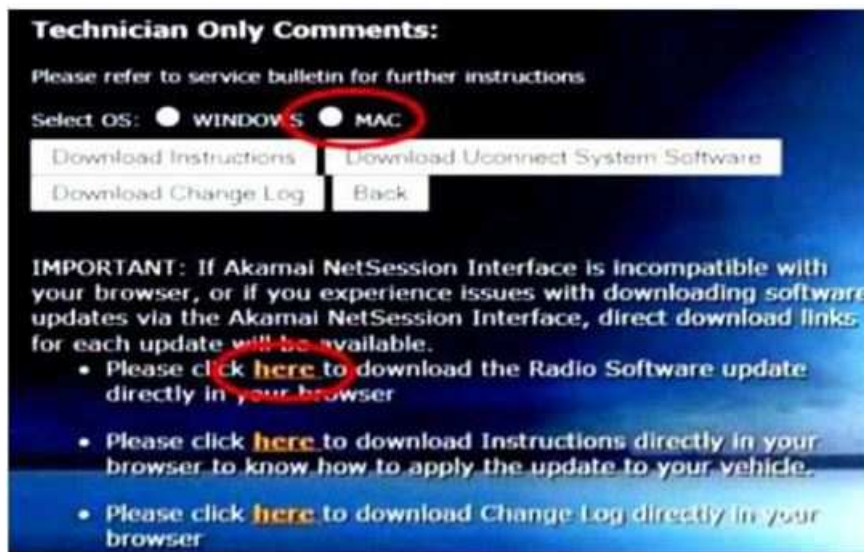
Fig. 3
MAC Download Steps

5. Download the software update file to your local PC’s desktop. Make sure to select the “MAC” radial button for all downloads (Fig. 4) .

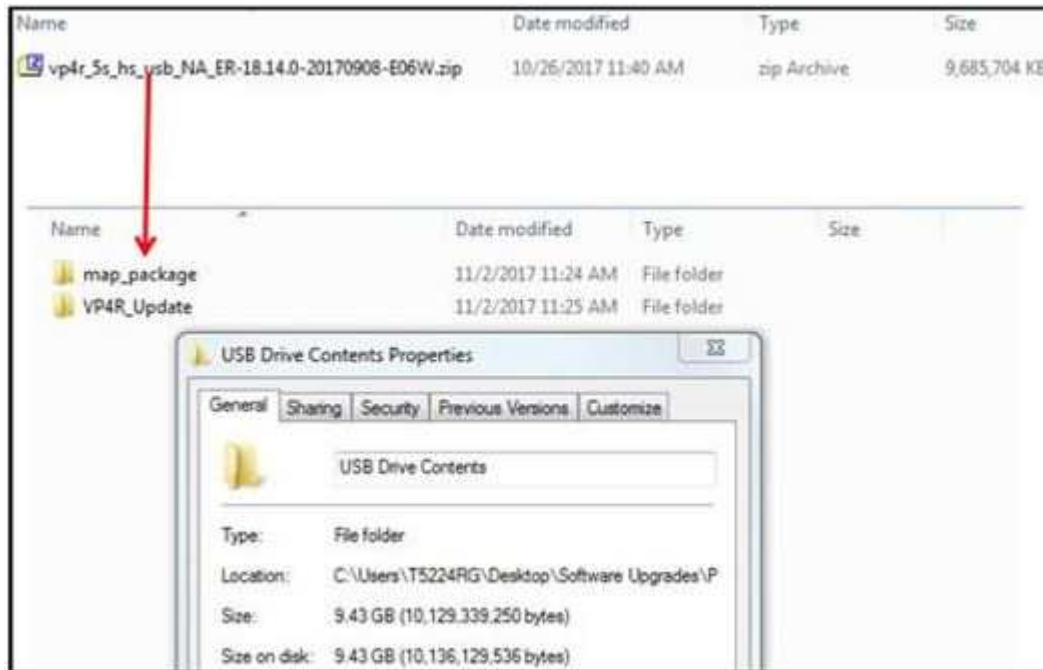
Fig. 4
Files/Folders In The USB Flash Drive

- Unzip all the files to the root folder of USB flash drive. Files should not be within a zip folder. Your USB files should look like (Fig. 5) when you open it, displaying multiple files/folders.

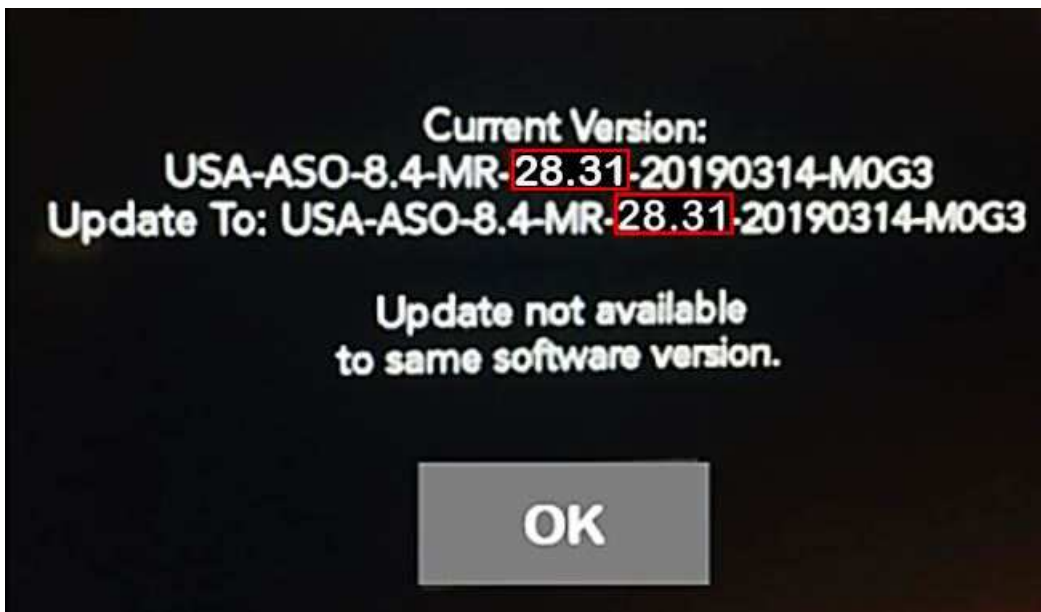
Fig. 6
Screen Displayed When Radio Software Level Is Up To Date

11. If the radio software is up to date, the screen in (Fig. 7) will be displayed. Press "OK" and remove the USB flash drive.

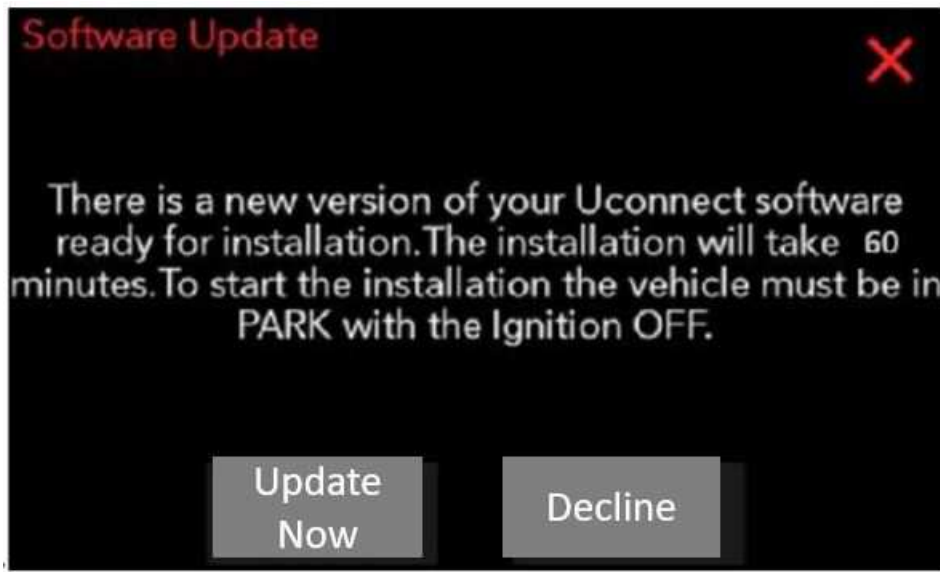
Fig. 7

Software Update Is Available

12. Once the system has verified there is an available update, press the “Update Now” button. Make sure the vehicle is in park. **Turn off the ignition at this point, (Fig. 8) .**

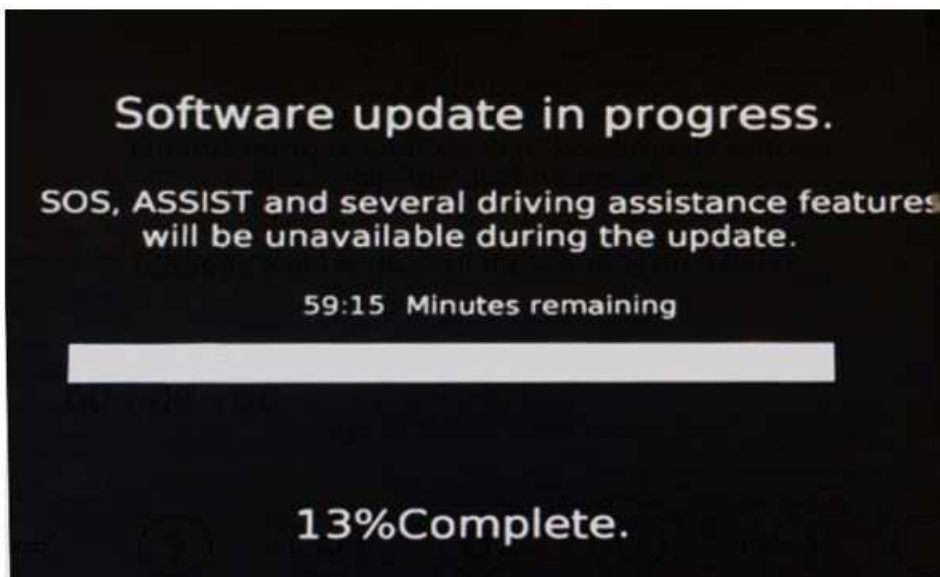
Fig. 9

Software Update In Progress

14. The radio will reboot and the update will begin. The update should only take 50 minutes, the timer on the screen may display the incorrect time remaining, (Fig. 10) .

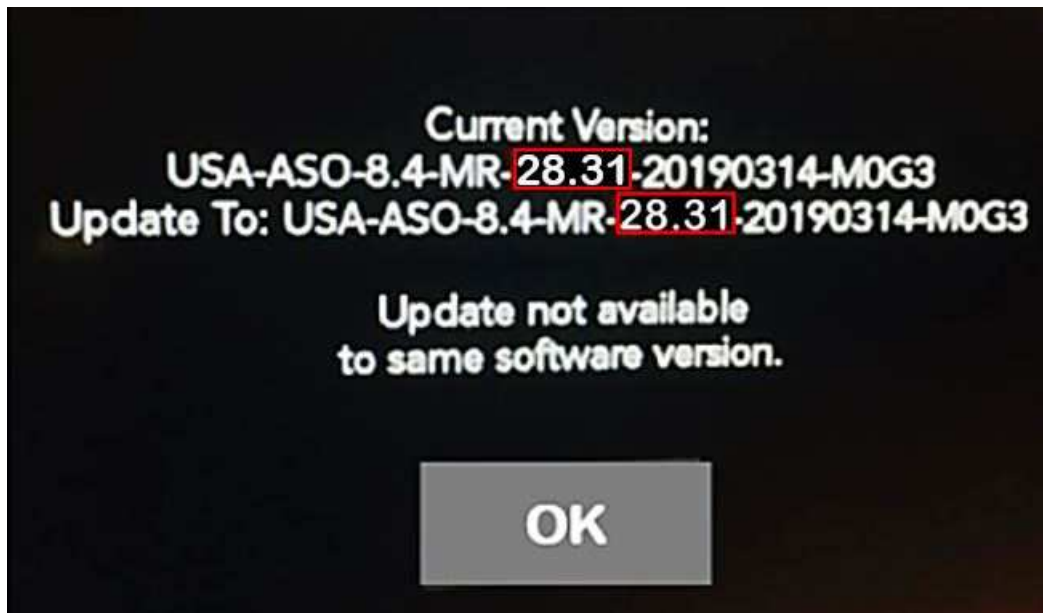
Fig. 10
Radio Software Has Been Updated.

15. After the update has completed, the radio will shut down. With the USB flash drive still inserted in the USB port, turn the ignition back to the run position. If the radio has been updated correctly, the screen in (Fig. 11) will be displayed. Press “OK” and remove the USB flash drive.
