NUMBER: 23-033-19 REV. A

Hood Bezel is Warped and Hood Paint is Damaged or Chipped

2018 (LA) Dodge Challenger (Demon)

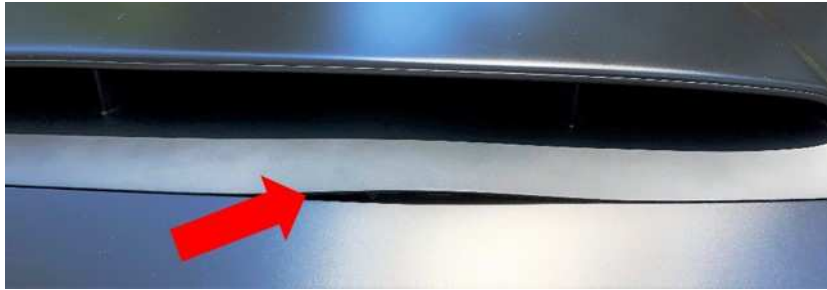
Fig. 1

- The hood bezel is warping and in some cases, chipping the paint on the sides and corners of the hood bezel opening.

Example Of A Warped Hood Bezel (Bezel May Be Warped In More Than One Location)

1. Replace the hood bezel, discarding the old bezel. Refer to the detailed service procedure available in:
 ** <https://www.fcamastertech.com/content/eLearning/MT1908-Master-Tech/index.html> .**
 This bulletin has been completed, use LOP (23-09-57-90) to close the active RRT.
2. Remove and discard the hood bezel. Refer to the detailed service procedure available in:
<https://www.fcamastertech.com/content/eLearning/MT1908-Master-Tech/index.html> .**
3. Refinish the hood per the Axalta refinish process.
4. Feather sand the surface area with P500 sandpaper.
5. Which type of basecoat will be used?
 - Solvent Basecoat >>> Proceed to [Step 1](#) of the Solvent Basecoat Procedure.
 - Waterborne Basecoat >>> Proceed to [Step 1](#) of the Waterborne Basecoat Procedure.

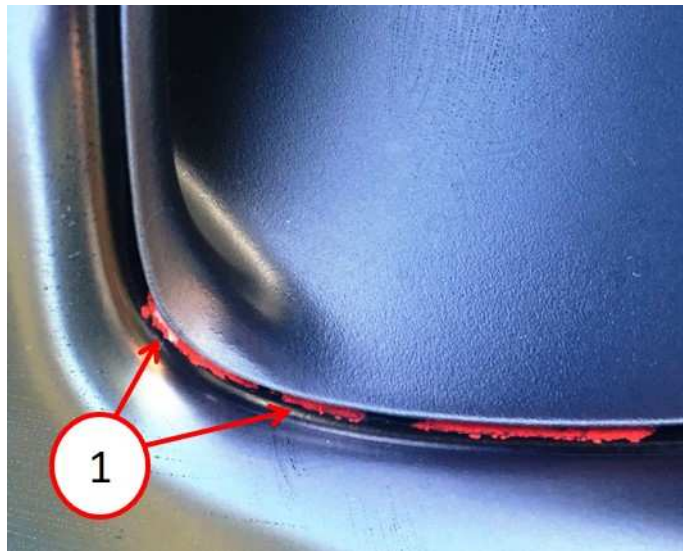
Fig. 2

Example Of Damaged Hood Paint

1 - Chipped Hood Paint (Requires Photos Of Damaged Paint)
