NUMBER: 23-035-19

Rattle Noise in the Headliner

This bulletin involves inspecting the front headliner upper zone for excessive gap caused by a lack of sealer and if necessary, lowering headliner and adding sealer.

2020 (MP) Jeep Compass

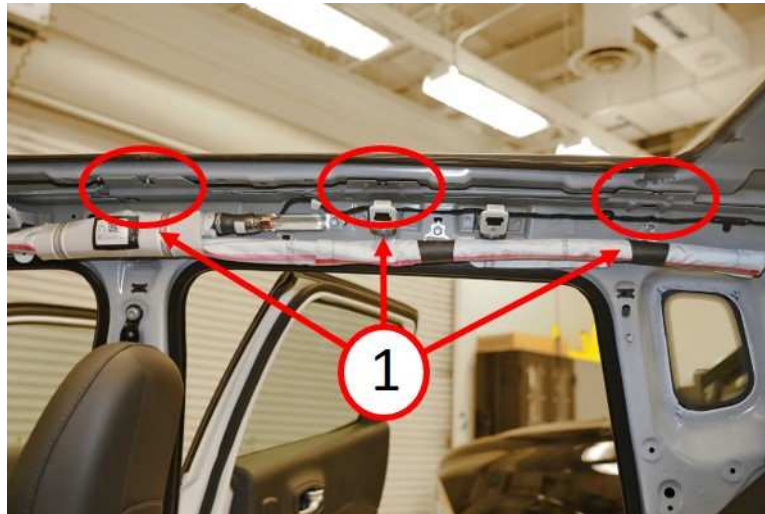
Fig. 1
Areas To Inspect

2. Inspect the B-pillar reinforcement to roof panel for any gap (Fig. 1) .

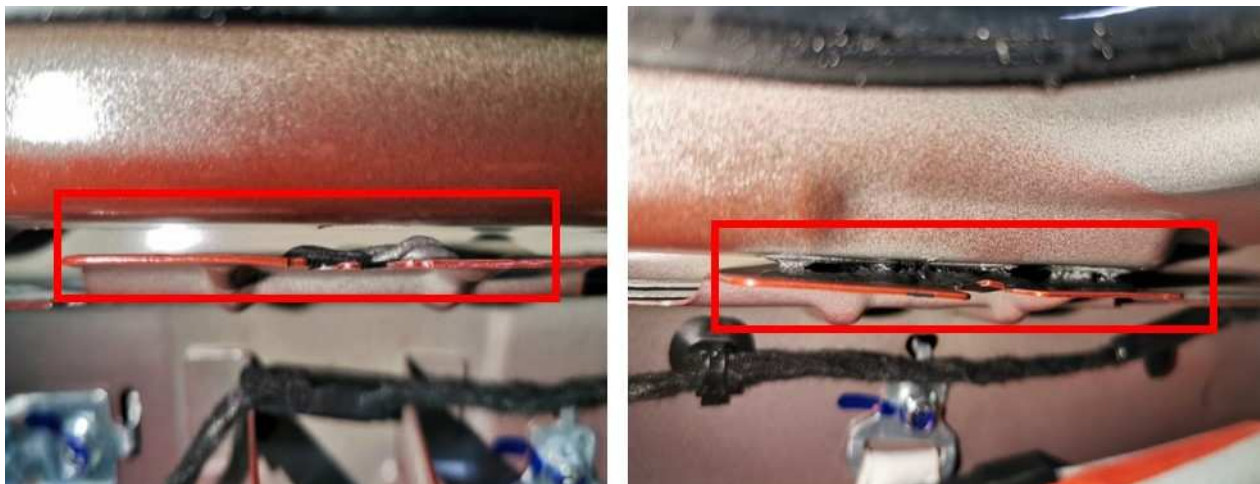
Fig. 2
Sealer Inspection Area (shown with gap)

NOTE: The reinforcement tabs should be in contact to the roof panel with sealer in between and no gap (Fig. 2) .
