NUMBER: 23-036-19

Leather Instrument Panel (IP) Cover Delaminating - X81 Warranty Extension

2011 - 2014 (WK) Jeep Grand Cherokee

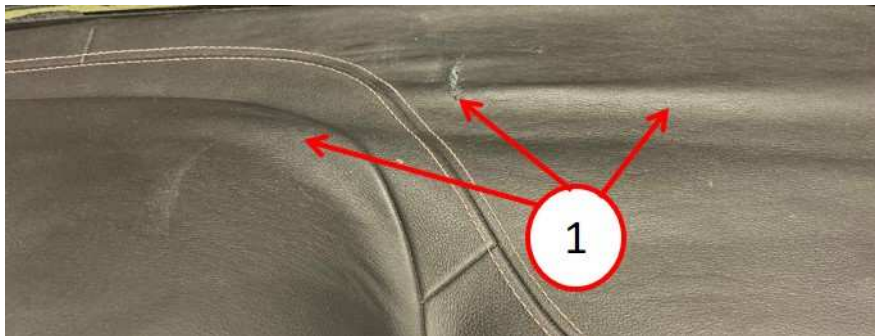
- The upper leather IP cover is delaminating or separating.

Fig. 1
IP Upper Cover Delamination

1. Were digital photos taken of the VIN, IP cover at both A-pillars, IP cover damage and the entire width of IP cover submitted and approval given?
 - YES>>> Proceed to [Step 2](#) of the Repair Procedure.
 - NO>>> Take photos of the VIN, IP cover at both A-pillars, IP cover damage and the entire width of IP cover and submit for approval.
2. Replace the upper IP cover. Refer to the detailed procedures available in DealerCONNECT > Service Library> under: 23 - Body/Instrument Panel/Cover, Instrument Panel/Removal/Installation.

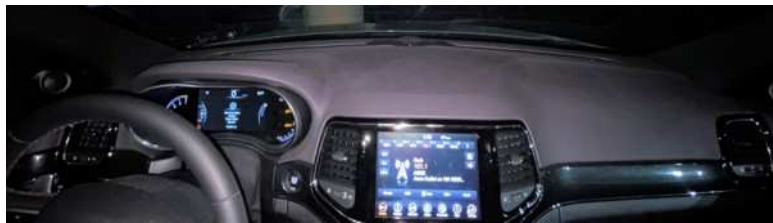
Fig. 2
Entire Width Of IP Cover For Claim Submittal

- To obtain pre-approval for this Repair Procedure, submit digital photos of the VIN, IP cover at the A-pillars, IP cover damage (Fig. 1) and an entire width of the IP cover (Fig. 2) .
- Submit all digital photos to the following email address:
x81digitalimagingapproval@fcagroup.com
