**NUMBER:** 23-035-19 REV. A

Rattle Noise in the Headliner

2020 (MP) Jeep Compass

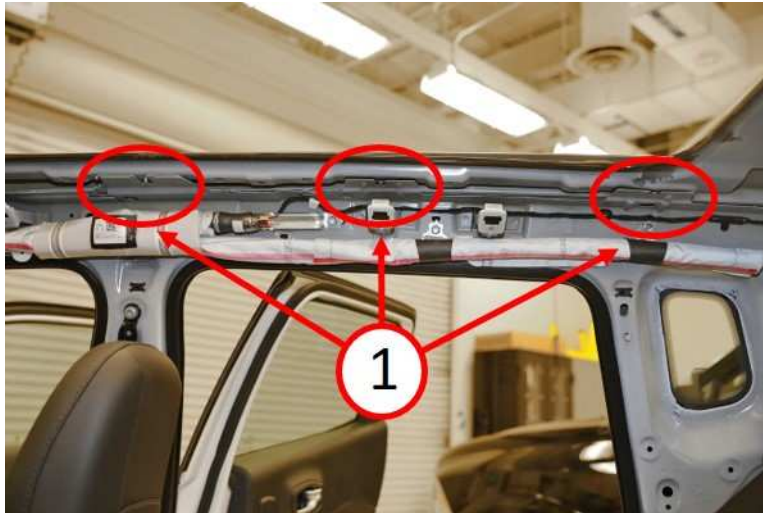
**Fig. 1**  
**Areas To Inspect**

2. Inspect the B-pillar reinforcement and the two other flange locations to roof panel (Fig. 1) for any gap.

1 - Reinforcement Flange to Roof Locations

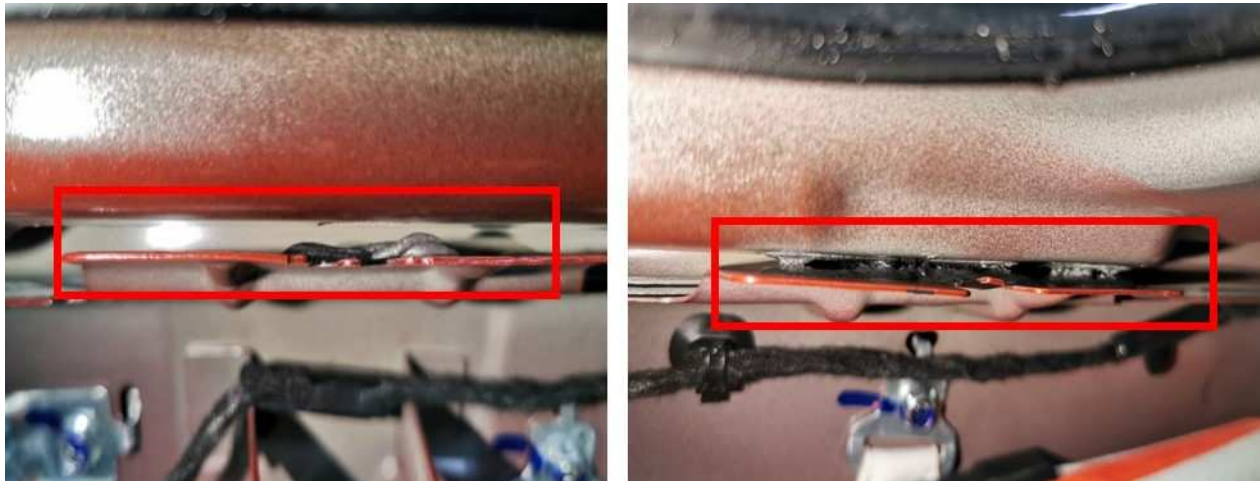
**Fig. 2**  
**Sealer Inspection Area (shown with gap)**

**NOTE:** The reinforcement tabs should be in contact to the roof panel with sealer in between and no gap (Fig. 2) .

3. Was any gap found?
  - YES>>> Proceed to [Step 1](#) of the Repair Procedure.
  - NO>>> This bulletin has been completed. Use inspection LOP (23-85-41-97) to close the active RRT.
