NUMBER: 08-126-19

Right Rear Window Switch Inoperable at Times

2019	(LX)	Chrysler 300
2019	(LD)	Dodge Charger

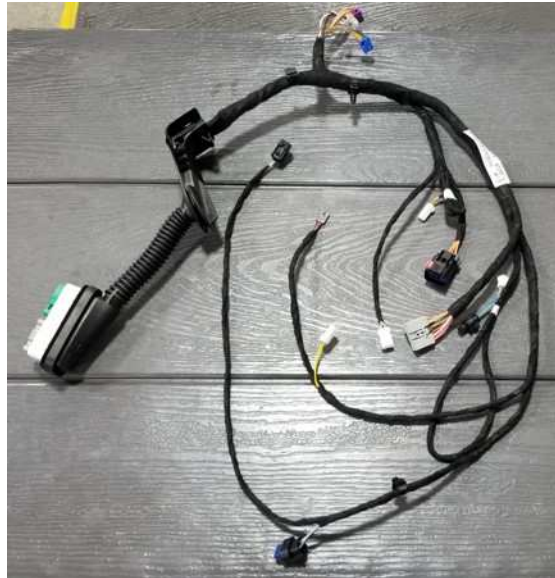
Fig. 1
Right Rear Door Wiring Harness And Wiring Connectors

- The right rear window switch intermittently will not power up or down the window.

1. Remove the rear door trim panel. Refer to the detailed service procedures available in DealerCONNECT/Service Library under: Service Info>23 - Body/Doors - Rear/Panel, Rear Door Trim/Removal.
2. Disconnect all wiring connectors and replace the right rear door wiring harness (Fig. 1) .
