**NUMBER:** 08-022-19 REV. A

UJQ without RS9 Radio Enhancements

This bulletin involves inspecting and if required, updating the radio software level to **\*\*22.5\*\***.

2018 - 2019	(LA)	Dodge Challenger
2018 - 2019	(LD)	Dodge Charger
2018 - 2019	(LX)	Chrysler 300

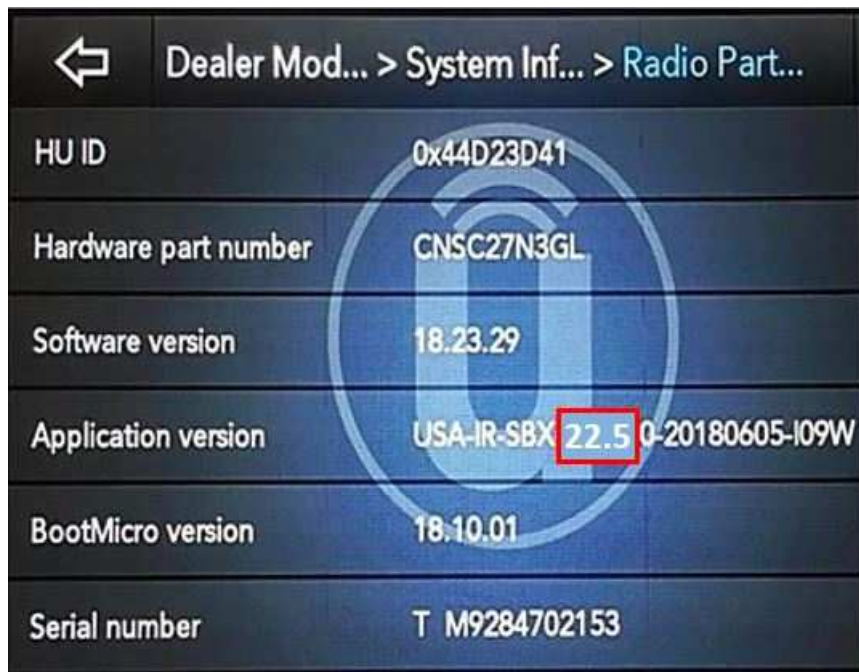
Fig. 1

1. Verify the radio software version. Radio must be in "Dealer Mode" to verify. To put the radio into "Dealer Mode" perform the following steps:
  - a. Push and hold the front defrost, driver temperature up and temperature down buttons simultaneously until the 'Dealer Mode' screen appears (approximately seven seconds). Release buttons.
  - b. Select "Radio Part Information". The software version will be listed next to "Application Version" (Fig. 1) .

Radio Software Level Screen

2. Is the radio software level (Application Version) at or higher than \*\*22.5\*\*?
  - YES >>> The radio software is already up to date. Normal diagnostic should be performed.
  - NO >>> Proceed to [Step 1](#) of the Repair Procedure.

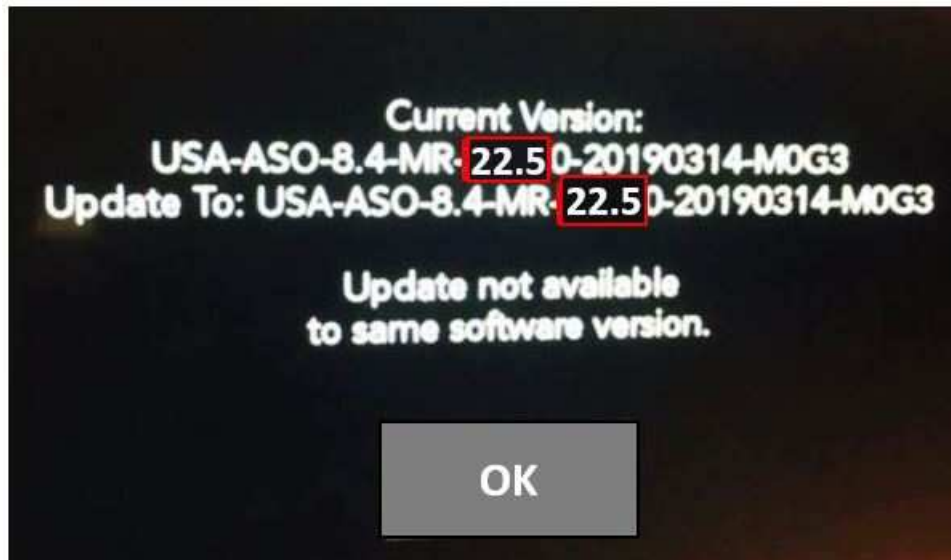
Fig. 6  
Screen Displayed When Radio Software Level Is Up To Date

11. If the radio software is up to date, the screen in (Fig. 6) will be displayed. Press "OK" and remove the USB flash drive.

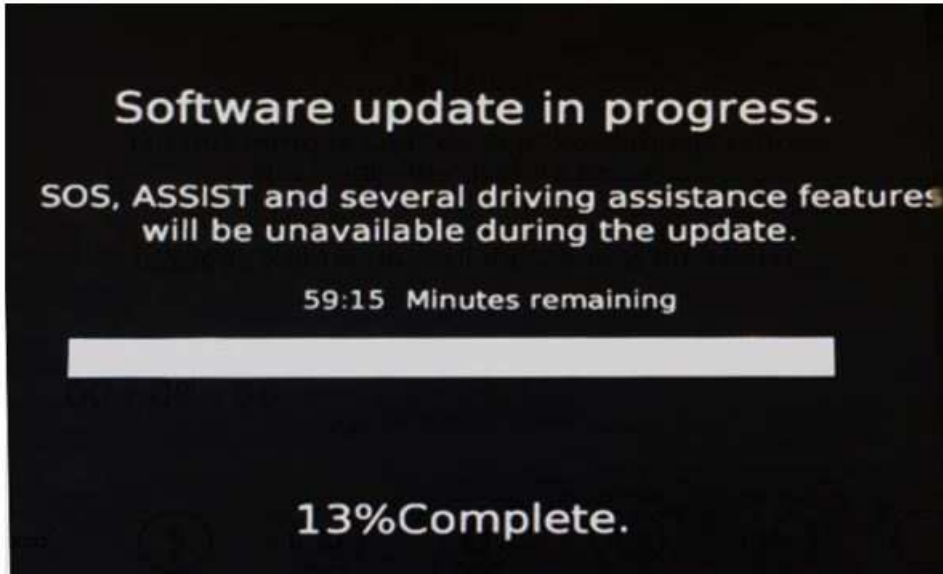
**NOTE:** The completion indicator may not reach 100%, even though the software update has been completed. Once the software update has finished, the radio and display screen will turn off.

Fig. 9  
Software Update In Progress

- 14. The radio will reboot and the update will begin. The update should only take 50 minutes, the timer on the screen may display the incorrect time remaining, (Fig. 9) .
