NUMBER: 23-034-19 REV. A

Poor Rear Wheel Opening Molding Adhesion to The Body

2019 (DS) RAM 1500 Pickup

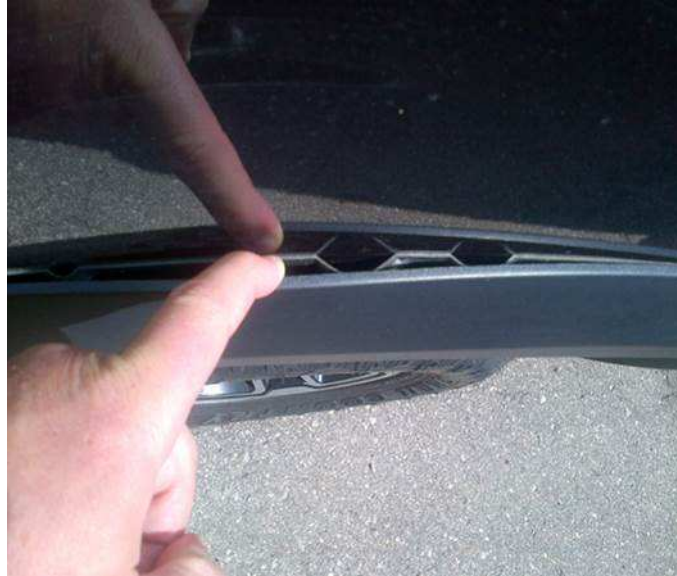
The customer may describe what appears to be a gap between the rear wheel opening molding and the body of the vehicle.

Rear wheel opening moldings may separate at body due to insufficient adhesive bond strength (Fig. 1) .

Fig. 1
Rear Wheel Opening Molding Separation

1. If rear wheel opening molding separation is visible at the body, the affected rear wheel opening molding will need to be replaced.
2. Was any seam separation found at the rear wheel opening moldings?
 - NO>>> Rear wheel opening molding separation was not found. This bulletin has been completed. Use LOP (23-02-60-95) to close the active RRT.
 - YES>>> Replace the affected rear wheel opening molding as require if signs of separation are shown. Refer to the detailed service procedures available in DealerConnect> Service Library under: Service Info>23 - Body / Exterior / Molding, Rear Wheel Opening / Removal/Installation.
