NUMBER: 08-128-19

DATE: December 21, 2019

UJQ Radio Enhancements

2018 - ****2019**** (JL) Jeep Wrangler

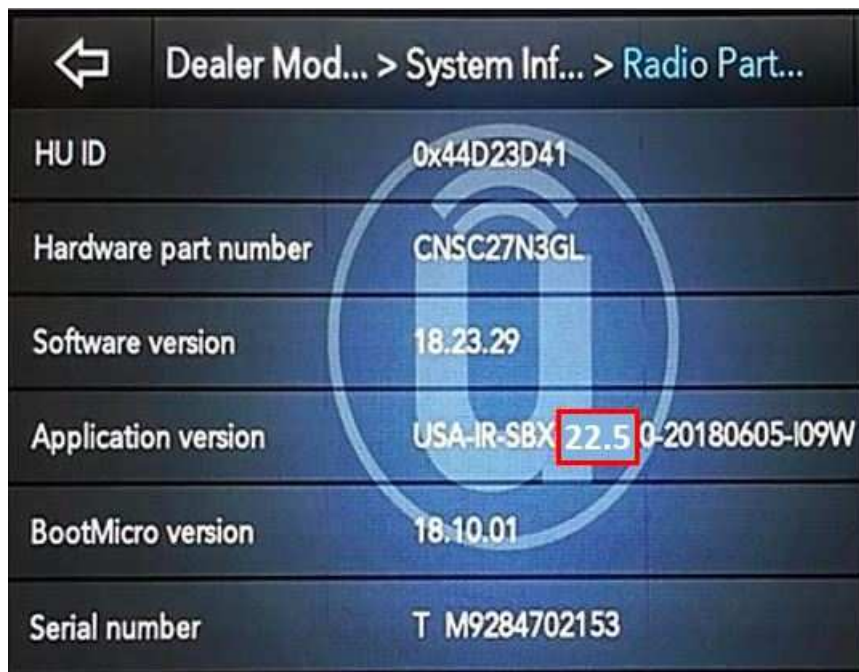
Fig. 1

1. Verify the radio software version. Radio must be in "Dealer Mode" to verify. To put the radio into "Dealer Mode" perform the following steps:
 - a. Push and hold the front defrost, driver temperature up and temperature down buttons simultaneously until the 'Dealer Mode' screen appears (approximately seven seconds). Release buttons.
 - b. Select "Radio Part Information". The software version will be listed next to "Application Version" (Fig. 1) .

Radio Software Level Screen

2. Is the radio software level (Application Version) at or higher than, 21.10 (With RS9) or 22.5 (Without RS9)?
 - YES >>> The radio software is already up to date. Normal diagnostic should be performed.
 - NO >>> Proceed to [Step 1](#) of the Repair Procedure.

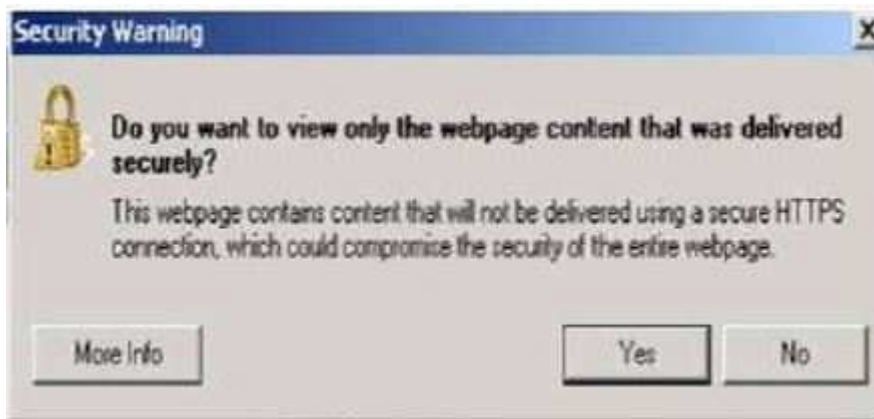
Fig. 2
Pop-Up Security Message

2. Go to DealerCONNECT>Service>Uconnect Command Center>Uconnect>More Information >Dealer software downloads to download the files.
3. If a security message appears “Do you want to view only the web page content that was delivered securely?” (Fig. 2) . Press “No” to continue.

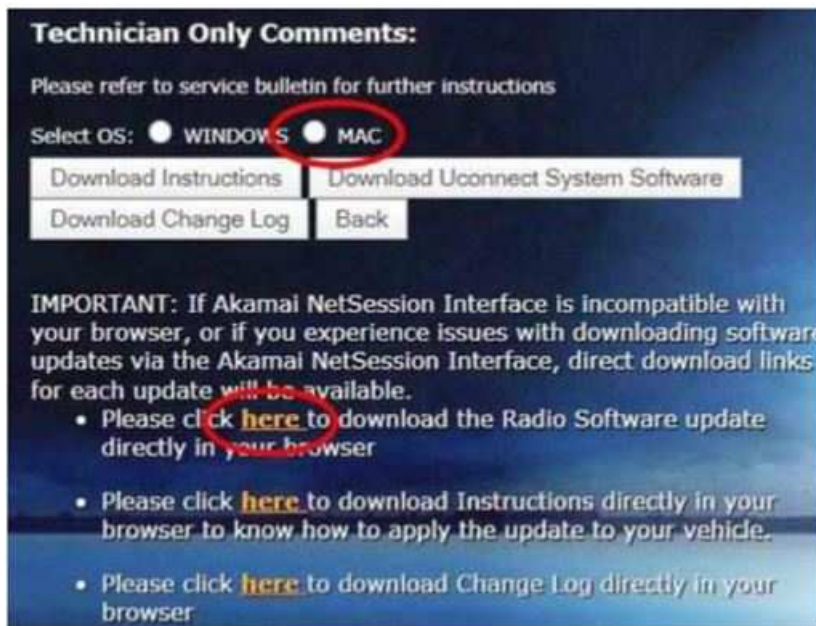
Fig. 3
MAC Download Steps

4. Use a blank USB flash drive with at least 16GB of space. Follow the on-screen instructions to download the software files.
5. Download the software update file to your local PC's desktop. Make sure to select the “MAC” radial button for all downloads (Fig. 3) .

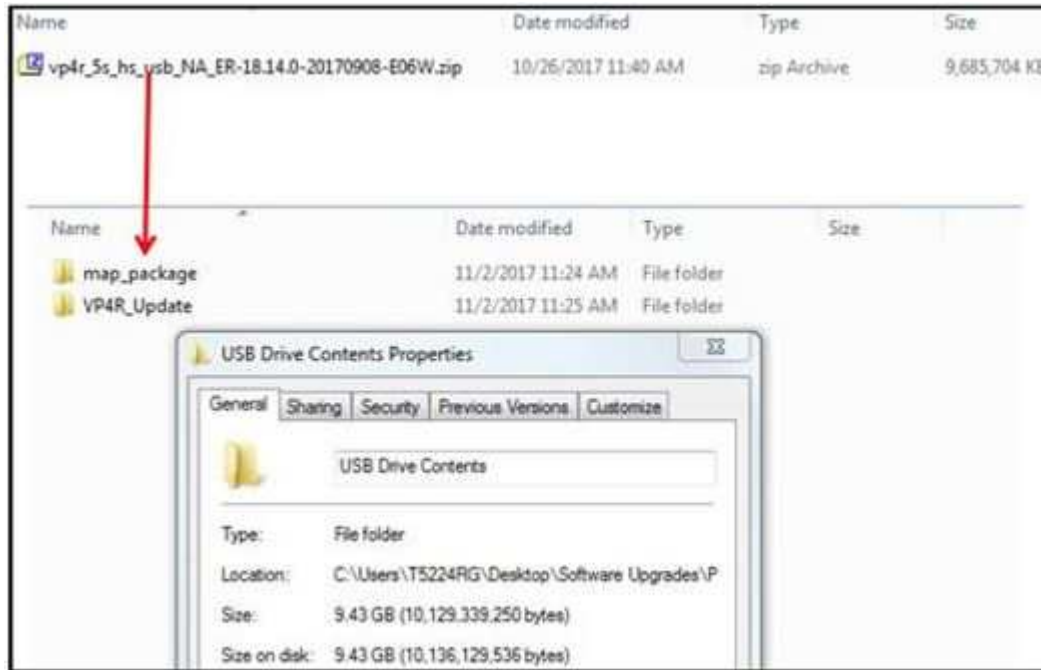
Fig. 4
Files/Folders In The USB Flash Drive

7. Unzip all the files to the root folder of USB flash drive. Files should not be within a zip folder. Your USB files should look like (Fig. 4) when you open it, displaying multiple files/folders.

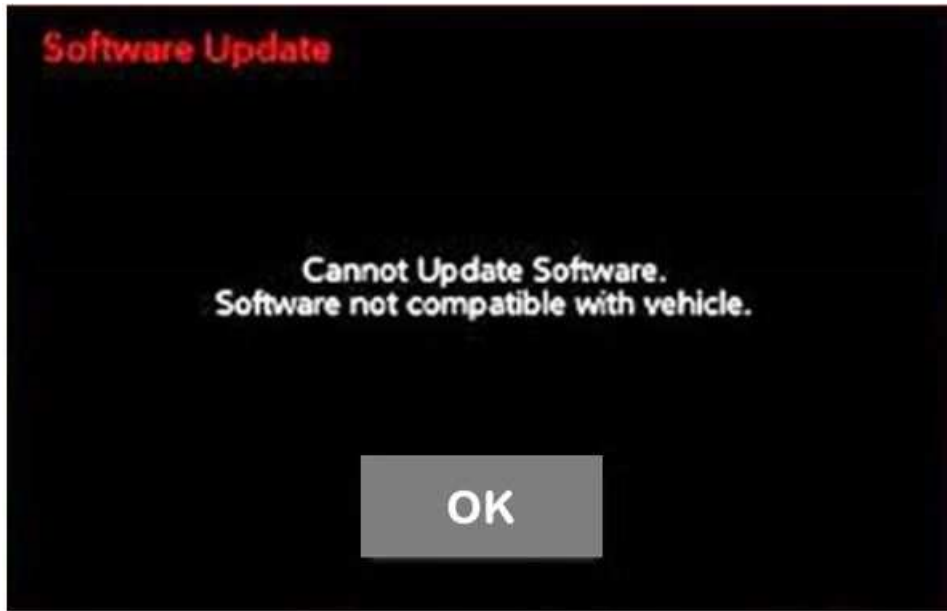
10. If the screen in (Fig. 5) is displayed, the USB flash drive was not set up correctly. Use a top name brand USB flash drive and create a new USB flash drive. Start the update again.

Fig. 5
Software Not Compatible

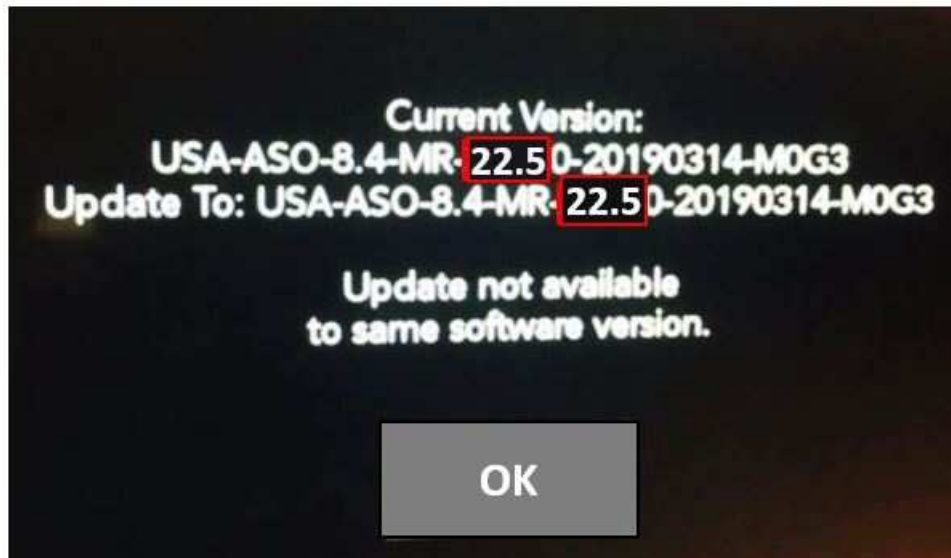
Fig. 6
Screen Displayed When Radio Software Level Is Up To Date

11. If the radio software is up to date, the screen in (Fig. 6) will be displayed. Press "OK" and remove the USB flash drive.

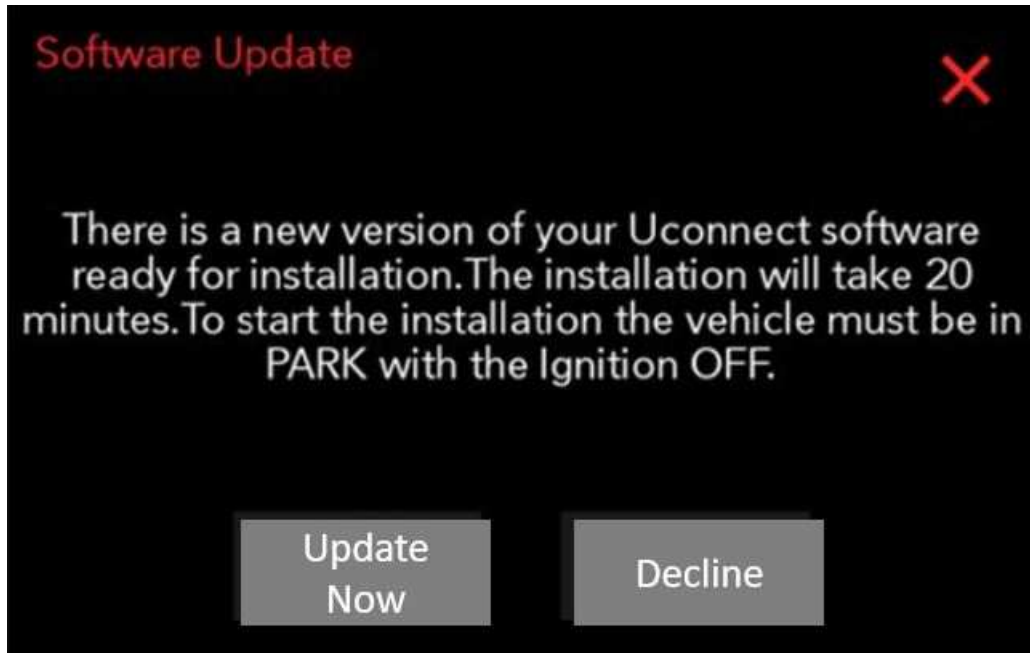
Fig. 7
Software Update Is Available

12. Once the system has verified there is an available update, press the “Update Now” button. Make sure the vehicle is in park. **Turn off the ignition, (Fig. 7) .**

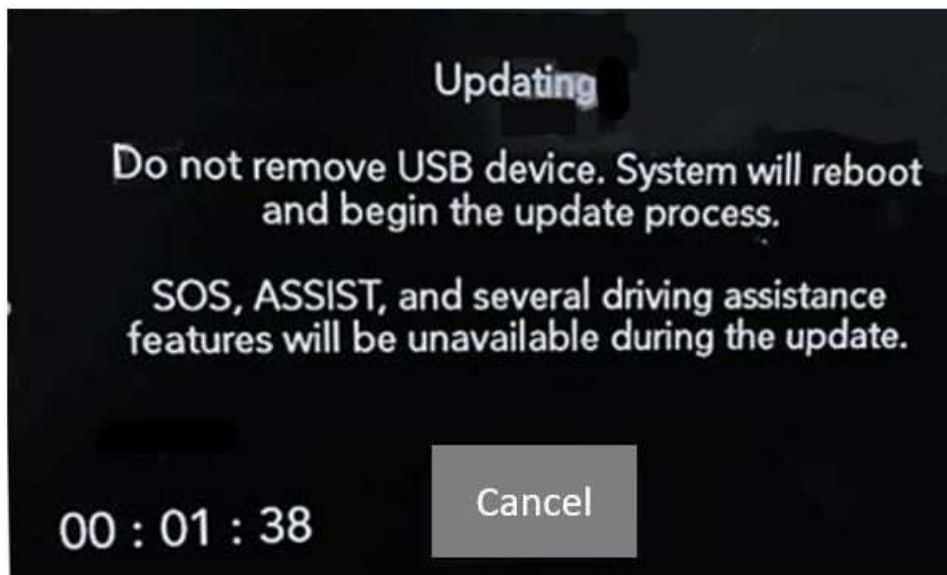
Fig. 8
Radio Update Process Begins

13. When the radio starts updating, the screen in (Fig. 8) will be displayed.

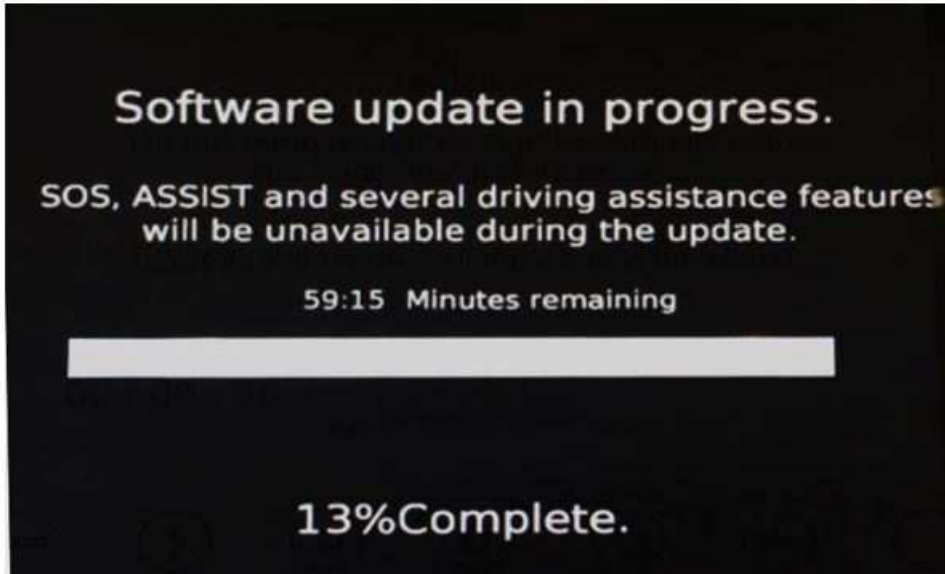
- 14. The radio will reboot and the update will begin. The update should only take 50 minutes, the timer on the screen may display the incorrect time remaining, (Fig. 9) .

Fig. 9
Software Update In Progress

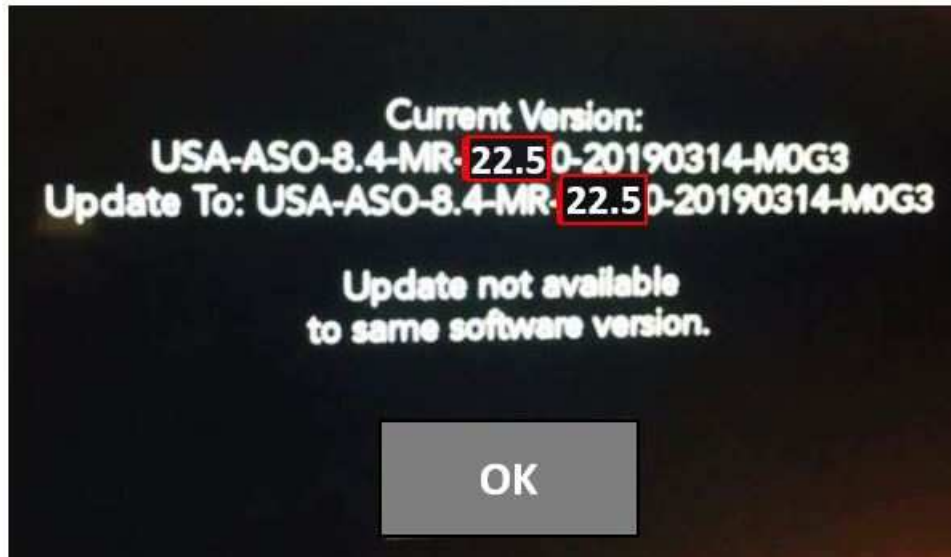
Fig. 10
Radio Software Has Been Updated.

- 15. After the update has completed, the radio will shut down. With the USB flash drive still inserted in the USB port, turn the ignition back to the run position. If the radio has been updated correctly, the screen in (Fig. 10) will be displayed. Press "OK" and remove the USB flash drive.
