NUMBER: 08-127-19

UJQ without RS9 Radio Enhancements

This bulletin involves inspecting and if required, updating the radio software level to 22.5.

2018 - 2019 (MP) Jeep Compass

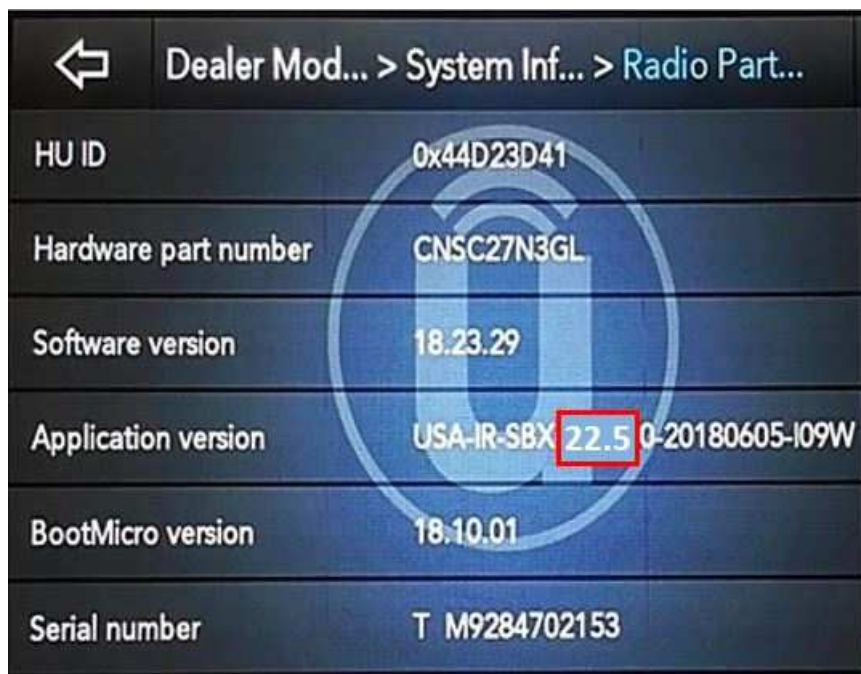
Fig. 1

1. Verify the radio software version. Radio must be in "Dealer Mode" to verify. To put the radio into "Dealer Mode" perform the following steps:
 - a. Push and hold the front defrost, driver temperature up and temperature down buttons simultaneously until the 'Dealer Mode' screen appears (approximately seven seconds). Release buttons.
 - b. Select "Radio Part Information". The software version will be listed next to "Application Version" (Fig. 1) .

Radio Software Level Screen

2. Is the radio software level (Application Version) at or higher than 22.5?
 - YES >>> The radio software is already up to date. Normal diagnostic should be performed.
 - NO >>> Proceed to [Step 1](#) of the Repair Procedure.

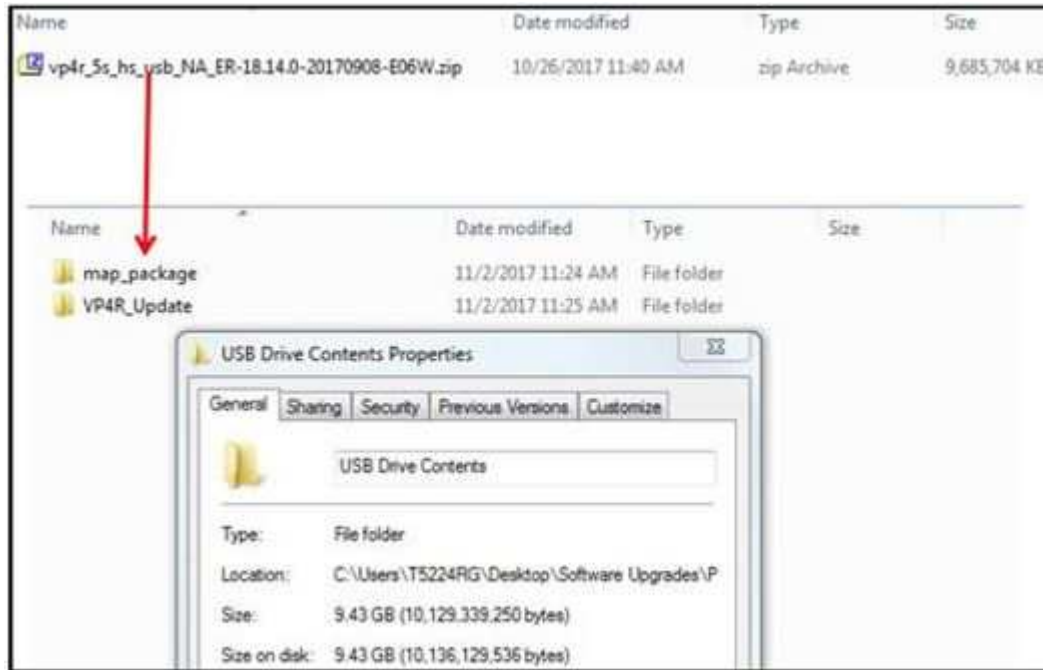
Fig. 4

Files/Folders In The USB Flash Drive

7. Unzip all the files to the root folder of USB flash drive. Files should not be within a zip folder. Your USB files should look like (Fig. 4) when you open it, displaying multiple files/folders.

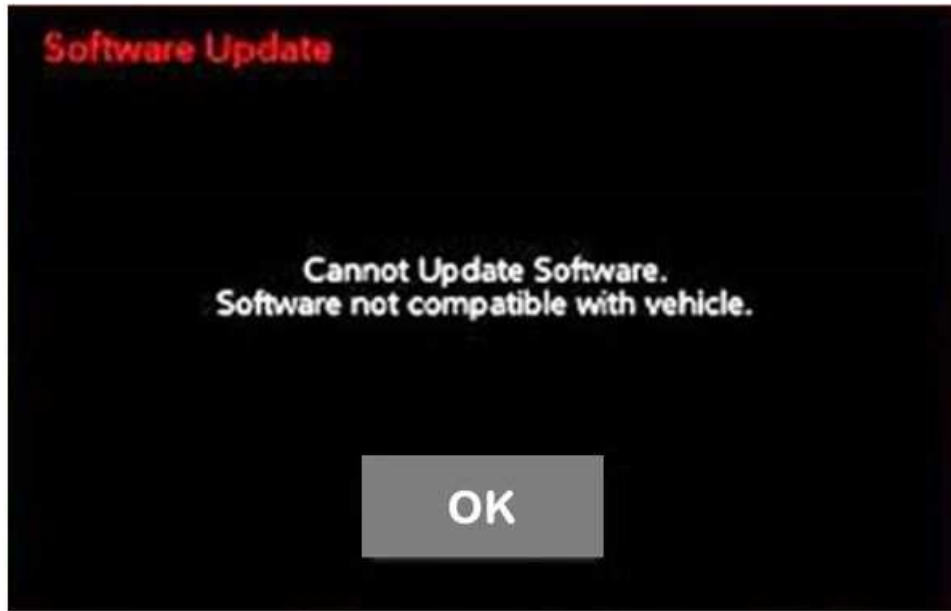
Fig. 5
Software Not Compatible

10. If the screen in (Fig. 5) is displayed, the USB flash drive was not set up correctly. Use a top name brand USB flash drive and create a new USB flash drive. Start the update again.

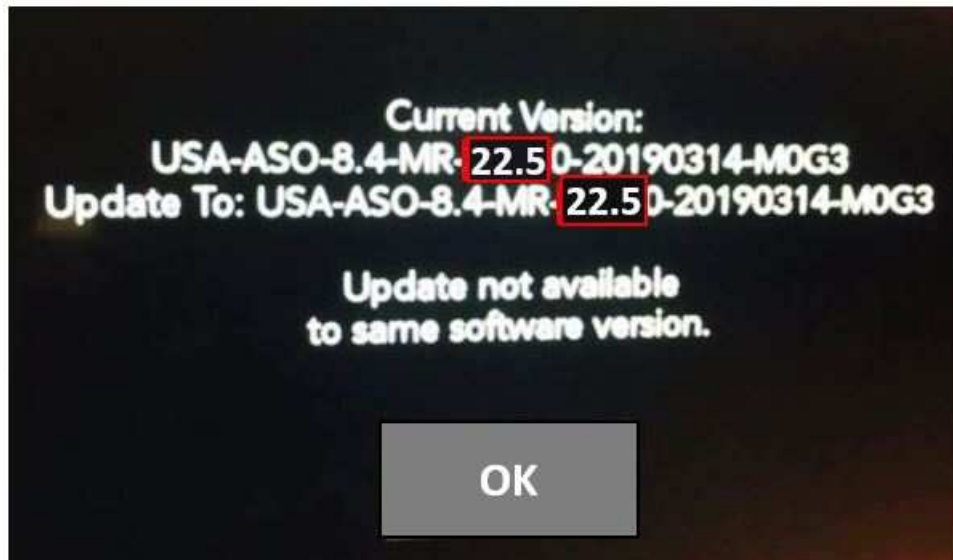
Fig. 6
Screen Displayed When Radio Software Level Is Up To Date

11. If the radio software is up to date, the screen in (Fig. 6) will be displayed. Press "OK" and remove the USB flash drive.

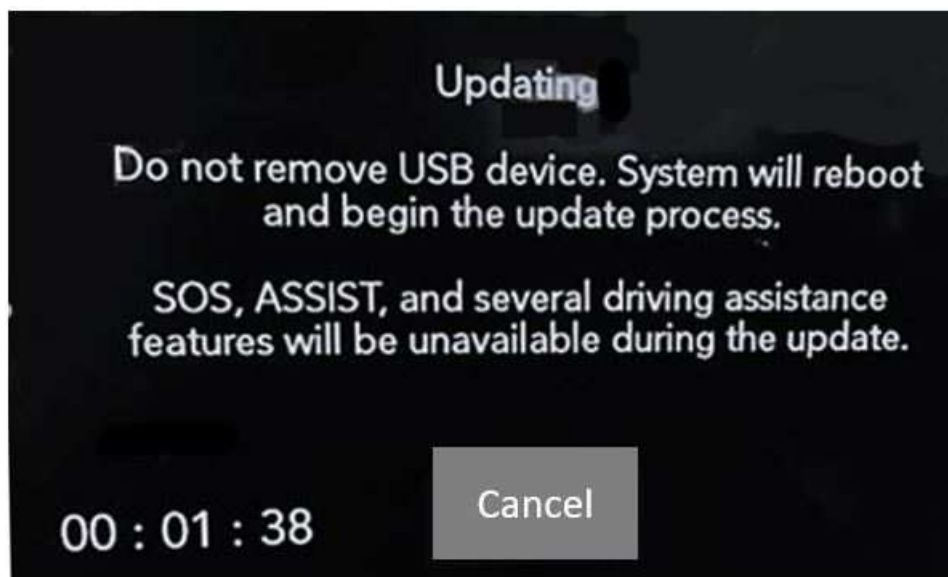
Fig. 8
Radio Update Process Begins

13. When the radio starts updating, the screen in (Fig. 8) will be displayed.

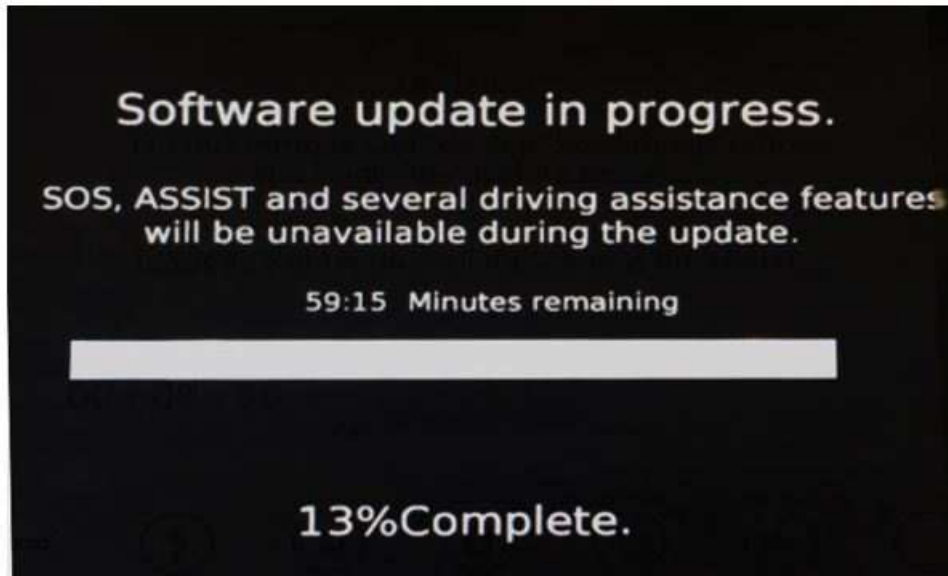
Fig. 9
Software Update In Progress

14. The radio will reboot and the update will begin. The update should only take 50 minutes, the timer on the screen may display the incorrect time remaining, (Fig. 9) .
