Preliminary Information

PIT5724 SES/MIL (Malfunction Indicator Lamp) Illuminated and Communication DTCs Stored

Brand:	Model:	Model Years:	VIN:		Engine:	Transmissions:
			from	to		
Cadillac	XT4	2019 - 2020	All	All	All	All

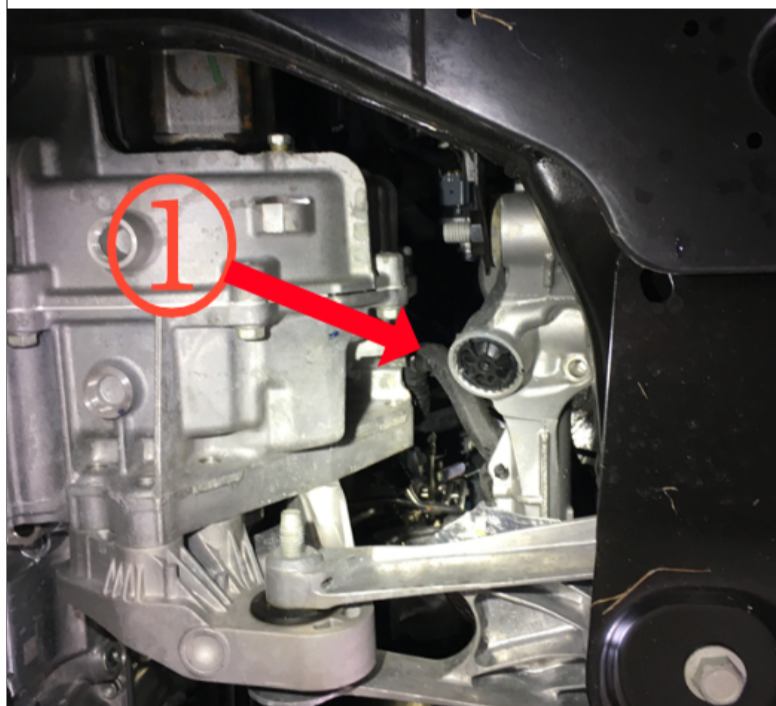
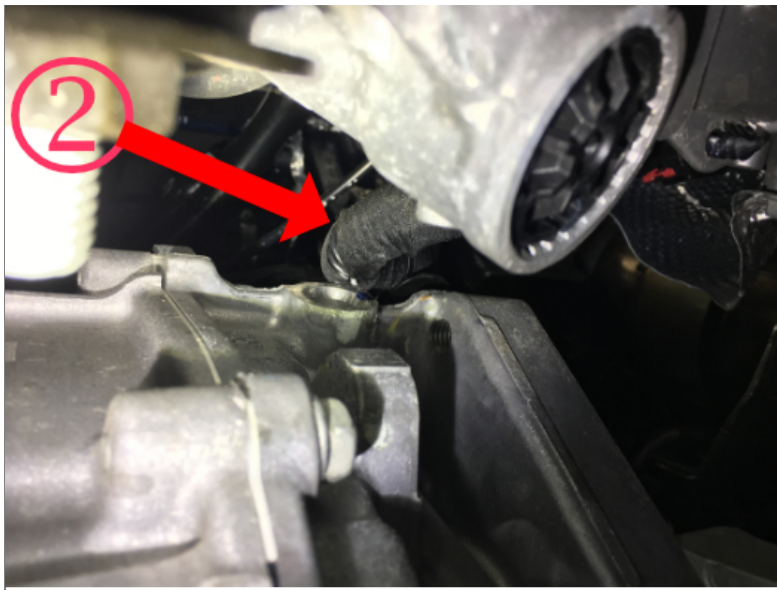
Cause	<p>This condition may be caused by the engine harness (1) chaffing between the power steering gear and the rear of the transmission case (2).</p>
-------	---

Note: This is a multi-wire bundled harness and, depending on which wire is damaged, can set a variety of DTCs.

To correct this concern, repair the damaged wiring following the SI wire-to-wire repair procedures. Once repaired, protect and reposition the engine wiring harness to prevent future harness damage.
