Technical Service Bulletin: TSB190209	Released Date: 03-Dec-2019
Engine Wire Harness Troubleshooting for Fuel Rail Pressure Sensor Circuit

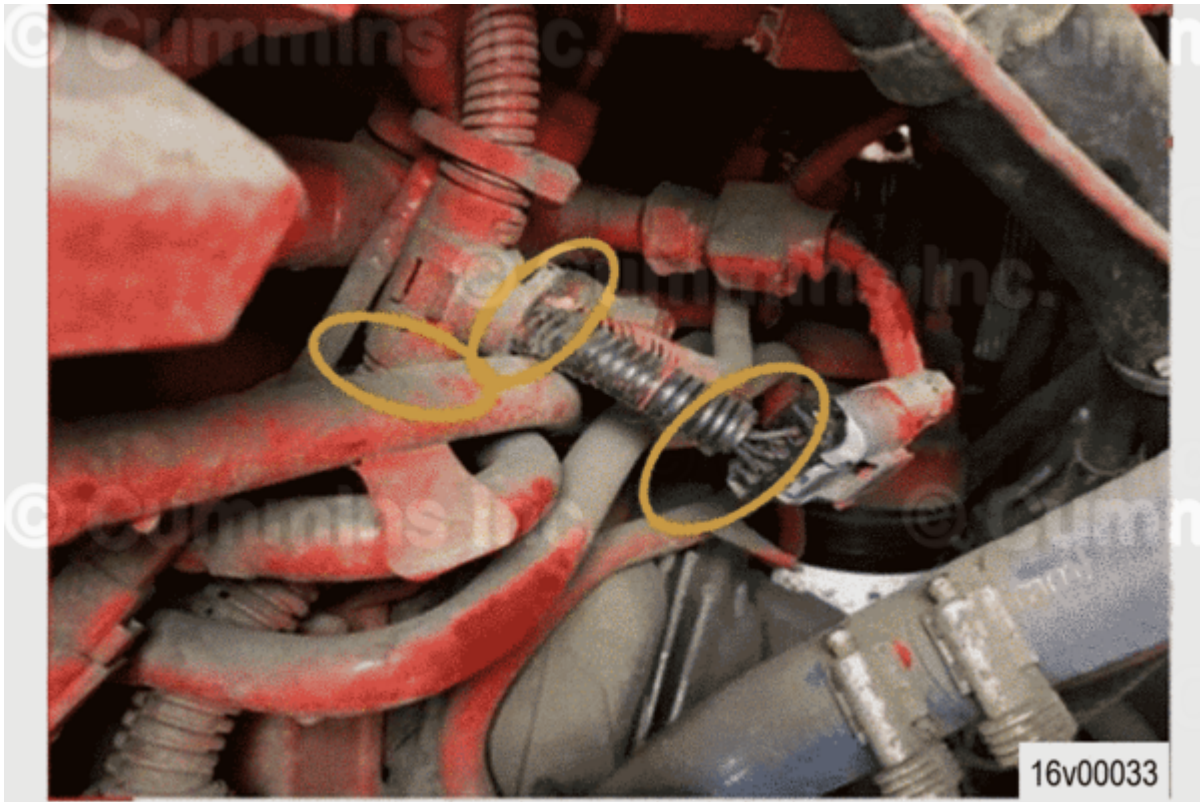
- If Troubleshooting directs replacement of fuel rail pressure sensor or engine wiring harness, perform thorough inspection of wiring going to fuel rail pressure sensor connector. See Figure 1 below. See corresponding Service Manual. Reference Procedures 019-361 and 019-362 in Section 19. Note that the wire can be broken but the insulation still intact.

Figure 1, Wiring near the Fuel Rail Pressure Sensor Engine Wire Harness Connector.

- If damage to fuel rail pressure sensor wiring is found, repair with electrical repair connector or electrical repair connector terminal. See corresponding Service Manual. Reference Procedure 019-199 in Section 19.

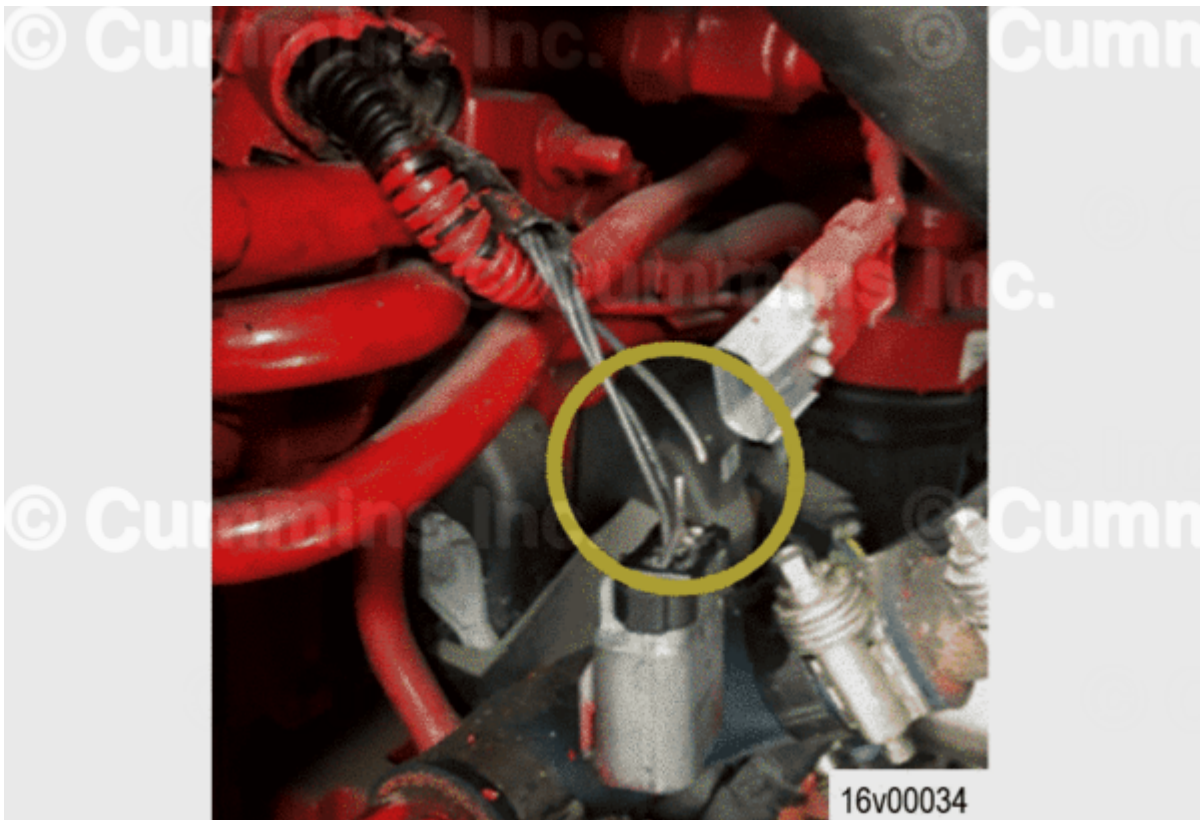
- Damaged wiring at or near the fuel rail pressure sensor engine wire harness connector.
- See Figures 1 and 2 below.

Figure 2, Example of Damaged Wiring.
