M161 - AM Radio - Poor Reception

Date: 11/12/2019
Bulletin MAS002063
Section: Electrical Systems and
Devices

MASERATI

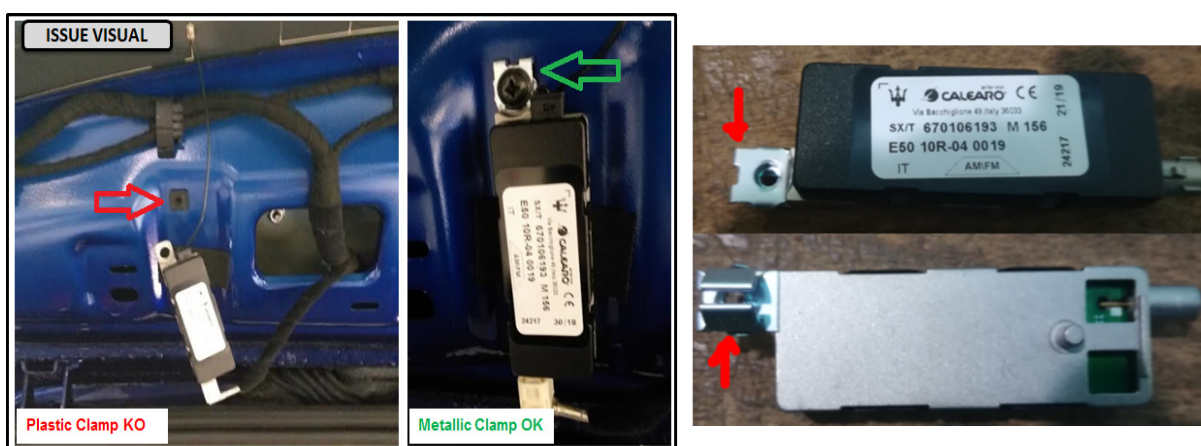
The problem could be caused by non-complaint fixing clip of the AM/FM1 Antenna Amplifier. If it is a plastic one, it might not give the proper ground to the Amplifier itself. The correct one is made of metallic material.

Figure 1. Left: fixing clip of the AM/FM1 Amplifier: left-hand side is plastic one (which is NOT OK), right-hand side is metallic one (which is OK). Right: detail of the metallic fixing clip.

If the fixing clip is plastic one, DO NOT replace AM/FM Amplifier but proceed replacing only the plastic clip with metallic one (PN 673010856).
