## Preliminary Information

### PIC6380 AC Blows Warm Air

Brand:	Model:	Model Years:	VIN:		Engine:	Transmissions:
			from	to		
Chevrolet	Impala	2017 - 2020	All	All	All	All

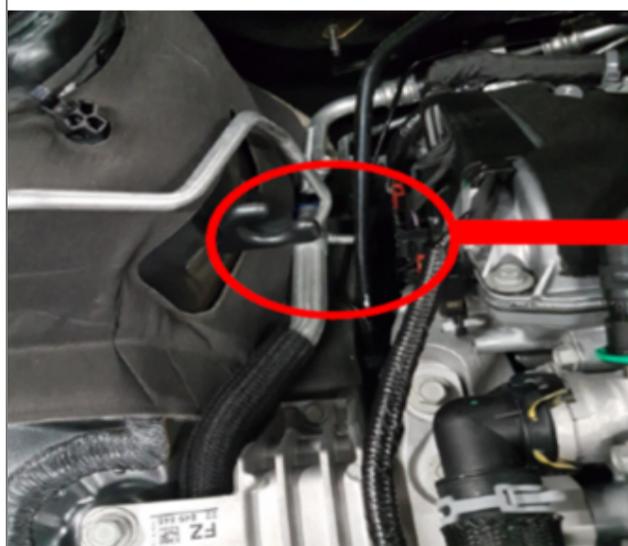
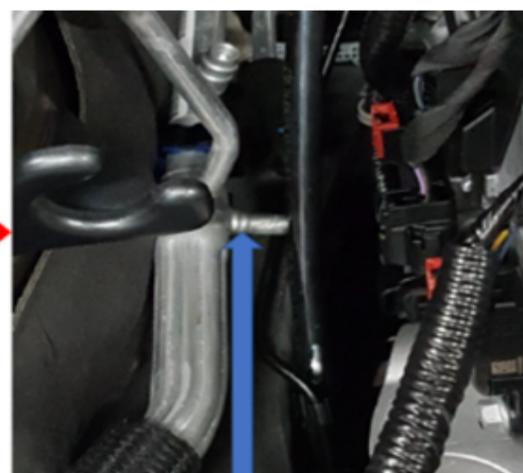
Cause	<p>Due to an inconsistency in the weld process, a welded joint in the evaporator lock ring, compressor hose, or low side evaporator line have been found to have the potential to slowly leak refrigerant over a period of time.</p> <p><b>Note: Please allow A/C system to run for 30 mins with refrigerant at the specified capacity before attempting to check for leaks. The dye that is installed is in the form of a pellet and may take about 30 minutes of continuous operation to dissolve and disperse throughout the system.</b></p>
-------	---

Inspect the Low side evaporator line in the area shown below:

Crack/pinhole on underside of pipe

If the Air Conditioning system is low or empty on refrigerant, please follow: Refrigerant Recovery and Recharging (R-134a) Doc ID: 4002719 or Refrigerant Recovery and Recharging (R-1234yf) Doc ID: 5035303.

Follow Leak testing guidelines, found here: Leak Testing (R-134a) Doc ID: 3953966 or Leak testing (R-134a) Leak testing (R-1234yf) Doc ID: 4379036 to find the source of the leak.

Once the source of the leak is found, follow SI for outlined repair procedures.

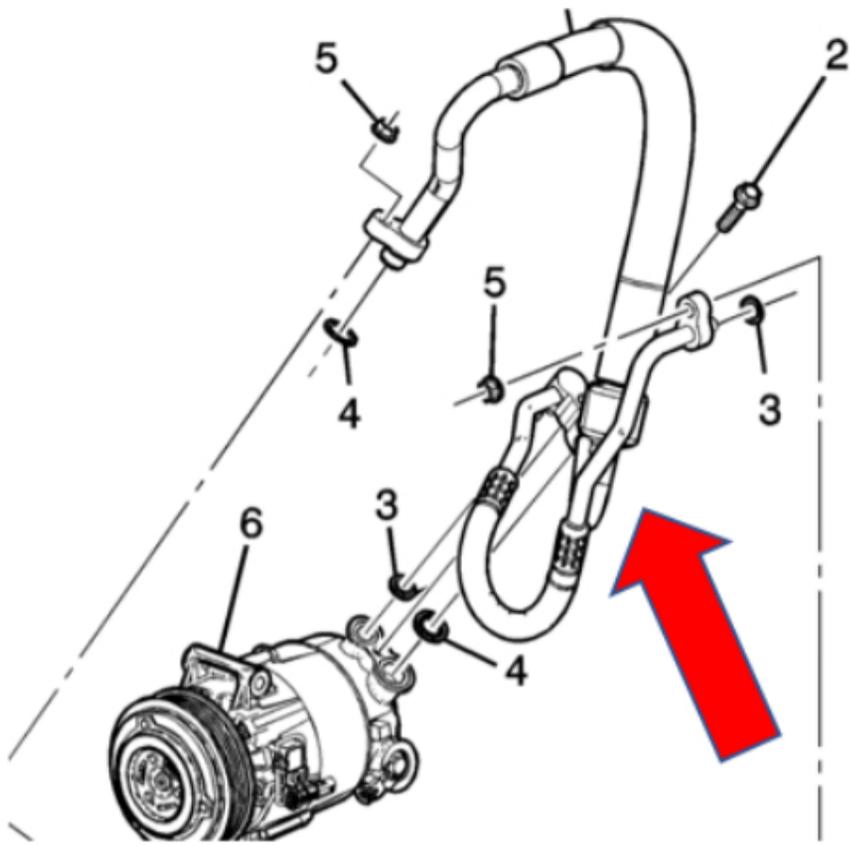
Inspect the joints at the AC compressor line and the fittings where it attaches to the compressor and the condenser.
