# Service Bulletin

Bulletin No.: 19-NA-269

Date: December, 2019

**Subject: Radio Software Version U148 Over-the-Air Update**

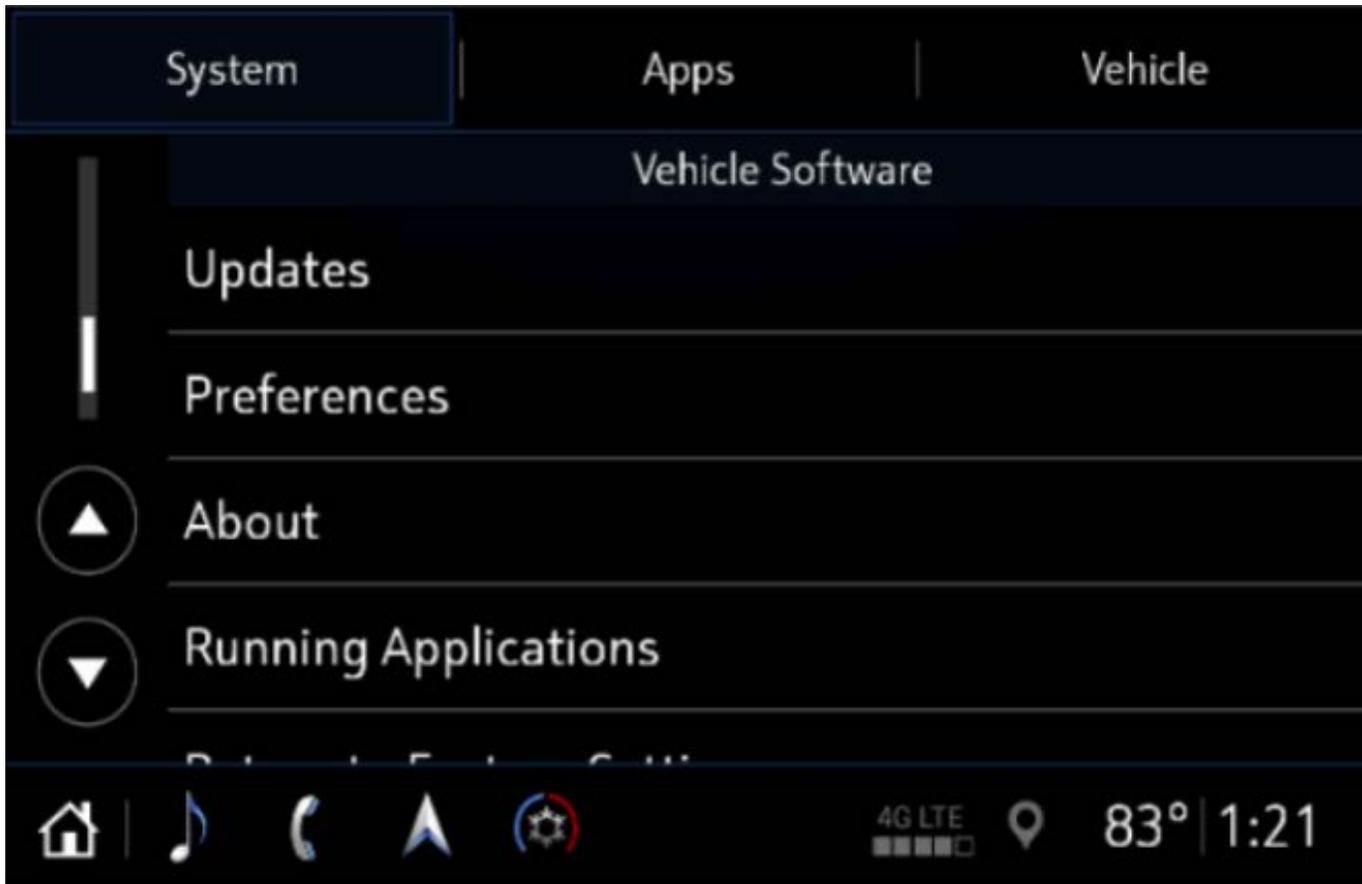
5313331

- If an update is shown under the “Updates” screen, proceed to the **Update Procedure Using Remote Vehicle Update** section of this document.

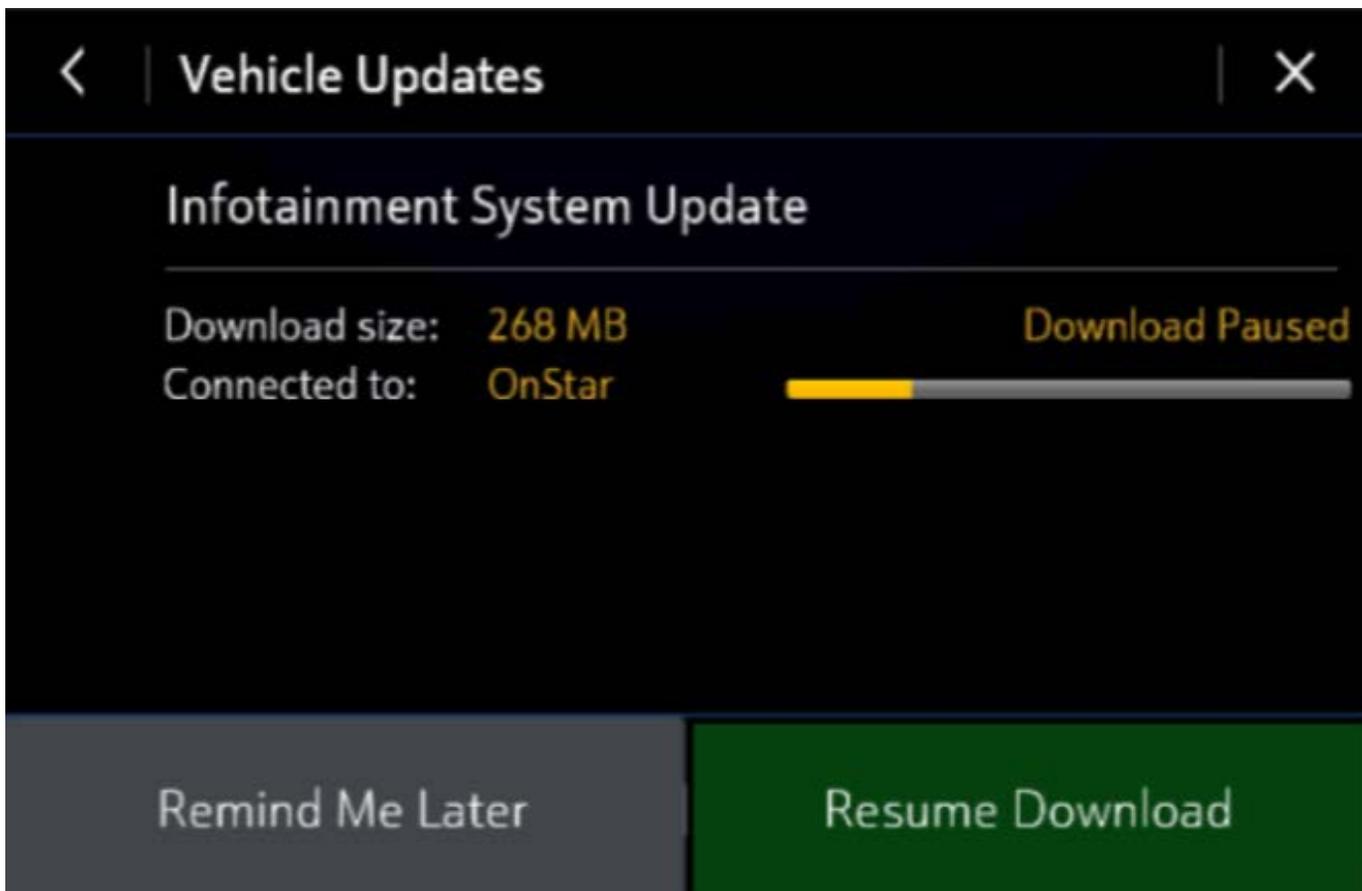
5313332

- If no update is shown (see “No Updates Available” image in next section), go to the “About” screen and verify the build number (i.e., U145, U146, etc.). If the build number is less than U148, proceed with the software update following the **Update Procedure Using TIS2WEB (USB Download)** section of this document.

**Caution:** If Vehicle Update screen shows “Infotainment System Update” (such as the screen above) do not use TIS2WEB or insert a USB stick. Use of the USB stick when the Remote Update has already been downloaded, installed, or paused during installation could result in program failures or module lockup condition. The update should be completed using the Remote Vehicle Update procedure, following prompts on the infotainment screen. Refer to Update Procedure Using Remote Vehicle Update after reading the remaining information in this section if the Remote Update has already been downloaded to the radio.

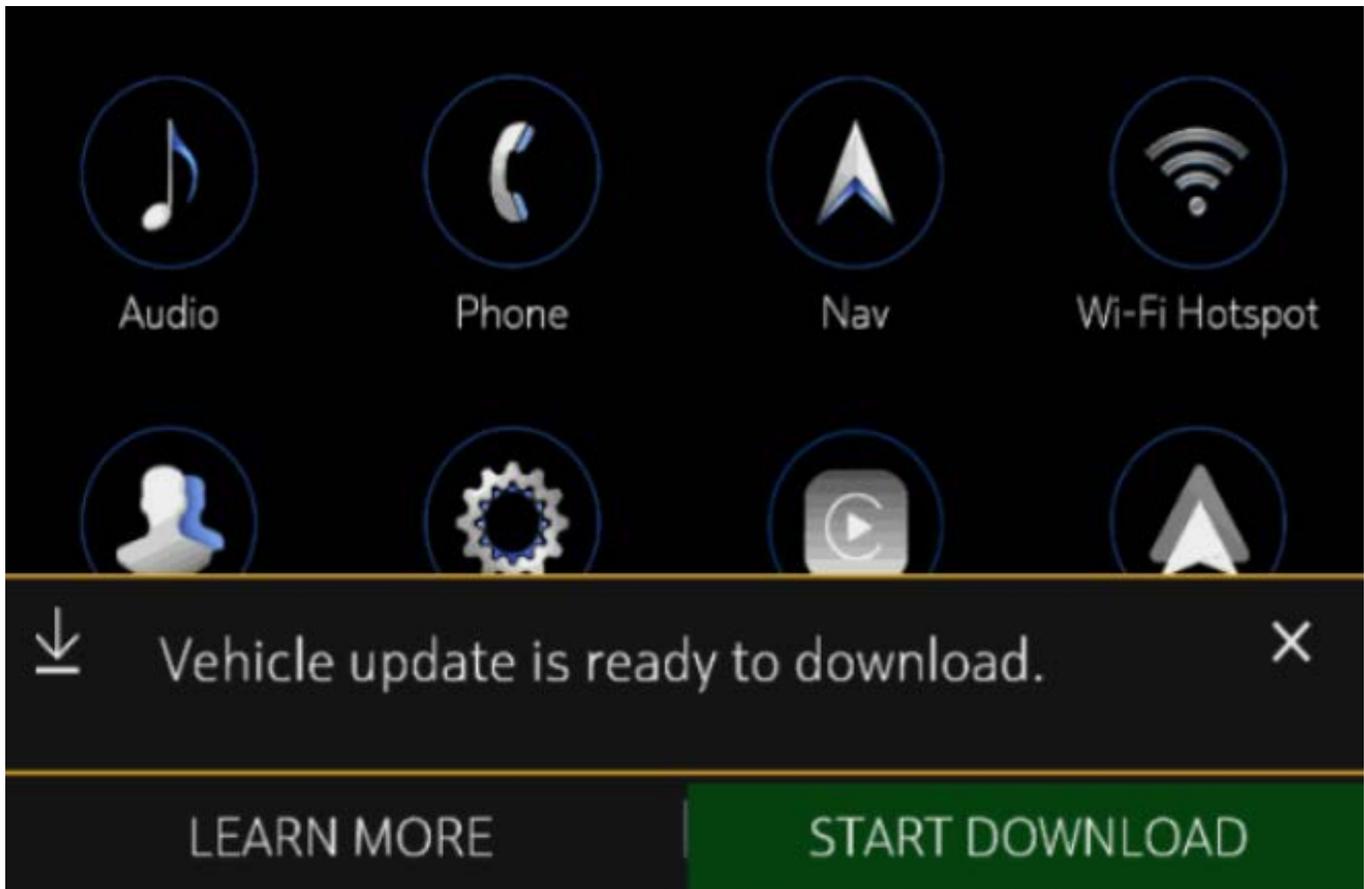
5313328

1. Verify if there is a remote package on the system, and check to see which of the below pop ups show.
  - If the remote vehicle update has not been downloaded, select “Start Download,” wait for the download to complete and then follow the prompts to complete installation.

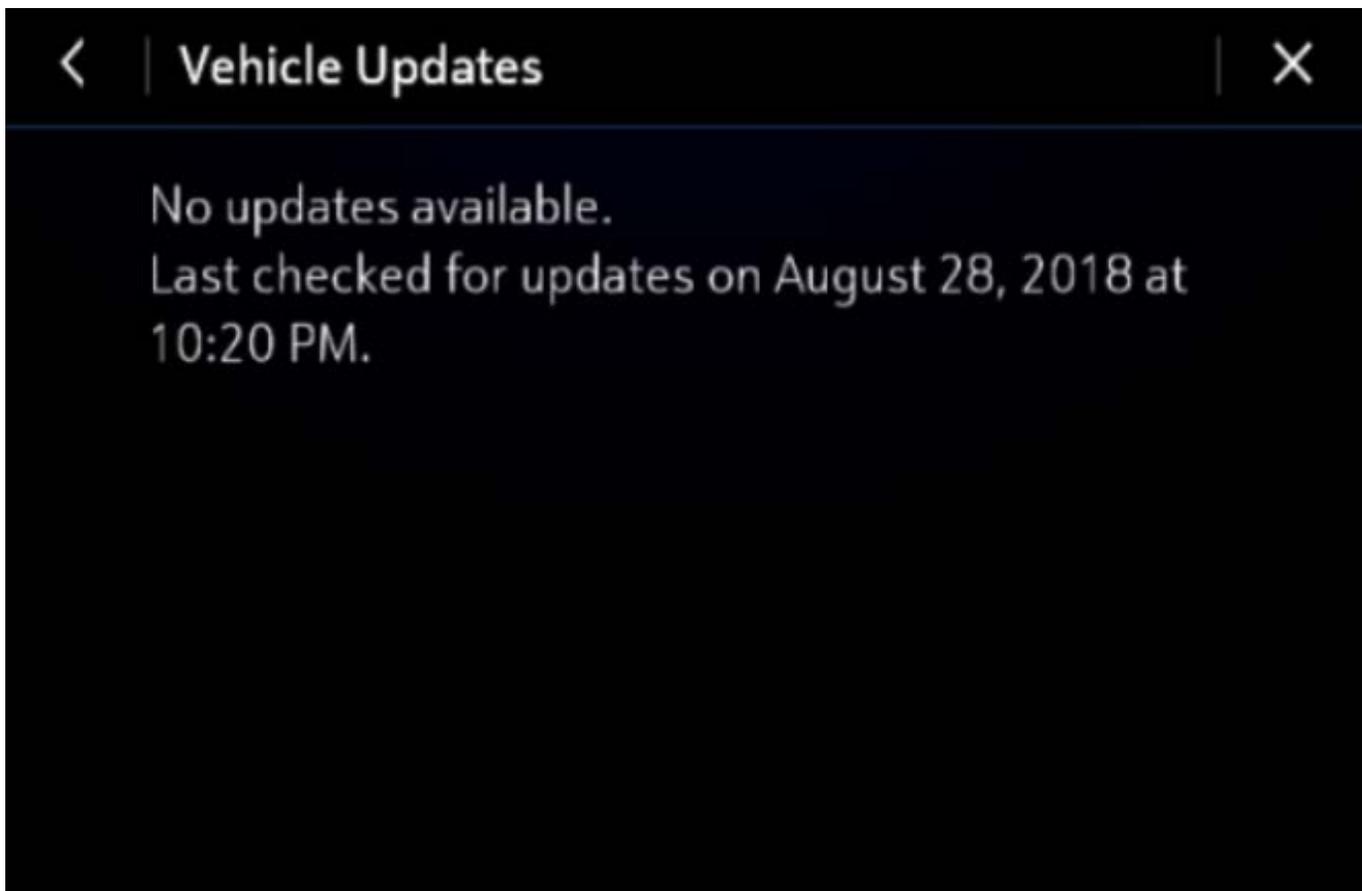
5313324

- If no "Start Download" or "Install Now" pop up is displayed, navigate to "Settings" -> "Updates." If there is a remote package on the system, it will display "Install Now" Or "Start Download." If the screen below is shown, then there is no remote update package on the system. Navigate to Settings -> About to verify the software version. If the build number is not U148 or greater, update via USB.

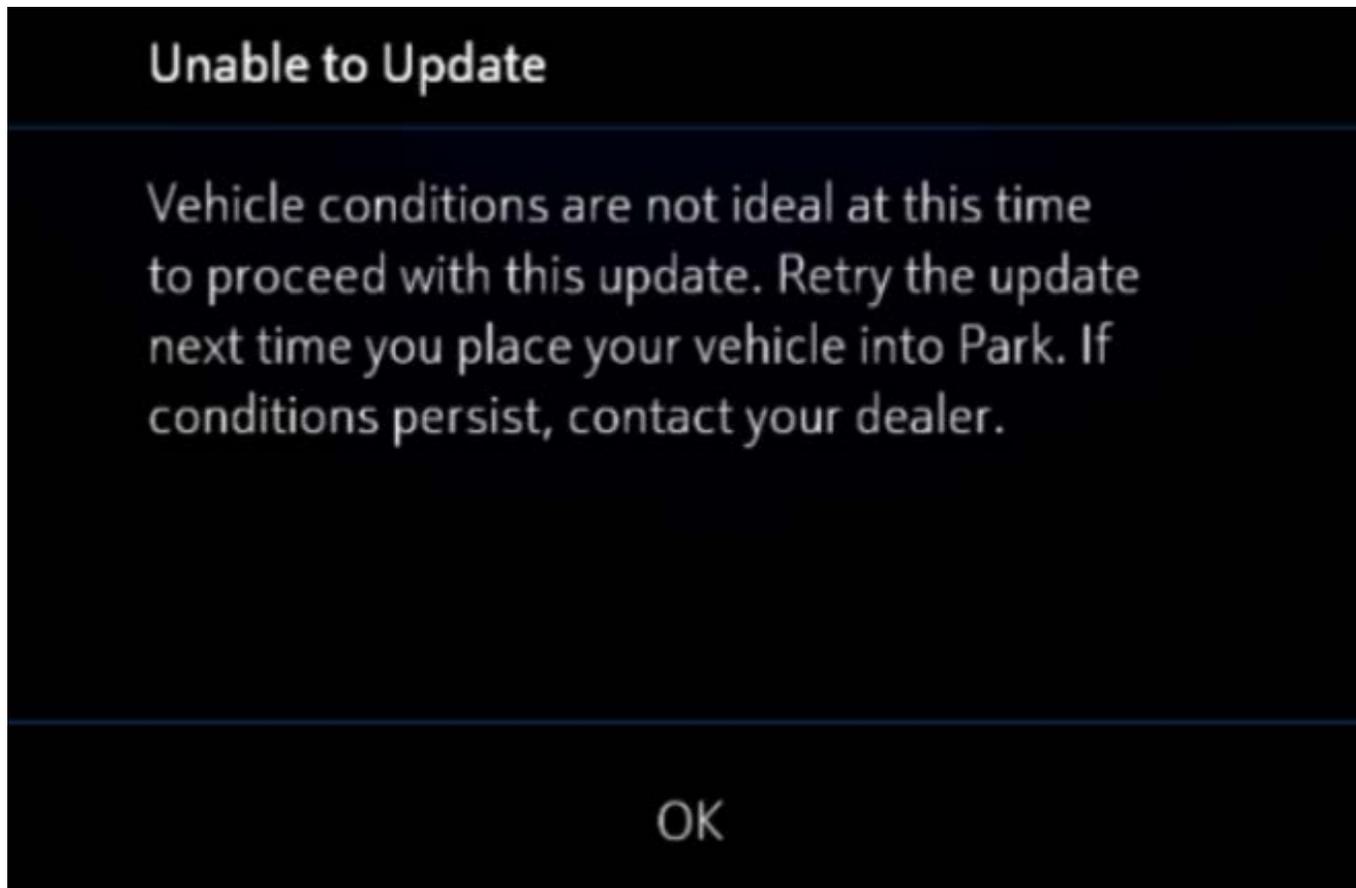
5313329

Scenario 1: Vehicle conditions are not ideal.

If the above screen is shown, download the update through TIS2Web and perform USB update. Upon USB insertion while vehicle is running, the "Install Now" pop up will be presented. Ensure the vehicle battery is being maintained (using EL-49642 or battery maintainer) while performing this update.

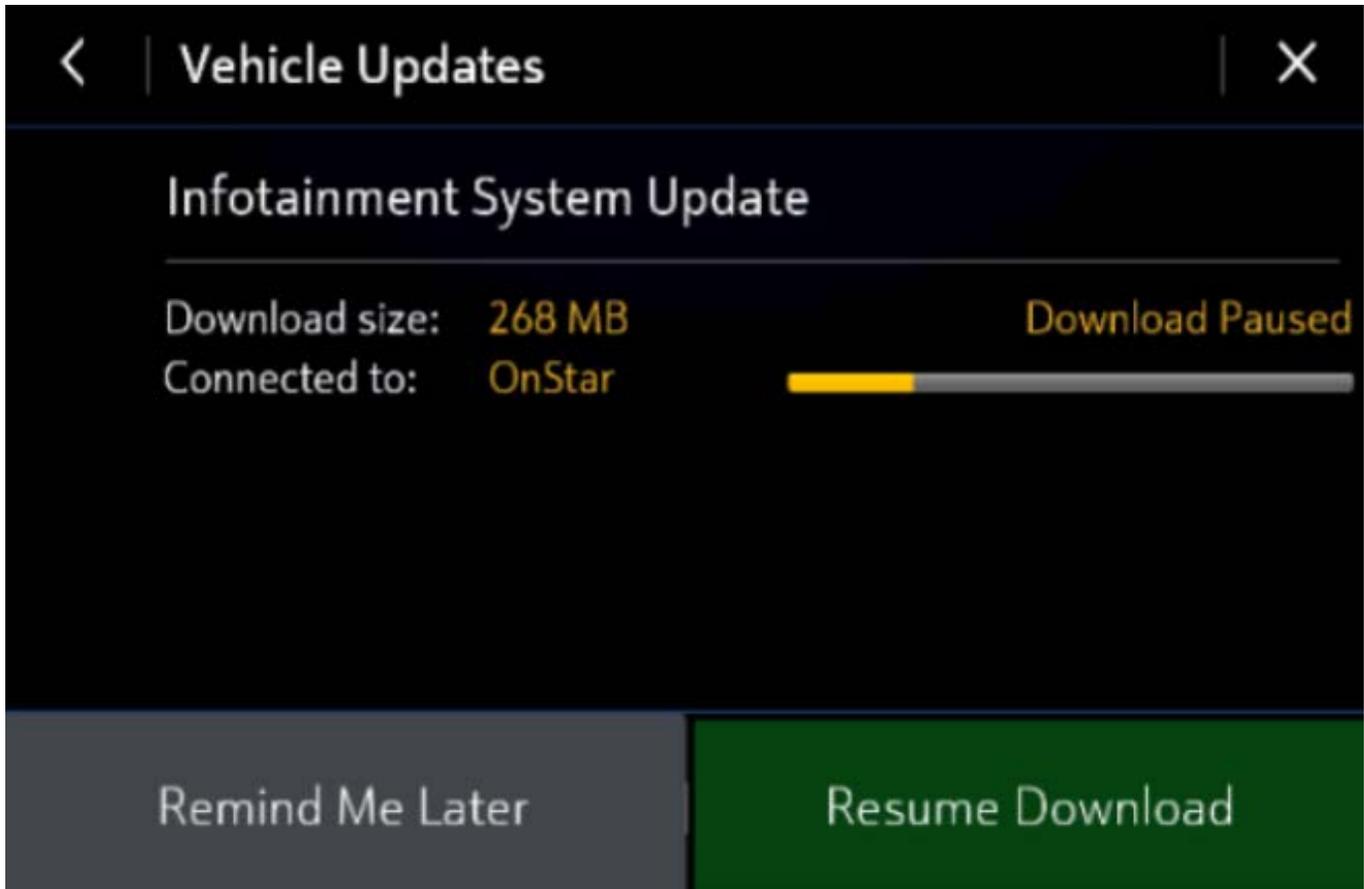
5313326

## Scenario 2: Consistently Paused Download

If the above screen is shown and resuming the download repeatedly fails, a USB update will need to be performed. Turn the vehicle on, return to the home screen, and insert USB stick (see previous section). A pop up should be shown to "Install Now." Click "Install Now", verify the part number is correct and follow on screen prompts.

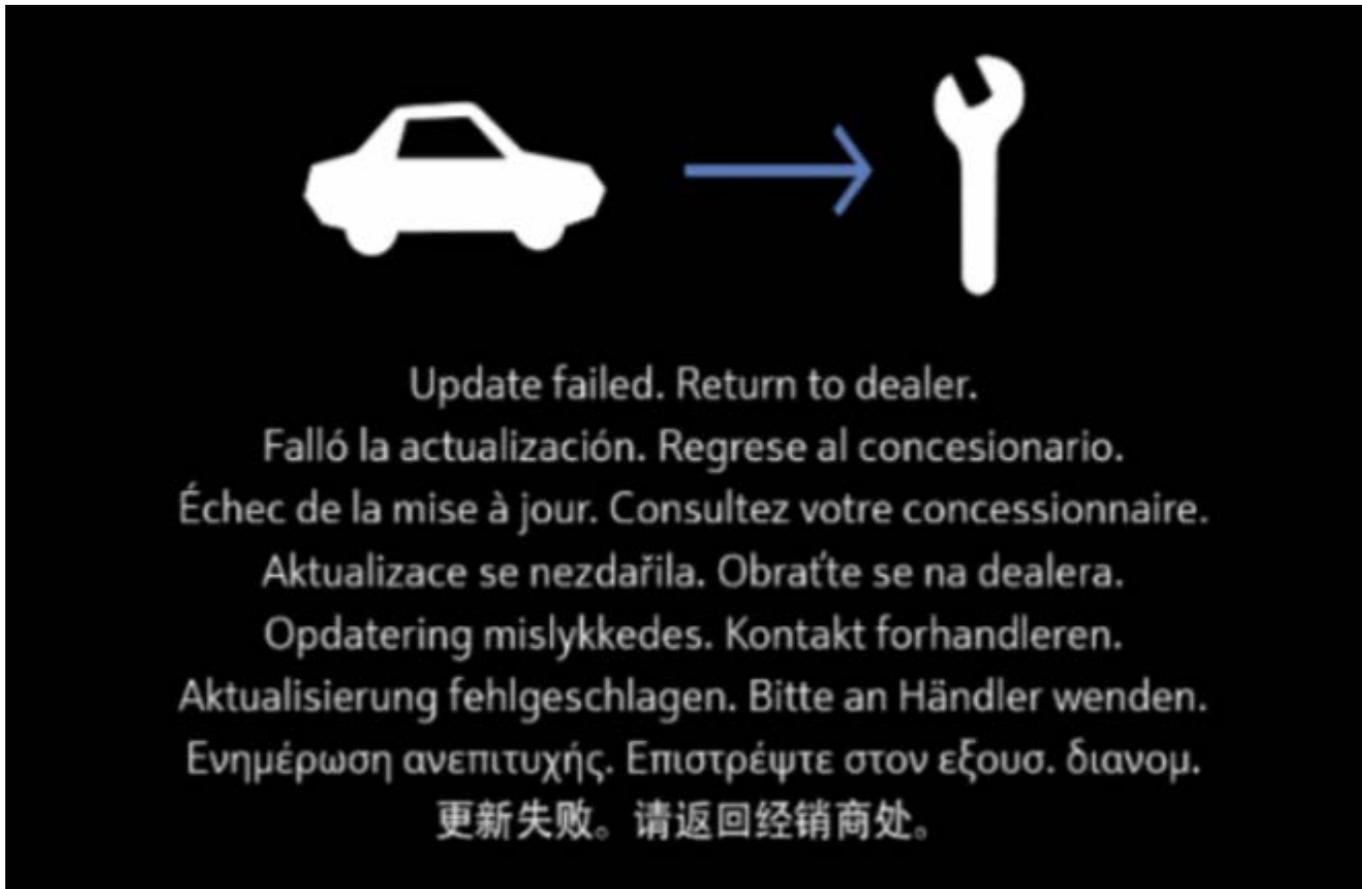
5313330

**Scenario 3:** Update Failed. Return to dealer screen.

1. If the above screen is shown, download the update through TIS2Web and insert USB stick into the radio **twice** (USB stick is not recognized on first insertion). A blue progress bar should come on the screen and update will proceed. If this screen above is shown when trying to update the radio through USB, reformat to FAT32 on your PC, and then try to download the update through TIS2WEB again.

2. After selecting USB File Transfer, if you are prompted by TIS2Web to select a software P/N, then follow the on-screen instruction to attempt to gather the software P/N from the A11 Radio using GDS2 scan tool. If GDS2 indicates the radio is not communicating, go back to TIS2Web, select A11 Radio, and select when radio displays "**Update failed. Return to dealer.**" to complete the USB File Transfer programming event.

3. If the screen above is shown again, contact Technical Assistance (TAC) for further assistance.
