Service Bulletin

Bulletin No.: 19-NA-272

Subject: Unwanted Forward Automatic Braking

Brand:	Model:	Model Year:		VIN:		Engine:	Transmission:
		from	to	from	to		
Chevrolet	Blazer	2019	2019	SOP	KS680041

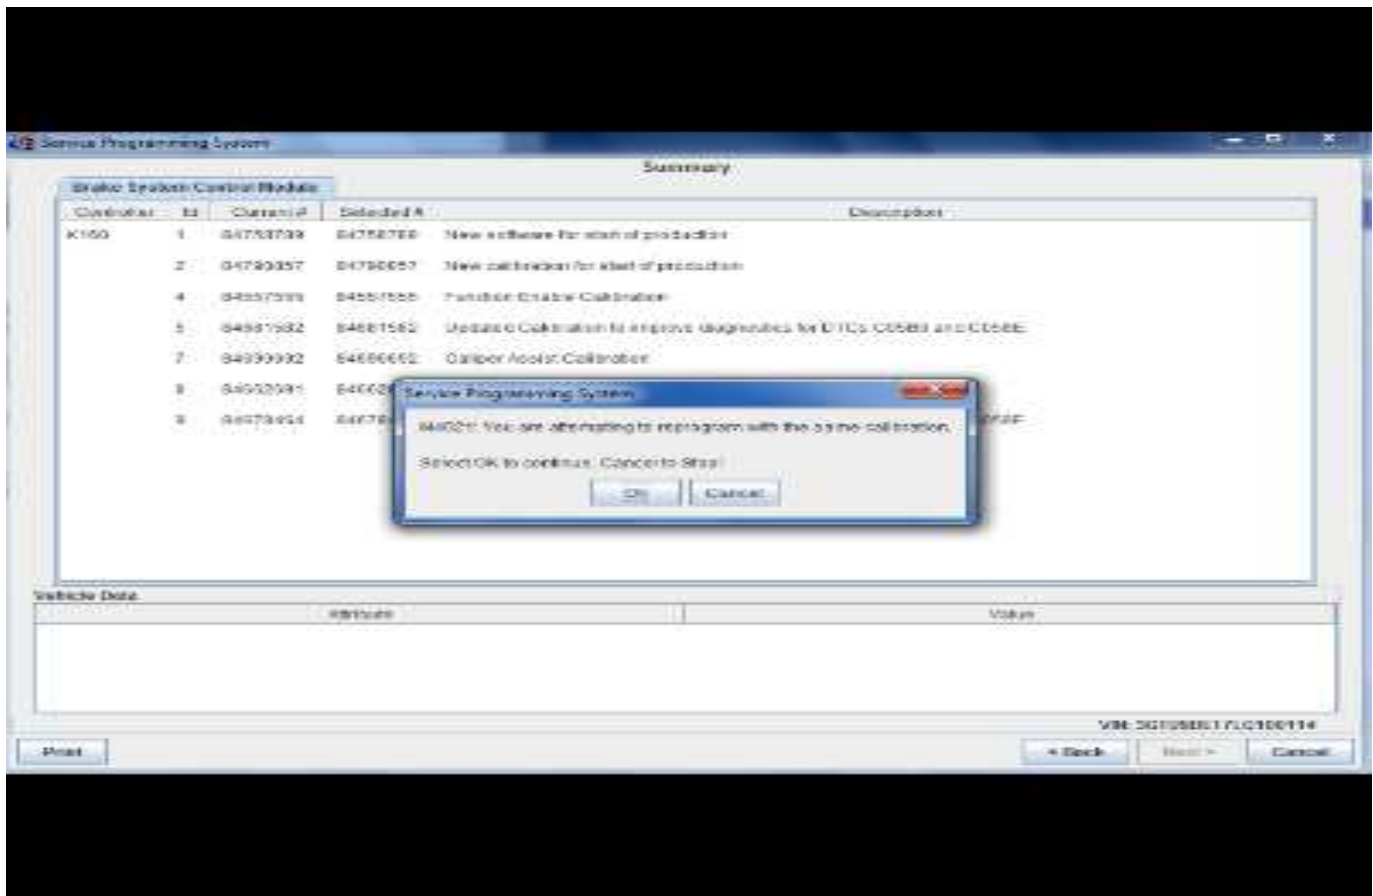
5431207

Note: If the Same Calibration/Software Warning is noted on the SPS screen, select OK and follow screen instructions. After a successful programming event, the WCC is located in the Service Programming System dialogue box of the SPS Summary screen. No further action is required. Refer to the Warranty section of the bulletin.

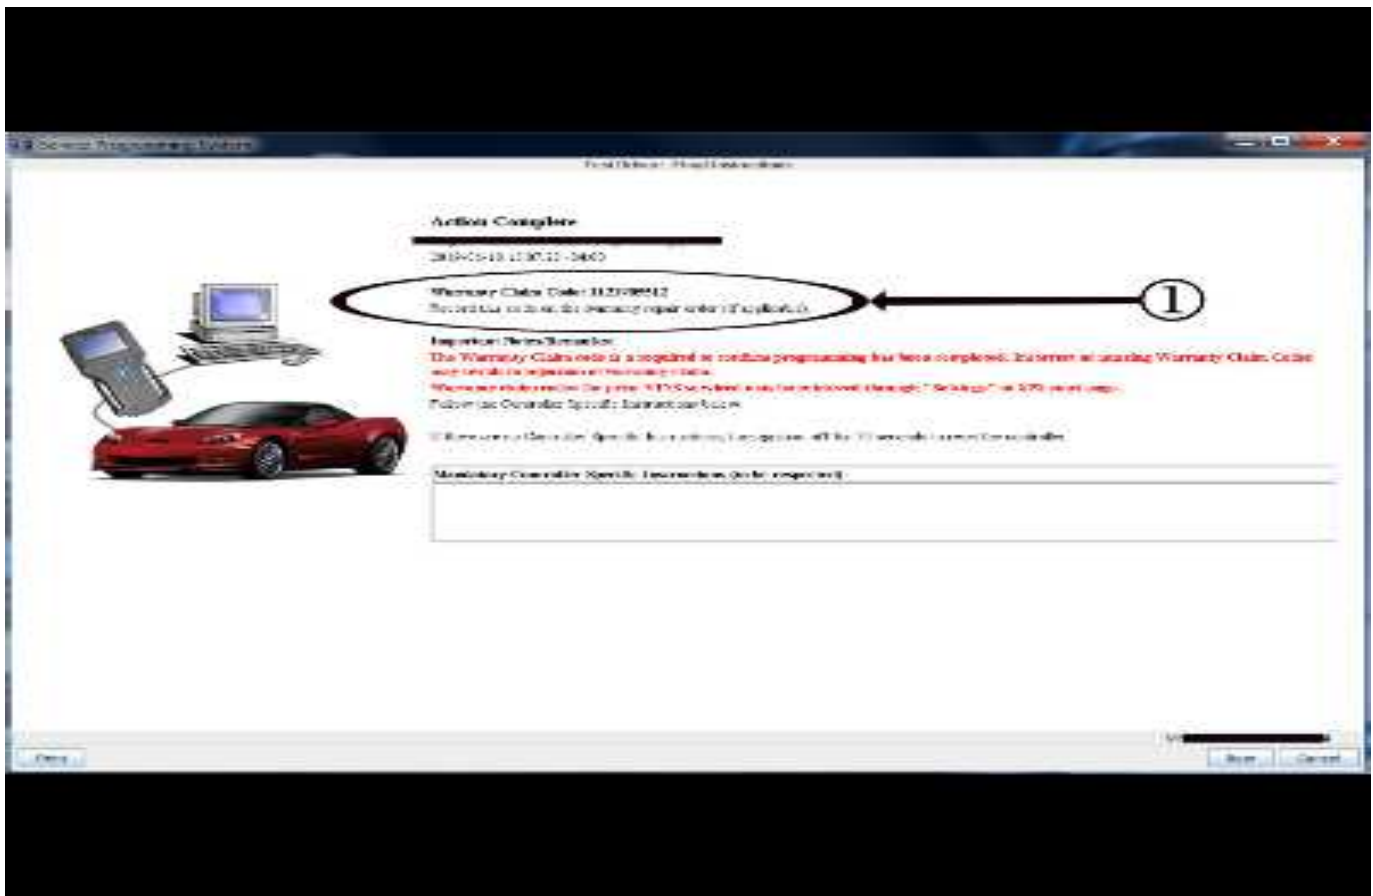
5431209

Note: To avoid warranty transaction rejections, you **MUST** record the warranty claim code provided on the SPS Warranty Claim Code (WCC) screen on the job card. Refer to callout 1 above for the location of the WCC on the SPS screen.

- Record SPS Warranty Claim Code on job card for warranty transaction submission.
