Service Bulletin

Bulletin No.: 19-NA-276

Subject: Potential Reduced Engine Power Message Displayed and/or Engine Stall with DTCs P1682 and/or P0689 Set

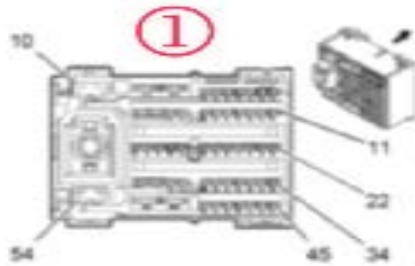
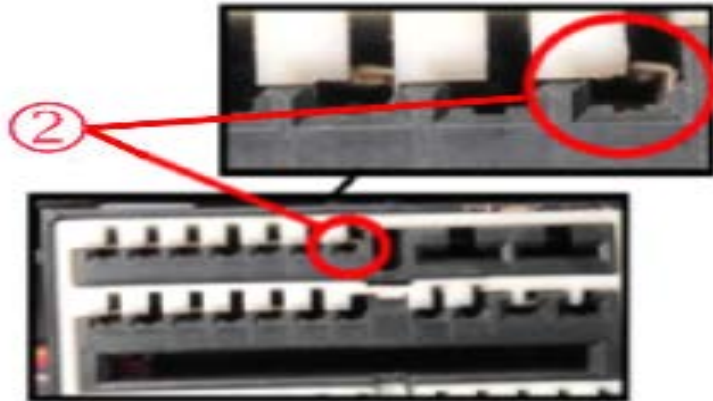
X3 Connector — Terminal 51

X3, Connector — Terminal 51 (1)

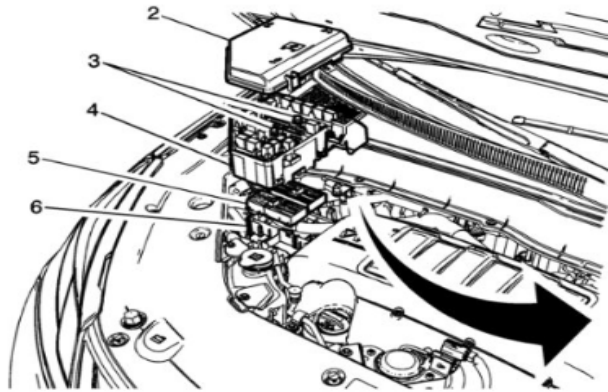
5453850

X3, Connector (1) — Terminal 51 (2)

1. Remove the front compartment fuse block housing (4) and inspect terminal 51 in X50A Fuse Block - Underhood X3. Refer to *Underhood Electrical Center or Junction Block Replacement*, in SI.

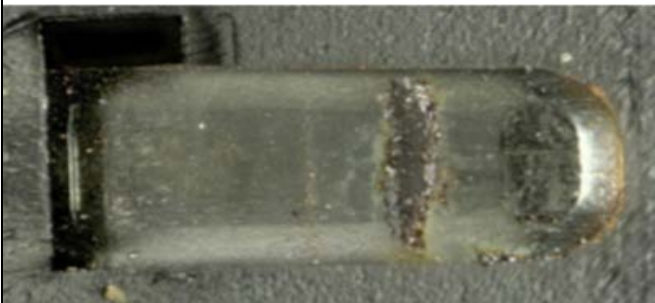
5454775

2. Inspect the front compartment fuse block housing for a damaged, or burnt, terminal in cavity 51 in X50A Fuse Block - Underhood X3.
3. If required, replace the terminated lead in cavity 51 in X50A Fuse Block - Underhood X3.
