Subject: Engineering Information – Roof Panel Joint Finish (Ditch) Molding Loose and/or Lifted

Brand:	Model:	Model Year:		VIN:		Engine:	Transmission:
		from	to	from	to		
Chevrolet	Sonic	2016	2019	-	-	-	-

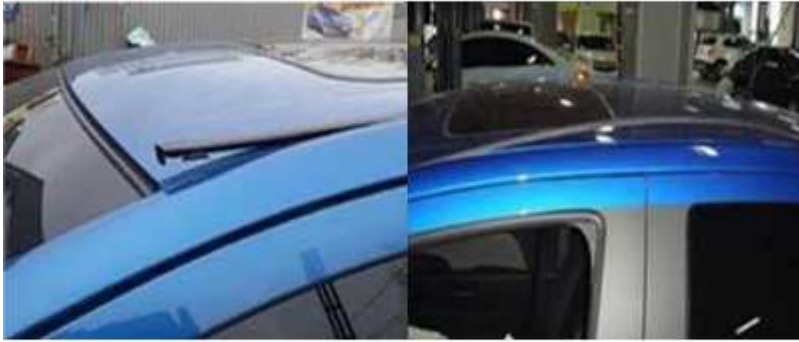
Shown above are pictures of the entire area of the vehicle showing the location of the issue area.

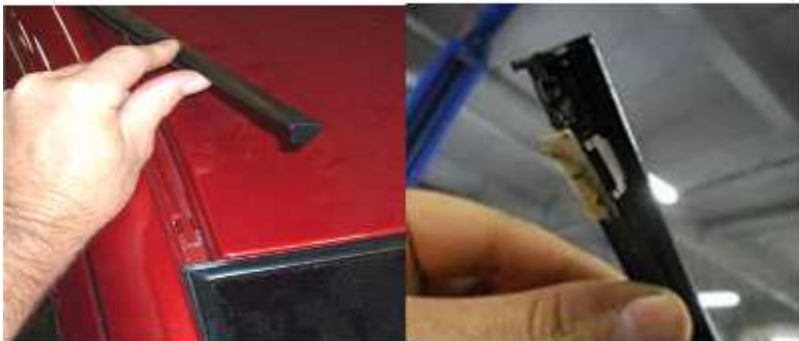
Shown above are examples of clear, close-up pictures to better show the detail of the issue (These example pictures show the ditch molding area on the vehicle and the actual area on the molding part that comes loose and/or is lifted).

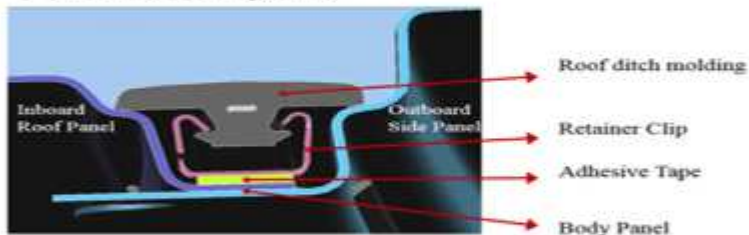
• Section A-A' (Clip Area)

Also, if the molding is coming loose and/or is lifted from either end (front or rear per Section A-A, shown in the picture above) indicate if the tape adhesive has lifted from the roof (body panel), or the tape adhesive has separated from the retainer clip, or the retainer clip has separated from the molding.

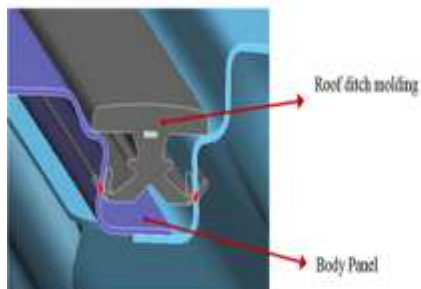
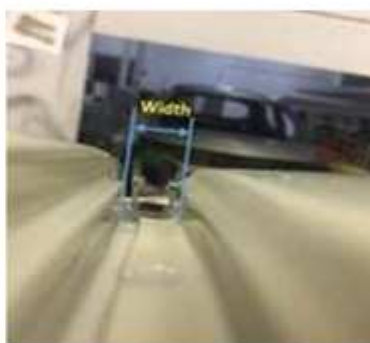
• Section B-B' (Molding Area)

If the molding is coming loose and/or lifted from in the center area of the molding (per Section B-B, shown in the picture above), if possible, check/measure the roof ditch width dimension at the detached location and include that measurement in the FPR.
