Subject: Engineering Information – Side Door Molding Loose and/or Lifted

Brand:	Model:	Model Year:		VIN:		Engine:	Transmission:
		from	to	from	to		
Cadillac	XT5	2019	2020	-	-	-	-

Loose and/or Lifted Side Door Molding

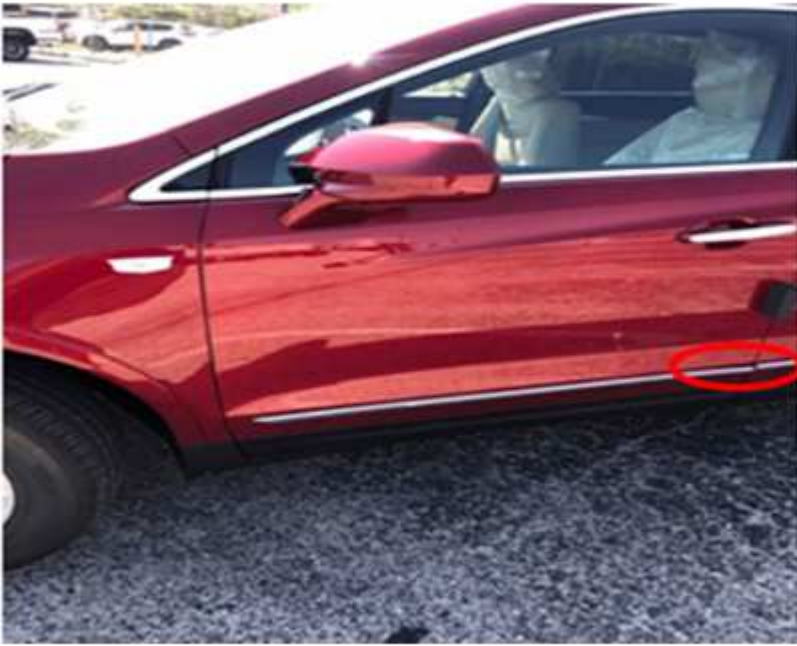
Shown above is a picture showing the entire area of the vehicle showing the location of the issue area.

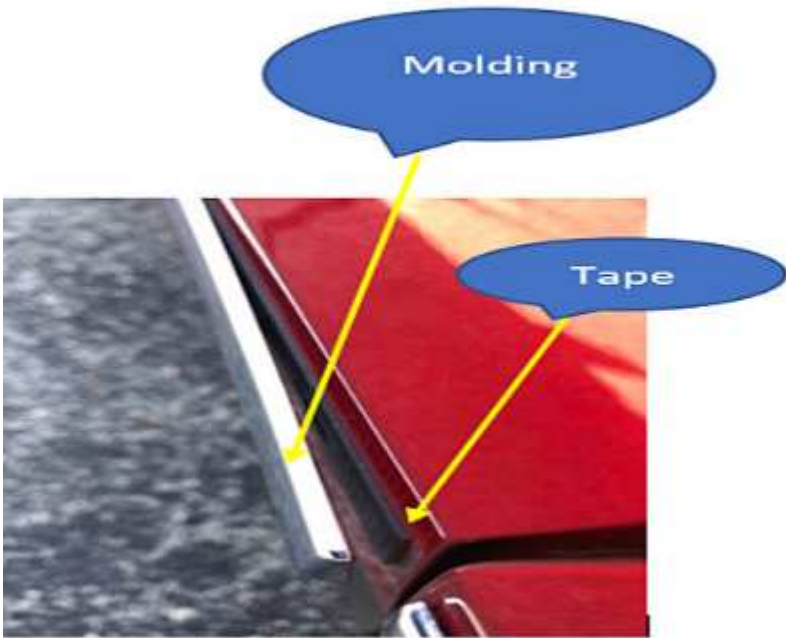
Shown above is a example of a clear close-up picture to better show the detail of the issue (example picture showing: the side door molding area on the vehicle and the actual area on the molding part that comes loose and/or lifted). Also, If the molding is coming loose and/or lifted, indicated if the tape adhesive has lifted from the door (body panel), or the tape adhesive has separated from the molding.
