Technical Service Bulletin

GROUP CAMPAIGN	NUMBER 19-01-043H
DATE DECEMBER, 2019	MODEL(S) Sonata (DN8)

SUBJECT: MAIN HARNESS & BRAKE BOOSTER INTERFERENCE
INSPECTION AND REPAIR (SERVICE CAMPAIGN T4J)

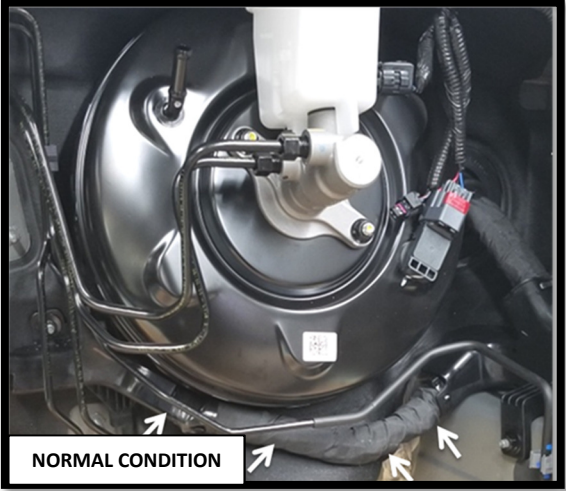
<p>NORMAL CONDITION</p>

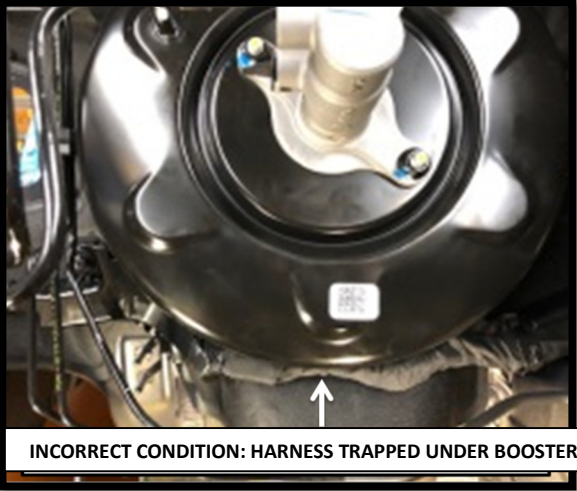
<p>INCORRECT CONDITION: HARNESS TRAPPED UNDER BOOSTER</p>
<p>Bottom View (through driver's wheel well)</p>

REPAIR PROCEDURE

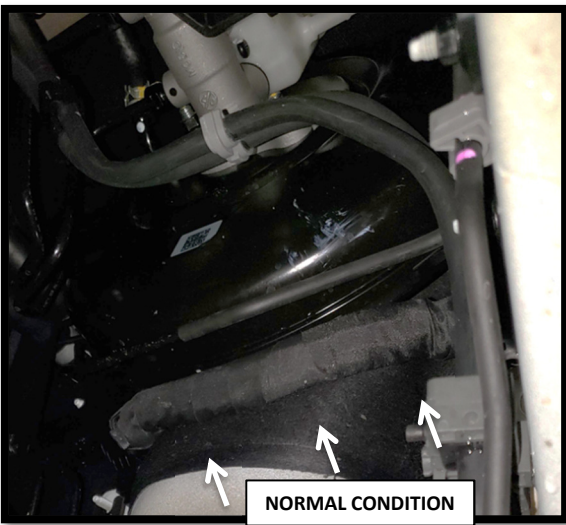
<p>NORMAL CONDITION</p>

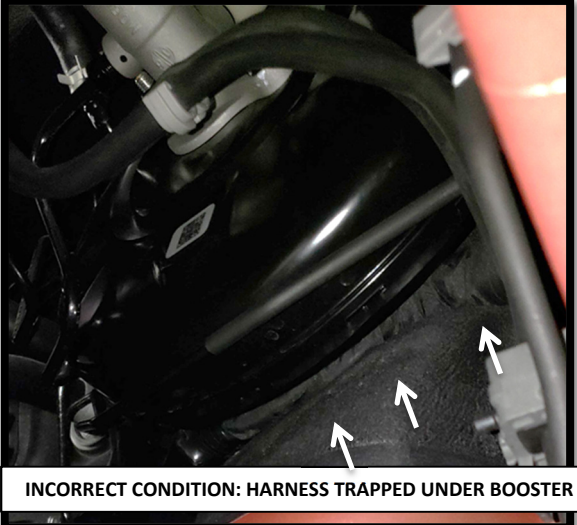
<p>INCORRECT CONDITION: HARNESS TRAPPED UNDER BOOSTER</p>
	<p>NO FURTHER ACTION REQUIRED</p>	<p>PROCEED TO REPAIR PROCEDURE</p>
