HYUNDAI Technical Service Bulletin	GROUP CAMPAIGN	NUMBER 19-01-046H
	DATE DECEMBER, 2019	MODEL(S) PALISADE (LX2)
SUBJECT: BLIND-SPOT COLLISION WARNING (BCW) RADAR UPDATE (SERVICE CAMPAIGN T4K)

**BLIND-SPOT COLLISION WARNING (BCW) RADAR UPDATE
(SERVICE CAMPAIGN TK4)**

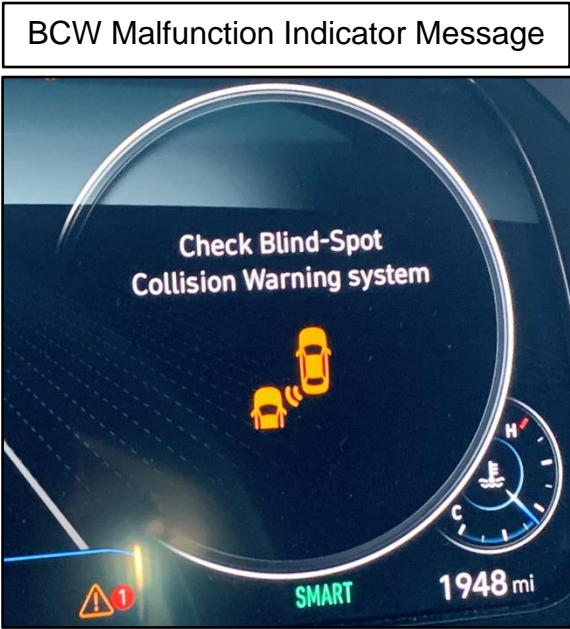
Description: Some Palisade (LX2) vehicles may intermittently experience the BCW Malfunction Indicator Light ON with a message “Check Blind-Spot Collision Warning System” displayed on the instrument cluster. When the BCW Malfunction Indicator Light is ON, the BCW function becomes inoperative. This bulletin provides the service procedure to update the BCW system software to correct the intermittent BCW Malfunction Indicator Light.

NOTE: When the BCW Malfunction Indicator Message turns ON, the diagnostic code C270354 (Control Module Slave Calibration) will be triggered.
