| RE: <b>Service Campaign Launch Notification</b><br><b>Correct Torque of Right Rear Engine Crossmember</b><br><b>MY 20 167 (GLE-Class)</b> | DATE: December 13, 2019 |

# Service Campaign Bulletin

Campaign No. 2019120001, December 2019

## **Correct torque of right rear engine cross member threaded connection**

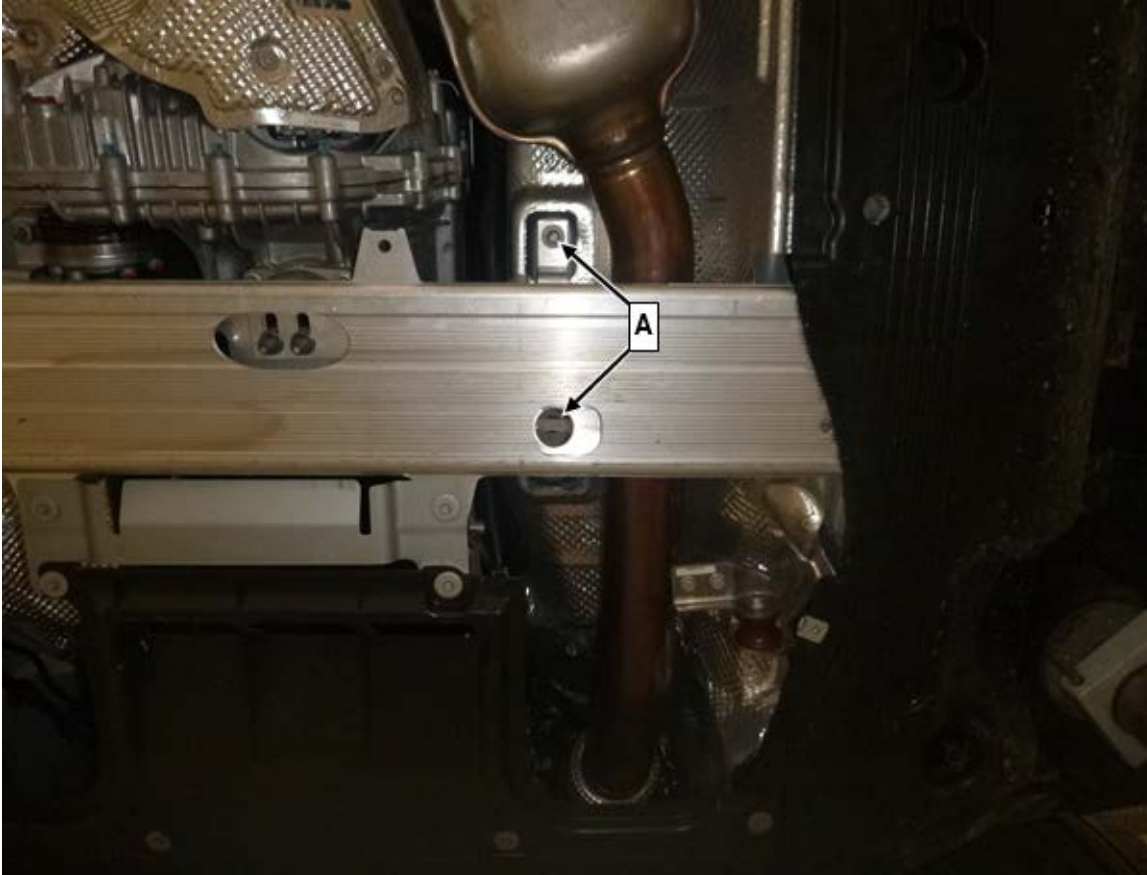
**Figure 1****Warranty Information**

Mercedes-Benz AG ("MBAG"), the manufacturer of Mercedes-Benz vehicles, has determined that on certain Model Year ("MY") 20 GLE-Class (167 platform) vehicles, the torque of the threaded connection for the cross member on the right rear of the engine might not meet current production specifications. An authorized Mercedes-Benz dealer will tighten the corresponding threaded connection to the specified torque on the affected vehicles.

1. Correct torque of **both** screws (A

50, Figure 1) on right rear engine cross member.
