## SIB 32 01 15

### NOISE WHEN ADJUSTING THE STEERING COLUMN UP OR DOWN

## MODEL

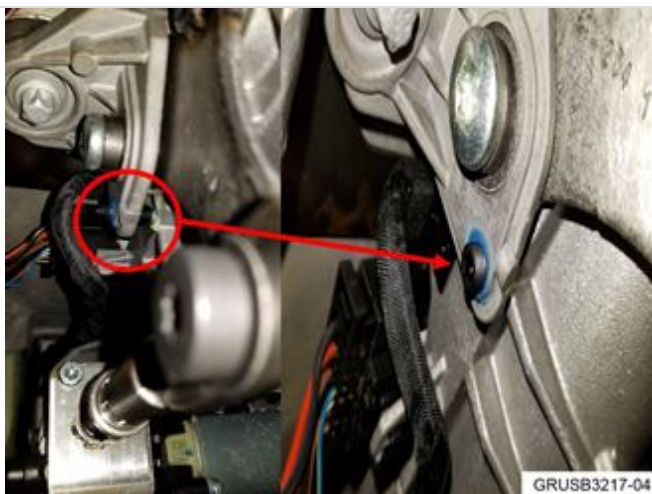
Creaking noise when raising or lowering the steering column position.

Steering column adjustment.

- 3) Remove the plastic screw (Torx T15).
