SIB 33 03 19

SERVICE ACTION: CHECKING THE THRUST WASHER AND THE REAR AXLE ANTI-ROLL BAR

F90 (M5 Sedan)	F91 (M8 Convertible)	F92 (M8 Coupe)	G14 (8 Series Convertible)
G15 (8 Series Coupe)	G16 (8 Series Gran Coupe)

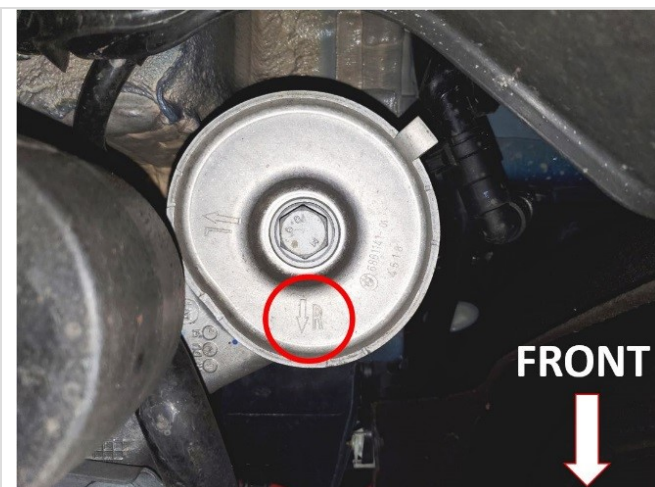
On vehicles with an incorrect setting of the thrust washer, contact between the thrust washer and the sway bar may occur over time. This can lead to corrosion and breakage of the anti-roll bar.

Installation error of the **right** side rear axle thrust washer during manufacturing.

Image shows the rear axle thrust washer on the right side.

Correct positioning:
Arrow R (circled) in the direction of travel

No: Remove and replace the thrust washer bolt. Correctly position the thrust washer on the rubber mount of the rear axle support.

- Tighten the new bolt to 185 Nm

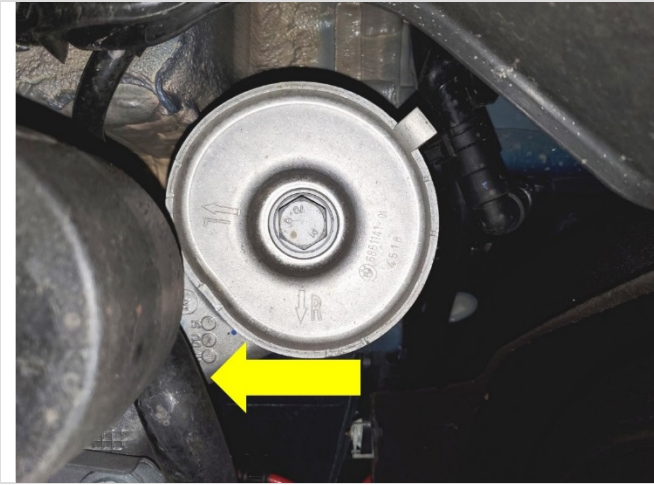
Was any visible damage to the anti-roll bar (arrow) noticed, paint / coating damaged?

Yes: Replace the anti-roll bar as per
REP 33 55 000
