SIB 51 13 19

DOOR LATCHING COMPLAINTS IN COLD WEATHER

2019-12-12

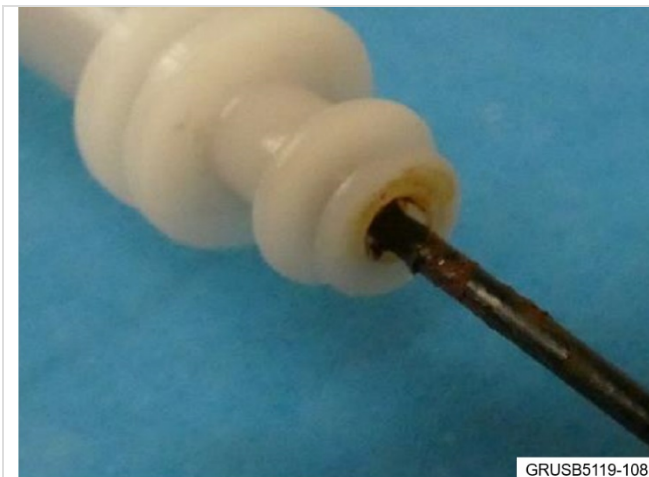
A leaking seal on the outer Bowden release cable may allow water to enter the cable sheathing and freeze.

1. Remove the outer Bowden cable on the affected door as per ISTA/AIR repair instructions.
2. Visually inspect the Bowden release cable for the outer door handle of the affected door(s).
 - Pull back the rubber seal (shown) to thoroughly inspect the cable sheathing for signs of corrosion or water droplets

Yes: Replace the affected Bowden cable, following ISTA/AIR repair instructions for the affected door.
