SIB 52 22 19

NOISE DURING FORWARD / BACK SEAT ADJUSTMENT OVER THE ENTIRE LENGTH OF TRAVEL

F39 (X2 Sports Activity Coupe)	F48 (X1 Sports Activity Vehicle)	G29 (Z4 Roadster)
Vehicles produced from April 7, 2019 to June 28, 2019

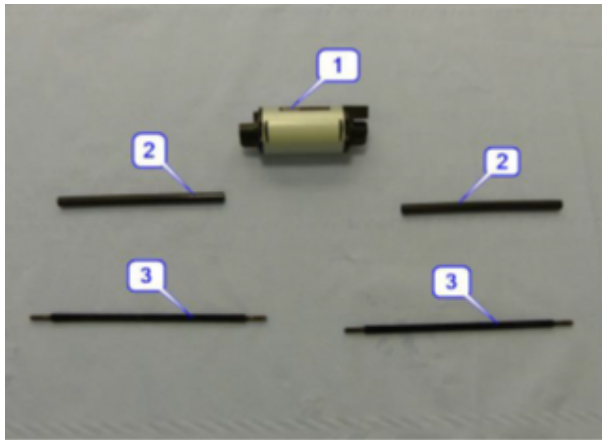
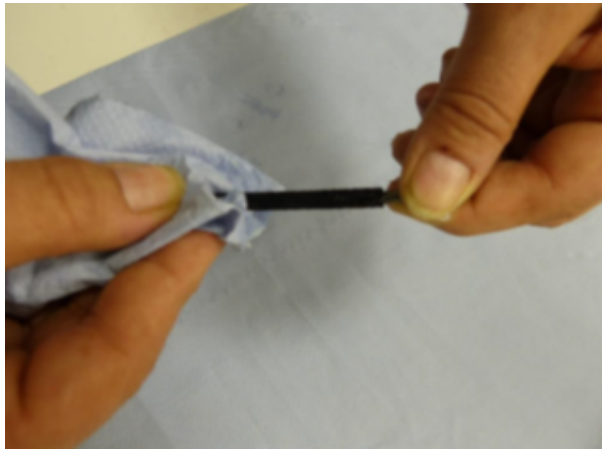
This picture shows the disassembled motor and drive shafts.

1. Motor

2. Outer housing of the cable
3. Flexible drive shafts

Lubricate the flexible drive shaft over its entire length using a lint-free cloth and P/N 83 23 9 407 810 Grease (NBU 12K)
