SIB 54 08 19

2019-12-03

**SUNROOF REVERSES WHEN CLOSING**

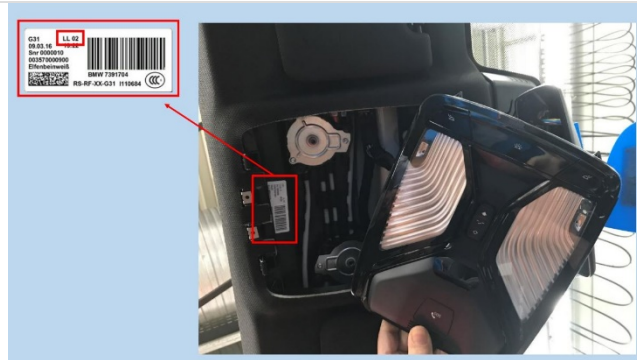
4. With the FZD removed, inspect the “LL” number on the ID tag on the bottom of the sunroof frame. Photo shows the location of the ID tag.

Utilize the tables below to identify the repair based on “LL” number.

**LL42 or Lower:** Replace the glass/slide sunroof frame and wind deflector following ISTA repair instructions **REP 54 13 556 “Replacing panorama glass roof frame”**.

**LL43 or LL44:** Replace only the sunroof wind deflector following repair instructions **REP 54 13 090 “Removing and installing/replacing wind deflector”**.
