**SIB 54 14 19**  
**CONVERTIBLE TOP CREAKING NOISE**

E-Series	Model Description
F23	2 Series Convertible

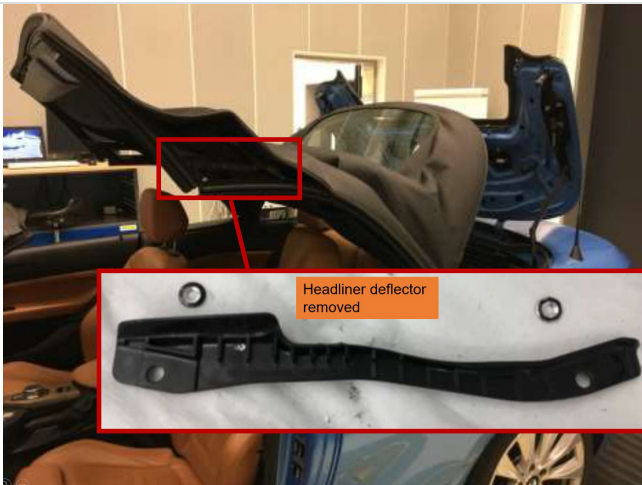
8. Shows the headliner and linkage separated.

9. Clean the contact point between the headliner deflector and the linkage (highlighted by green line).

Note: The anti-creak tape adheres best when the vehicle is at room temperature. If not possible, heat the linkage slightly.

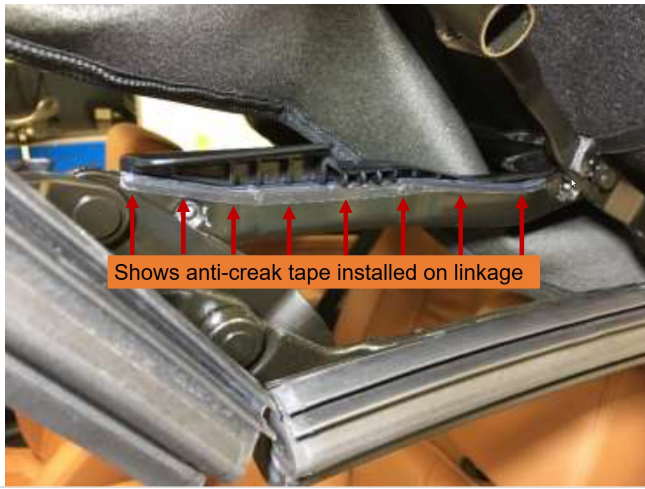
10. Shows the headliner deflector removed.

12. Shows the anti-creak tape (approx. 6 inches/15 cm) installed between the headliner deflector and linkage.

11. Do not reuse headliner deflector removed from the vehicle.

Note: Ensure there are no bubbles when the tape is applied.

13. Secure the new headliner deflector in place with the rivets provided in the kit.
