SIB 61 08 15

High-Voltage Charging Cable Lock Malfunction

PROCEDURE FOR LIM FAULT CODE 805532

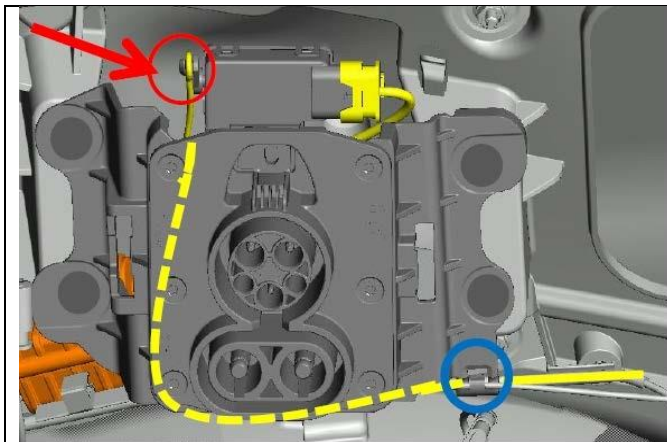
- Detach the tensioning strap from the actuator drive (indicated by the red arrow).

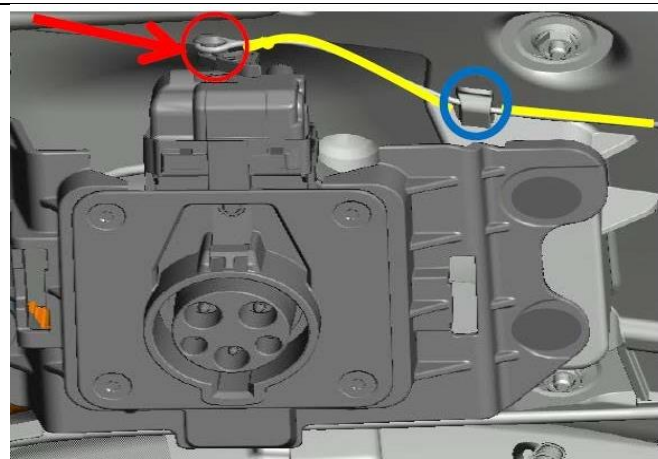
- Ensure that the tensioning strap can move freely in the guides (marked in blue). The tensioning strap must not be tensioned or under pressure or damage. **Otherwise, renew the emergency release cable strap (Refer to SIB 61 16 17).**
