SIB 61 16 17

## CHARGING SOCKET EMERGENCY RELEASE DAMAGED

2019-12-10

## MODEL

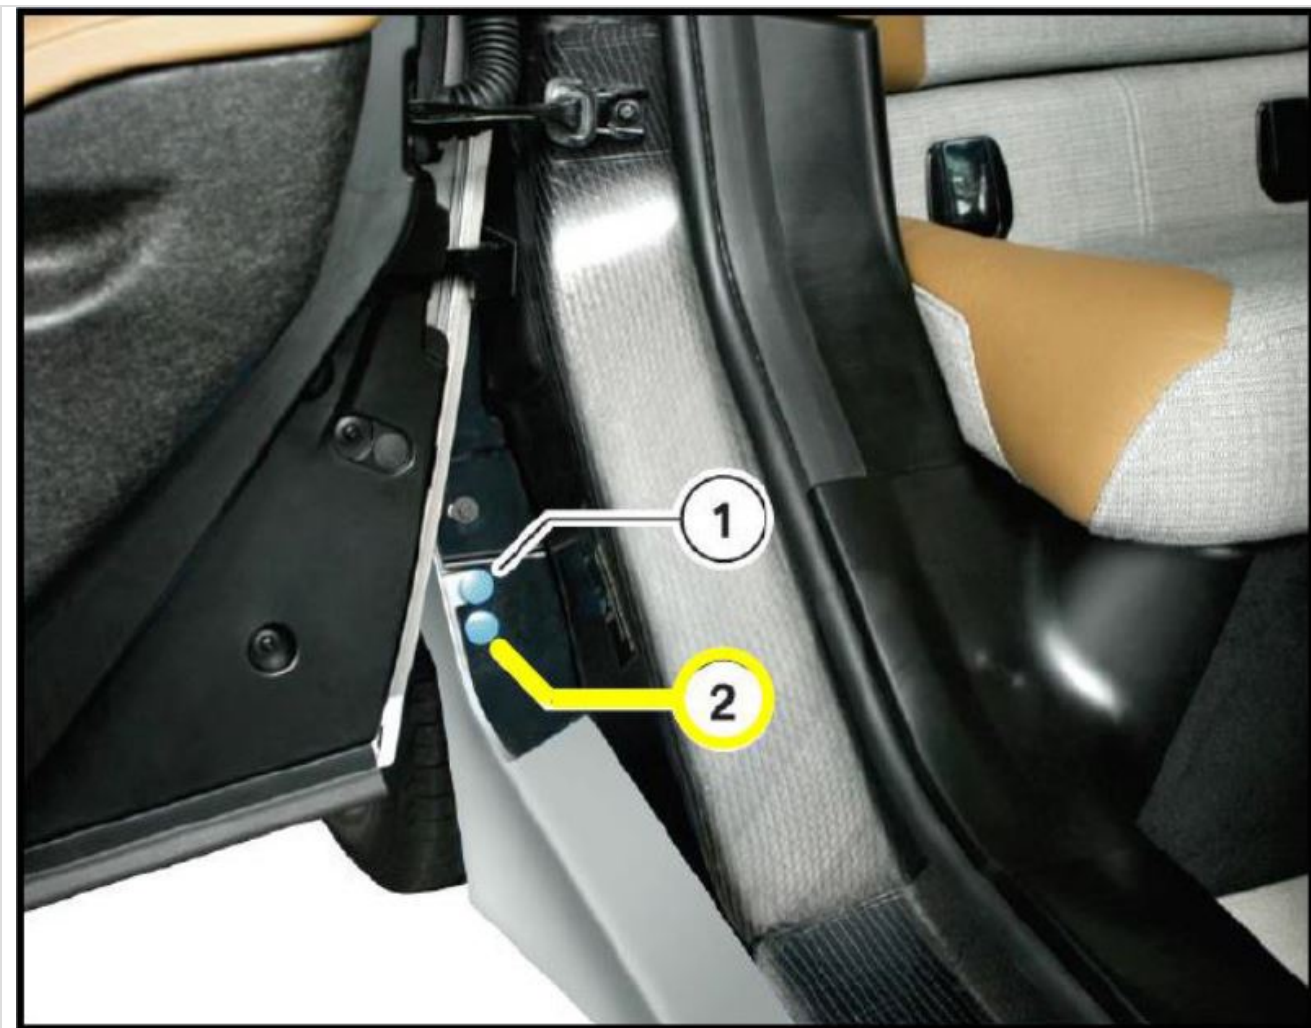
The tensioning strap of the emergency charging socket release has been damaged.

Charging Socket Emergency release (2).

Possible reasons for damage to the emergency release tensioning strap are:

- Excessive force was required to operate the emergency release
- Improper routing of tensioning strap

- Component failure

The replacement tensioning strap design has been improved to help the cable glide easier. Replace the original tensioning strap.
