SIB 66 21 19

LDW (LANE DEPARTURE WARNING): STEERING WHEEL VIBRATION NOT STRONG

This Service Information Bulletin (Revision 1) replaces SI B66 21 19 dated October 2019.

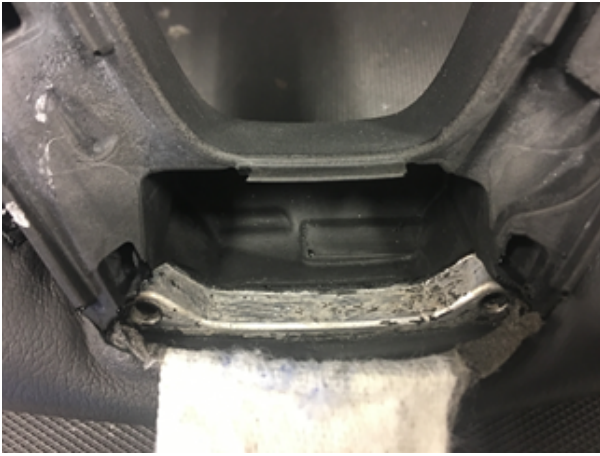
10. This image shows the rubber material coating on the steering wheel removed where the vibration actuator is mounted.

- Perform a software update dependent on the current integration level (I-level)
- Perform Test Plan AT6131_BDC11LRE,
and /or
 - Remove actuator insulation
- Replace the vibration generator
