SIB 66 29 19

2019-12-05

TOP VIEW CAMERA: IMAGE IS MISALIGNED

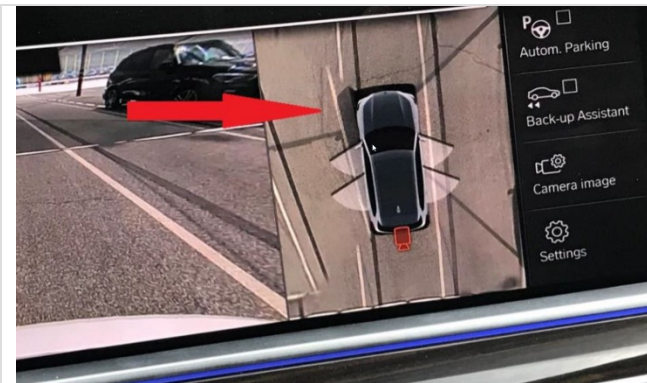
The top view image of the vehicle is misaligned when observed in the Control Information Display (CID). When the vehicle is parked in a parking spot with line markings, it is clearly noticed in the CID that the lines are not parallel to the side of the vehicle. This may be noticed on either the driver side, passenger side or both.

The arrow identifies the line which is shown as not parallel or straight alongside the vehicle.

Side view camera loose fitment in the exterior mirror bracket, causing changes to the top view image.

Reposition the camera in the exterior side view mirror with felt tape. The tape serves to firmly position the camera within the mirror bracket.
