SIM 22 03 17

CREAKING NOISE FROM THE LOWER ENGINE AREA

F54 (MINI Clubman)	F55 (MINI Hardtop 4 Door)	F56 (MINI Hardtop 2 Door)	F57 (MINI Convertible)
Produced up to July 2017

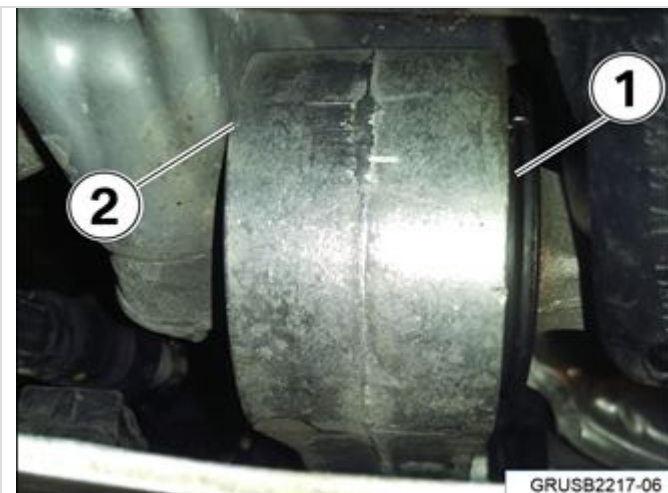
During load reversal or taking off from a stop, there is a creaking or droning noise heard from the lower engine area.

The bushing in the lower engine stabilizer link is working its way out of its aluminum housing, thereby rubbing against the engine oil pan.

The bushing in the lower engine stabilizer link (1) is working its way out of its aluminum housing. The aluminum housing starts to rub against the engine oil pan (2).

Confirm the noise is coming from the lower engine stabilizer link and replace the link. Refer to Repair Instruction 22 11 095 "Removing and installing/replacing holder with rubber mount".
