Service Bulletin

Bulletin No.: 17-NA-384

Subject: Squeak, Rattle or Creak Coming from Second Row/Rear Seat Area

Brand:	Model:	Model Year:		VIN:		Engine:	Transmission:
		from	to	from	to		
Cadillac	XT5	2017	2020			All	All
	XT6	2020	2020				
GMC	Acadia (VIN N)	2017	2020				
Holden	Acadia	2019	2019

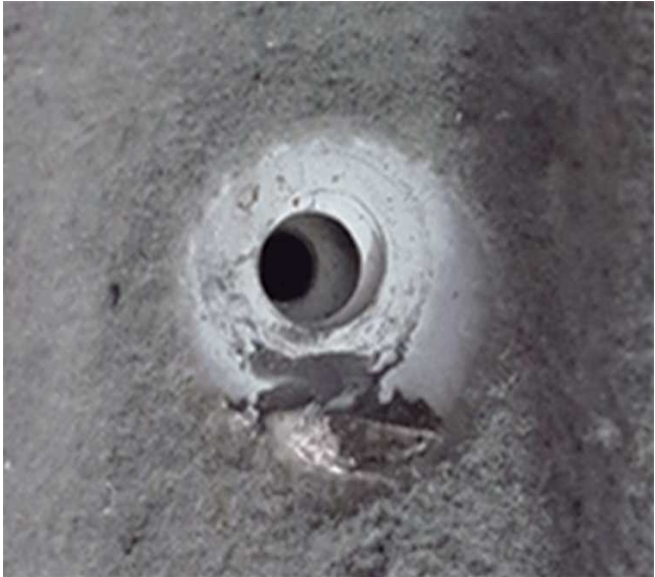
Involved Region or Country	North America, Europe, Russia, Middle East, Israel, Japan, South Korea and Egypt.
Condition	Some customers may comment on hearing a squeak, rattle or creak coming from the second row/rear seat area. The right 40% seat is more prone to this condition, however the left 60% seat could be affected.
Cause	<p>The cause of the condition may be either of the following:</p> <div style="text-align: center;">

</div> <p style="text-align: right; font-size: small;">4911773</p> <p>Note: The "winking" is caused by excessive overlap of body panels and, as shown in the graphic above, the sheet metal holes are offset. This is most commonly found at the right rear fastener location of the right rear seat, or the left rear fastener of the left rear seat.</p> <ul style="list-style-type: none"> Possible "winking" condition of right rear 40% seat floor pan outboard track rear bolt hole, or the left rear 60% seat floor pan outboard track rear bolt hole. A seat track synchronization/torque condition may require a torque sequencing of the seat attachment bolts, on either seat.

Correction	<p>Note: Perform the "winking" inspection, and repair procedure as necessary first, prior to performing the torque procedure.</p> <p>For vehicles exhibiting the condition, follow the Service Procedure below to inspect for and correct the winking condition, and also complete the torque sequencing procedure.</p>

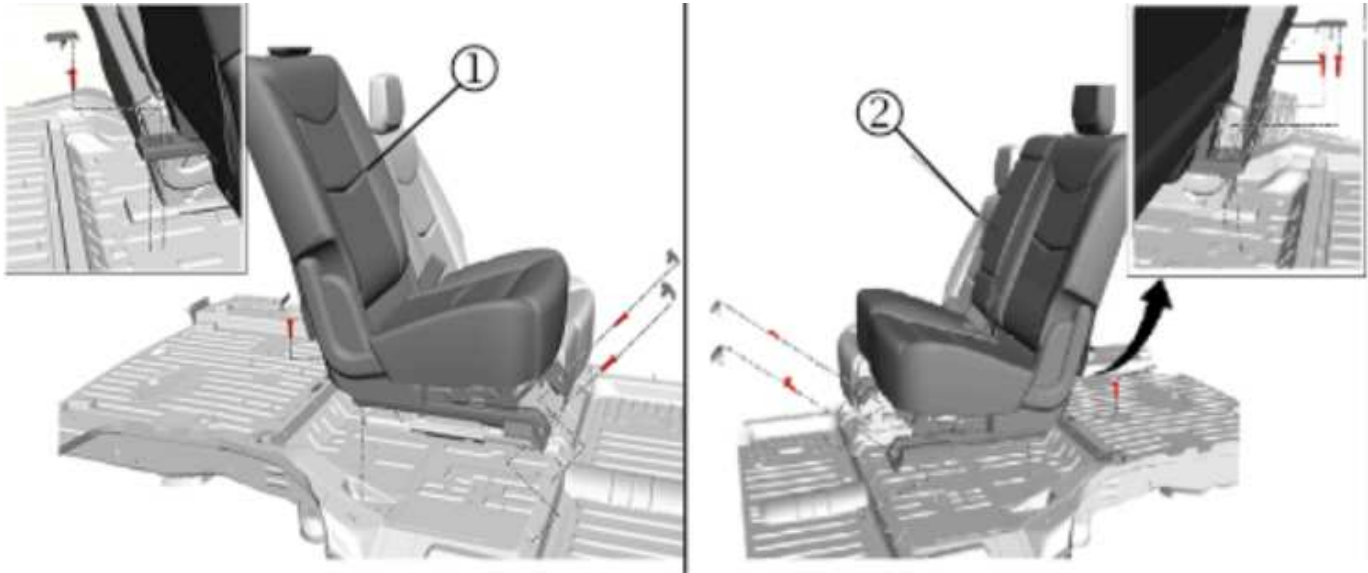
5403437

1. Verify which rear seat exhibits the condition: the right rear 40% seat, (1) and/or the left rear 60% seat. (2)

2. Remove the affected right (1) and/or left (2) rear seat. Refer to *Rear Seat Removal and Installation (40%)* and/or *Rear Seat Removal and Installation (60%)* in SI,
 - 2.1. Adjust the seat to full rearward position.
 - 2.2. Loosen the outboard front attachment bolt, then the inboard bolt.
 - 2.3. Adjust the seat to full forward position.

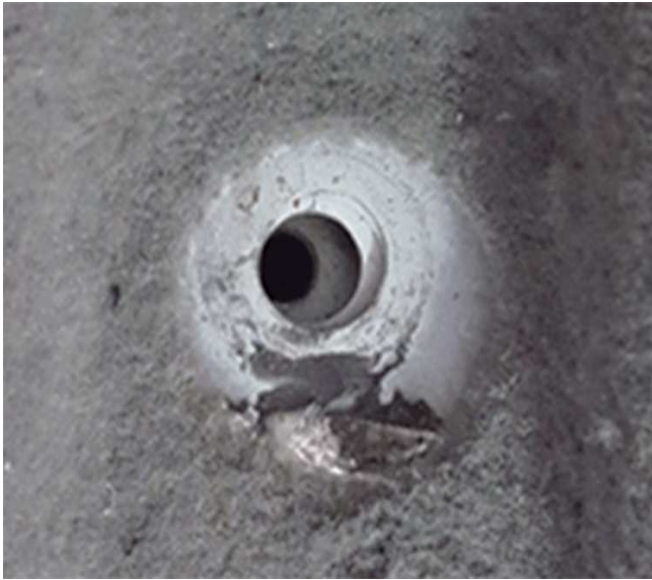
4911773

- 2.4. Ensure that both seat tracks are locked.
- 2.5. Loosen the outboard rear attachment bolt, then the inboard bolt.
3. inspect the right outboard rear seat fastener

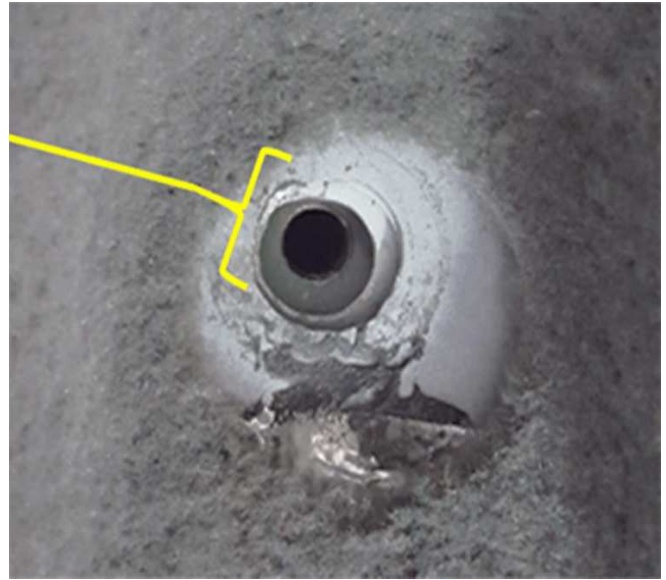
4911785

- If “winking” condition DOES exist, continue ahead to step #4 and remove sheet metal material.

4. Using a dremel, or suitable tool, grind a small amount of material from the floor sheet metal opening. Grind only enough of the overlapping metal to allow clearance for the seat bolt.
5. Use an air gun to blow out any metal debris in the nut and hole area.

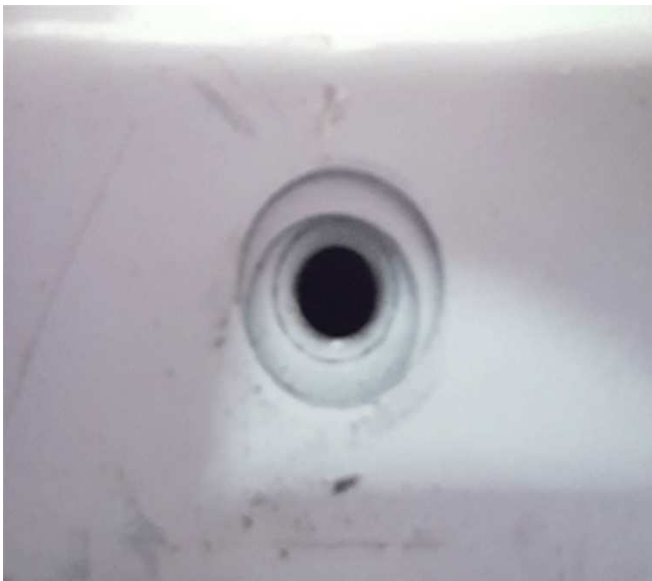
4911781

Note: In the graphic example above, the sheet metal is still offset, but the nut is centered enough to avoid contact of the seat bolt to the sheet metal.

- If “winking” condition DOES NOT exist, jump ahead to step #6 and follow the torque sequence procedure.
