Service Bulletin

Bulletin No.: 18-NA-020

Subject: Malfunction Indicator Lamp Illuminated with DTC P0300 and/or P0299/P2227 Set

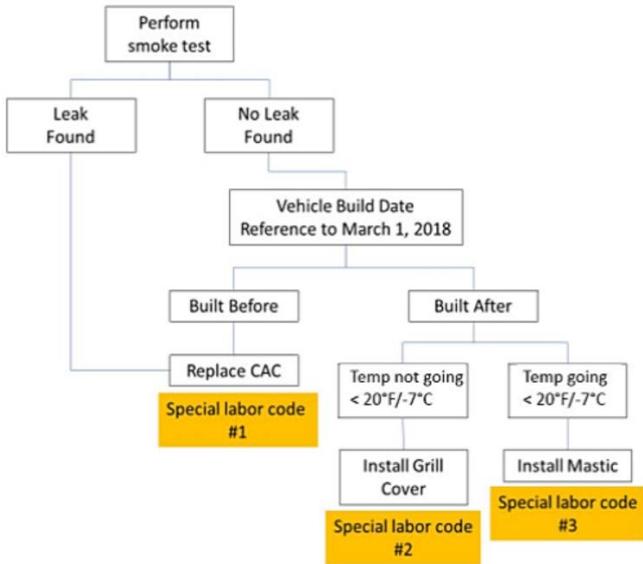
5336724

Flow Chart Based on Conditions

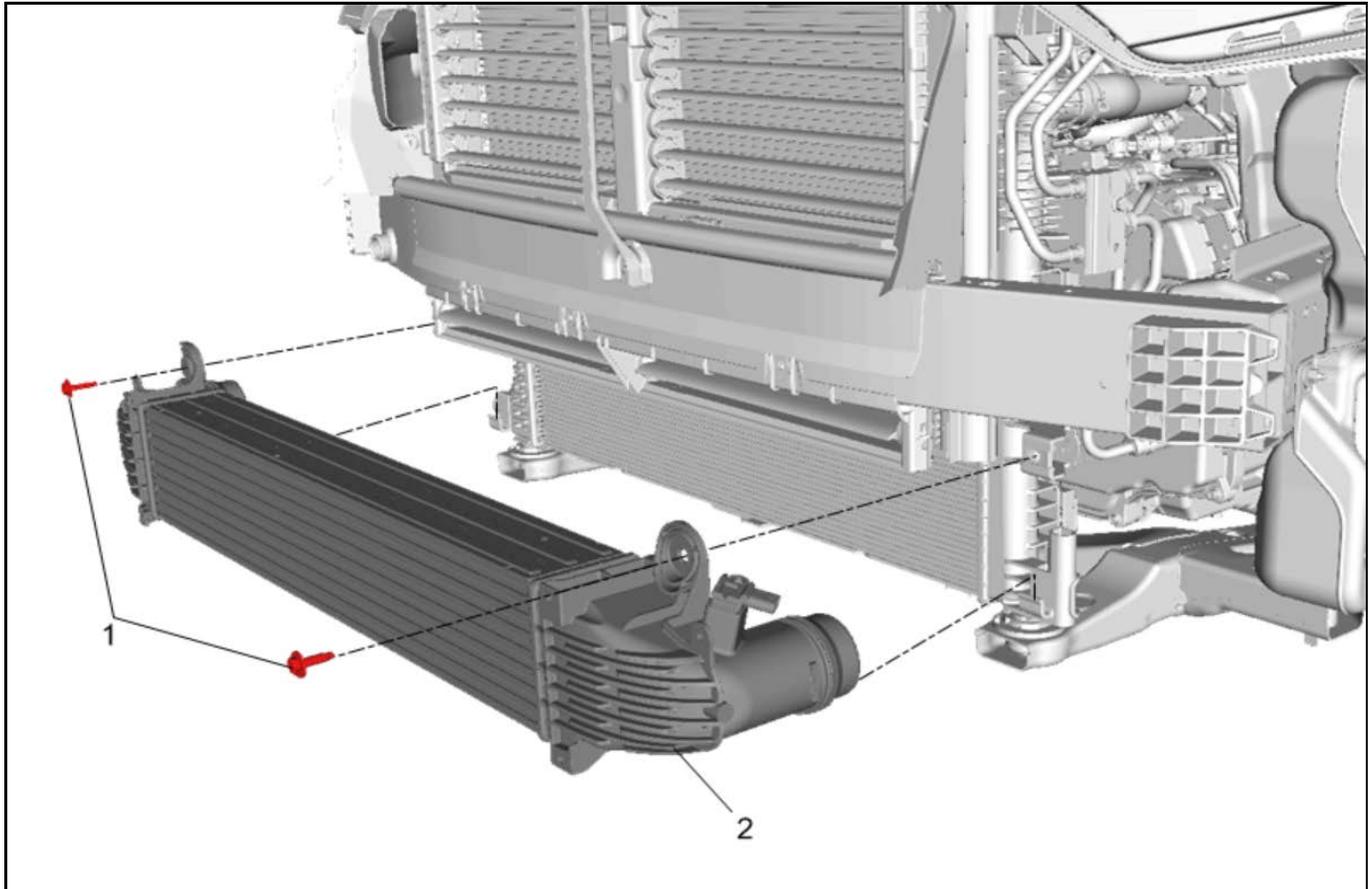
4597334

1. Perform a smoke leak test of the charge air cooler.

- If a leak is determined, replace the charge air cooler with the newly designed part. Refer to *Charge Air Cooler Replacement* in SI.
- If there is NO leak, but a P0300, P0299 and/or P2227 are present, **AND the vehicle was built ON or BEFORE March 1, 2018**, then replace the charge air cooler with the newly designed part. Refer to *Charge Air Cooler Replacement* in SI.
- If there is NO leak, but a P0300, P0299 and/or P2227 are present, **AND the vehicle was built AFTER March 1, 2018**, refer to SI for further diagnosis.

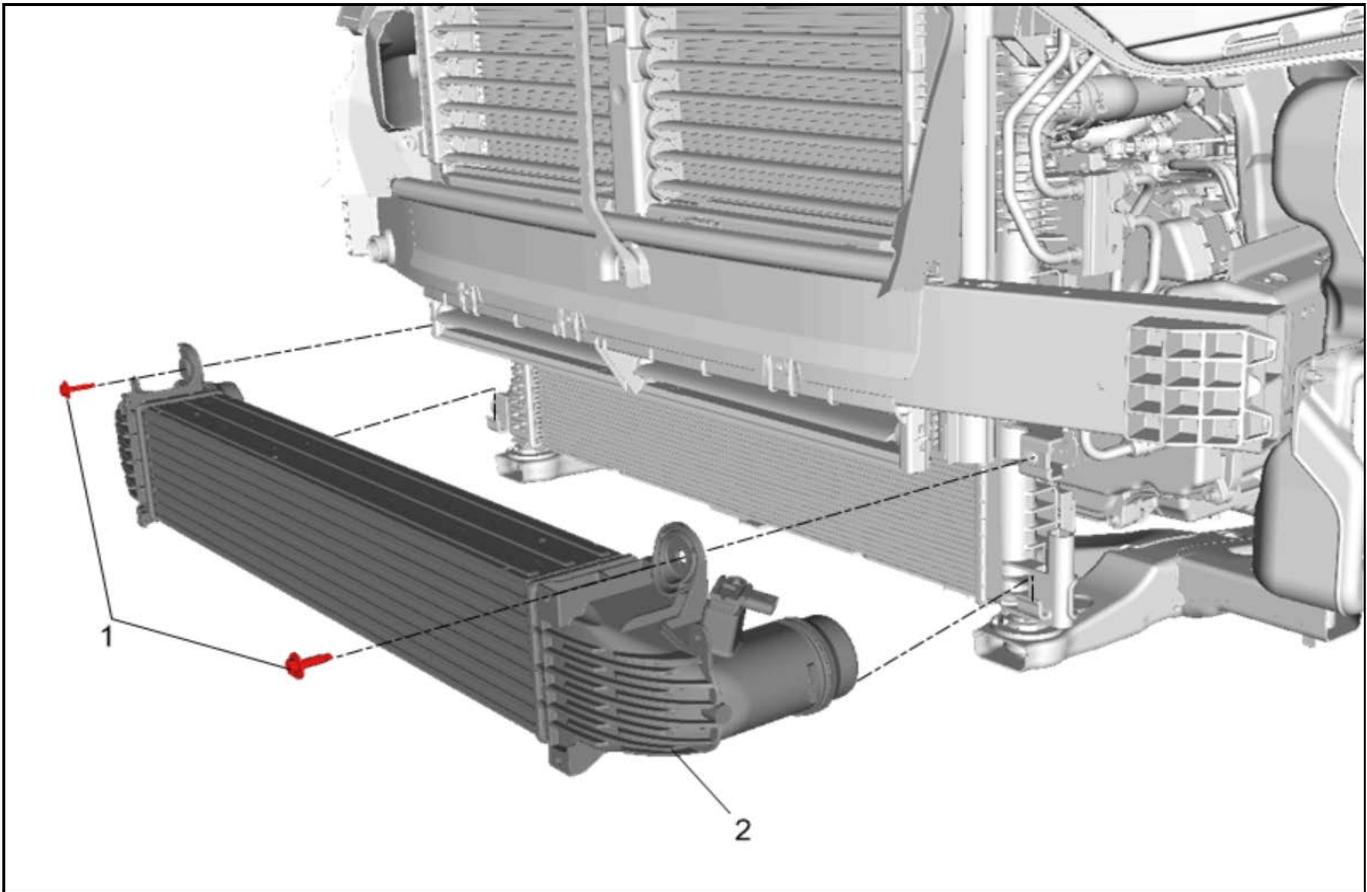
4597334

1. Perform a smoke leak test of the charge air cooler.

Important: The newly designed charge air cooler is wider and is NOT compatible with the existing lower baffle on the vehicle. The baffle will need to be replaced to accommodate the larger charge air cooler.

- If a leak is determined, replace the charge air cooler with the newly designed part. Refer to *Charge Air Cooler Replacement* in SI.
- If there is NO leak, but a P0300, P0299 and/or P2227 are present, **AND the vehicle was built ON or BEFORE January 5, 2019**, then replace the charge air cooler with the newly designed part. Refer to *Charge Air Cooler Replacement* in SI.
- If there is NO leak, but a P0300, P0299 and/or P2227 are present, **AND the vehicle was built AFTER January 5, 2019**, refer to SI for further diagnosis.
