# Service Bulletin

Bulletin No.: 19-NA-073

**Subject:** Difficult to Shift into Gear, Grinds When Shifting, Possible Gear Clash, Intermittent Gear Pop Out and/or Mushy Shifts

| Brand: | Model: | Model Year: | | VIN: | | Engine: | Transmission: |
|---|---|---|---|---|---|---|---|
| Chevrolet | Corvette | 2014 | 2019 | | | All | Equipped with 7-Speed Manual Transmission (RPO MEL, MEP or MEK) |

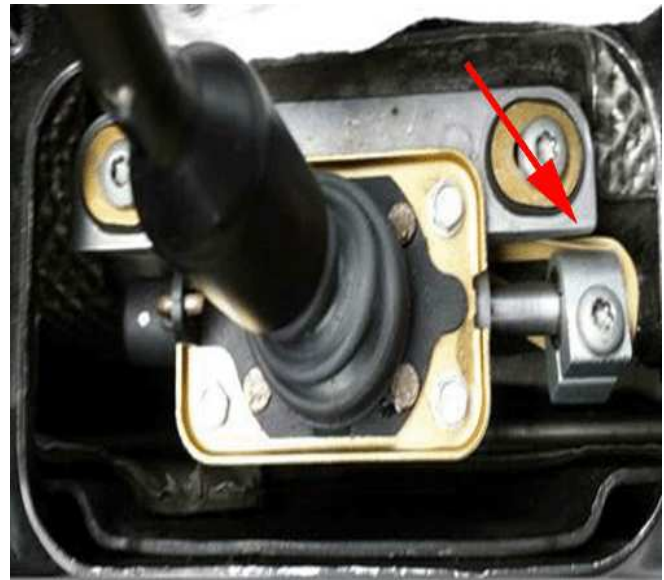
4329176

**Note:** There may be some variation on how and where the rubber band is placed. The above picture shows one possible location.

5. Before performing the shifter adjustment, make sure that the rubber band used to retain the shifter link during assembly is removed.

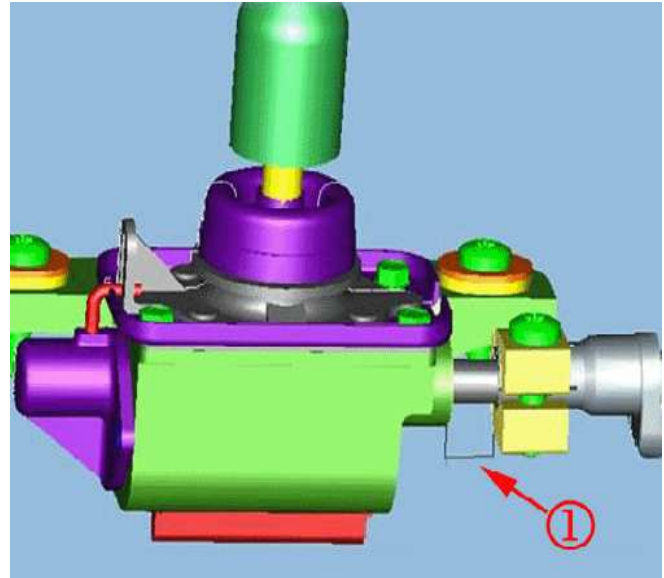
4072040

- 10.4. Inspect for proper alignment in the Neutral position. When the shift rod clamp is properly positioned the bolt will engage the slot/relief in the shift rod and be positioned approximately 15 mm (0.59 in) from the shifter assembly as shown above (1).
- 10.5. Fix if incorrectly aligned by grabbing the linkage and push/pull to the proper gate.
