# Service Bulletin

Bulletin No.: 19-NA-185

**Subject:** Steering Wheel Shimmy/Shaking

Brand:	Model:	Model Year:		VIN:		Engine:	Transmission:
		from	to	from	to		
Chevrolet	Malibu	2016	2020			All	All

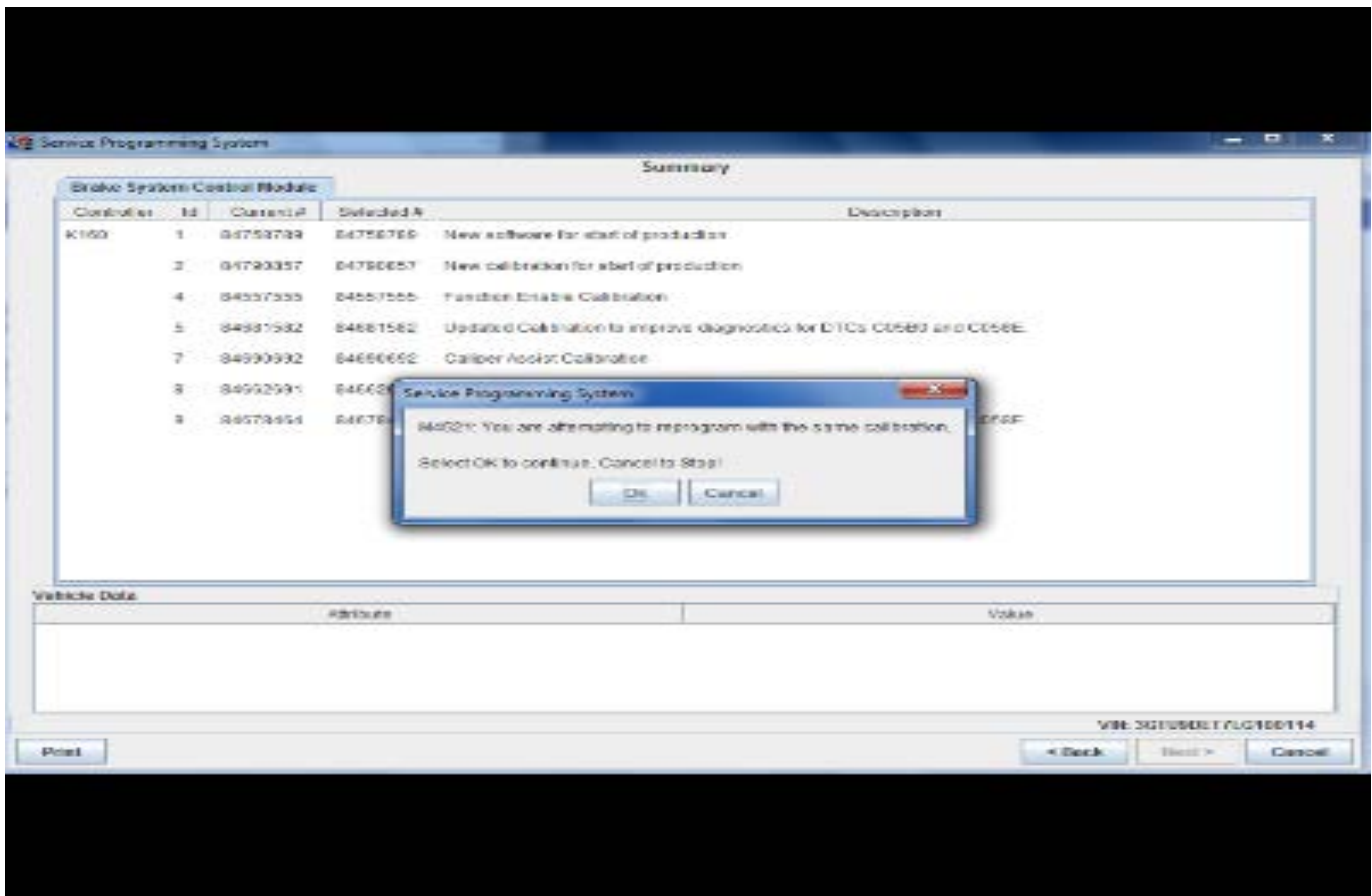
5431207

**Note:** If the Same Calibration/Software Warning is noted on the SPS screen, select OK and follow screen instructions. After a successful programming event, the WCC is located in the Service Programming System dialogue box of the SPS Summary screen. No further action is required. Refer to the Warranty section of the bulletin.

1. Reprogram the Power Steering Control Module. Refer to *K43 Power Steering Control Module: Programming and Setup* in SI.

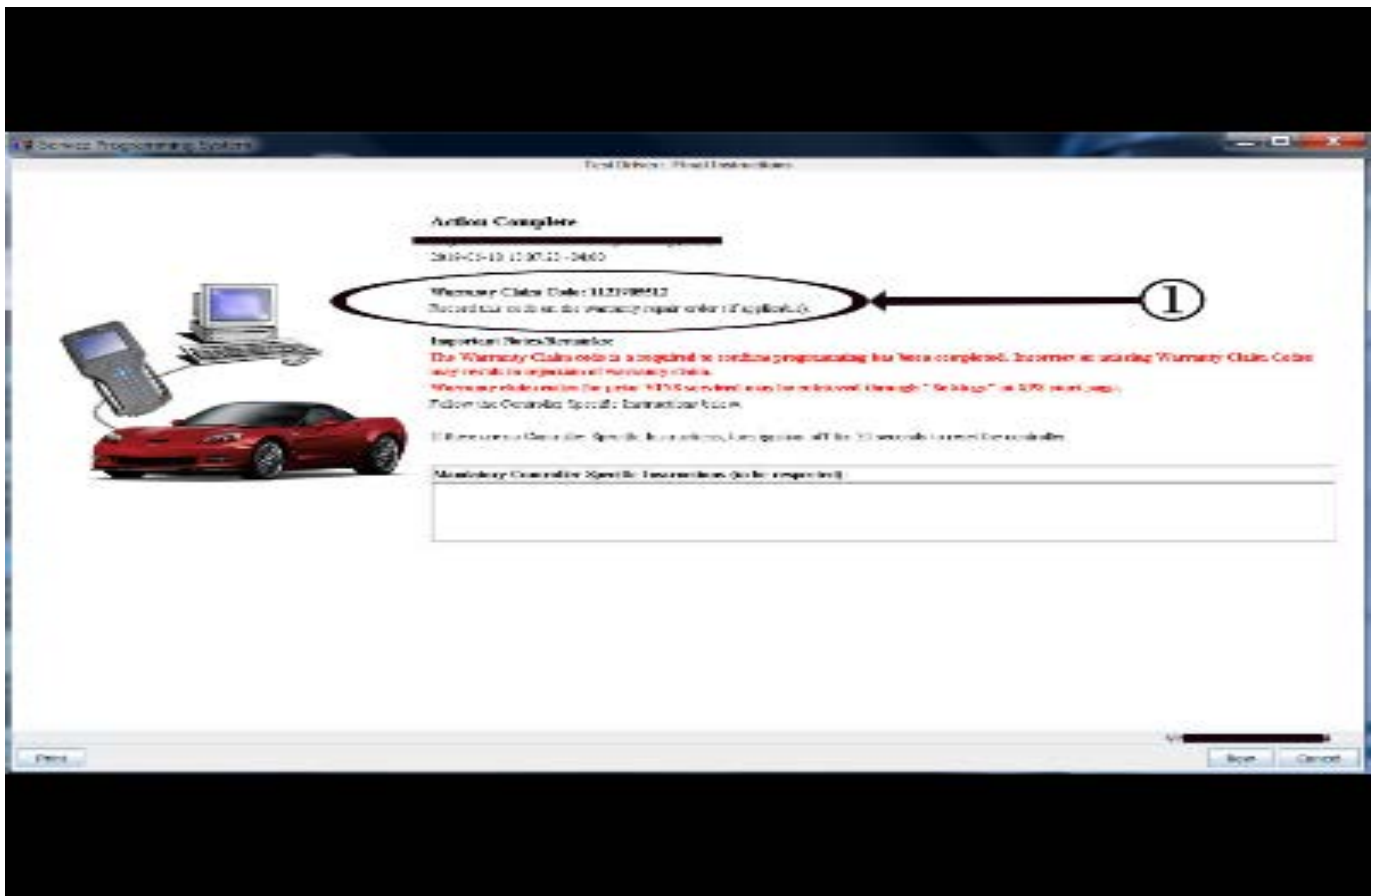
5431209

**Note:** To avoid warranty transaction rejections, you **MUST** record the warranty claim code provided on the SPS Warranty Claim Code (WCC) screen on the job card. Refer to callout 1 above for the location of the WCC on the SPS screen.

2. Record SPS Warranty Claim Code on job card for warranty transaction submission.
