# Service Bulletin

Bulletin No.: 19-NA-229

**Subject: Radio Software Version C146 Over-the-Air Update**

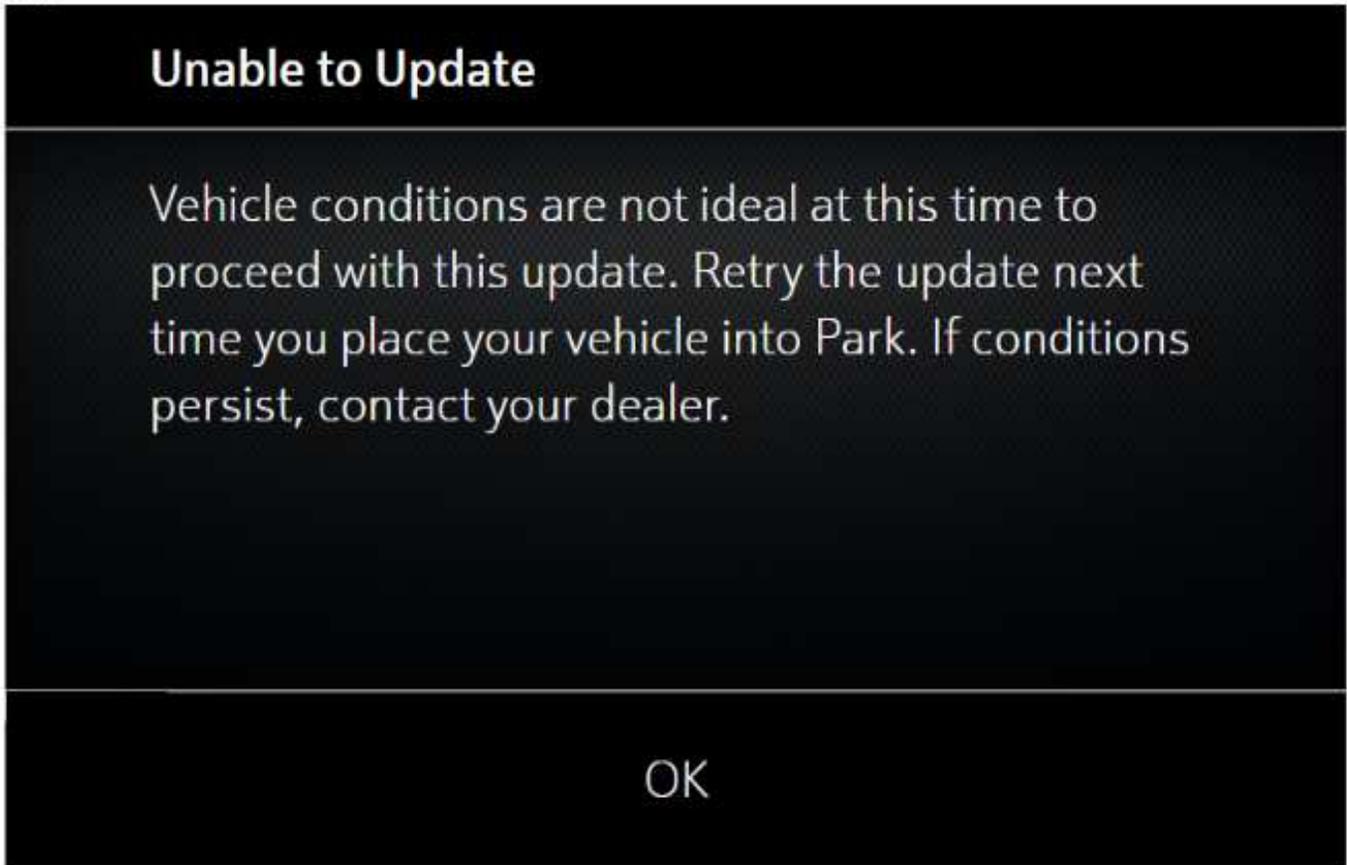
5420149

Scenario 1: Vehicle conditions are not ideal.

If the above screen is shown, download the update through TIS2Web and perform USB update. Ensure the vehicle battery is being maintained (using EL-49642 or battery maintainer) while performing this update

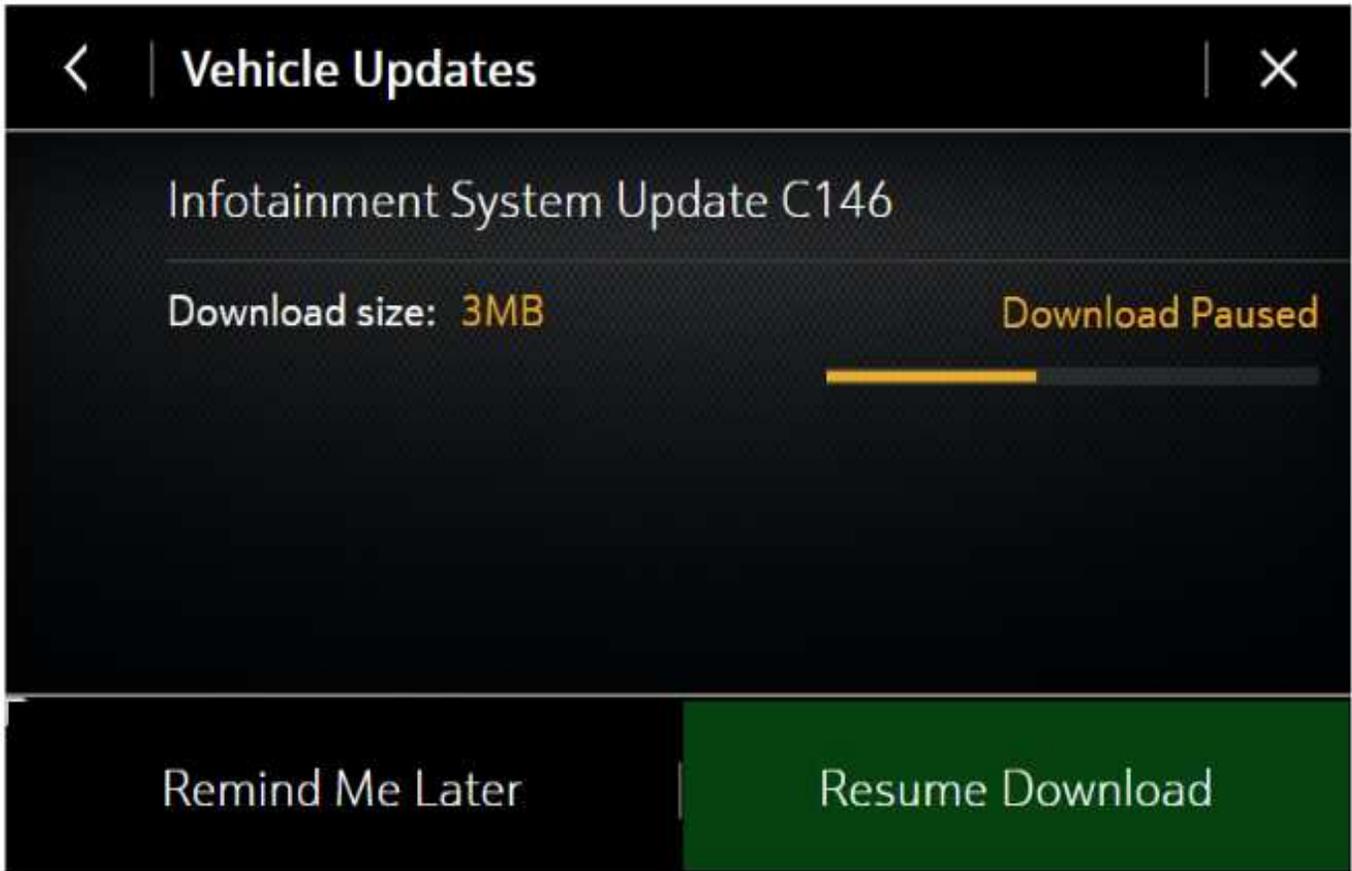
5420146

Scenario 2: Consistently Paused Download

If the above screen is shown and resuming the download repeatedly fails, a USB update will need to be performed. Turn the vehicle on, return to the home screen, and insert USB stick (see previous section). Verify the part number is correct and follow on screen prompts.

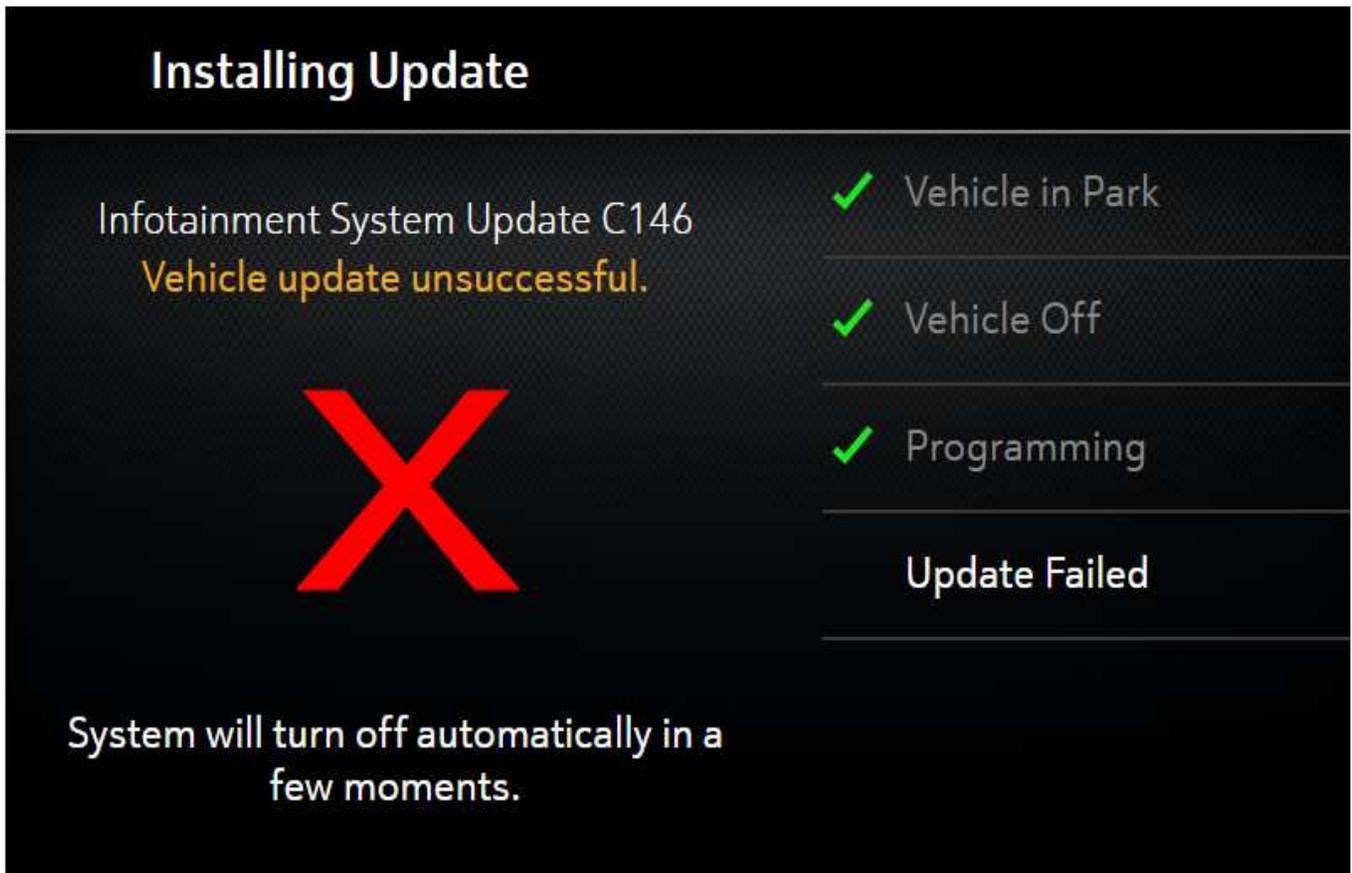
5420153

Scenario 3: Update Failed. Return to dealer screen.

1. If one of the above screens is shown, download the update through TIS2Web and insert USB stick into the radio. A yellow progress bar should come on the screen and the update will proceed. If this screen above is shown when trying to update the radio through USB, reformat the USB drive to FAT32 on your PC, and then try to download the update through TIS2WEB again.
