GLOBAL SAFETY FIELD INVESTIGATIONS
DCS5245
URGENT - DISTRIBUTE IMMEDIATELY

Subject: N192282430 - Service Update
Transmission in Neutral State

Models: Cadillac CT6
Equipped with Gas Engine, 8 CYL, 4.2L, V8, Twin Turbo (RPO LTA)

N192282430 Transmission in Neutral State

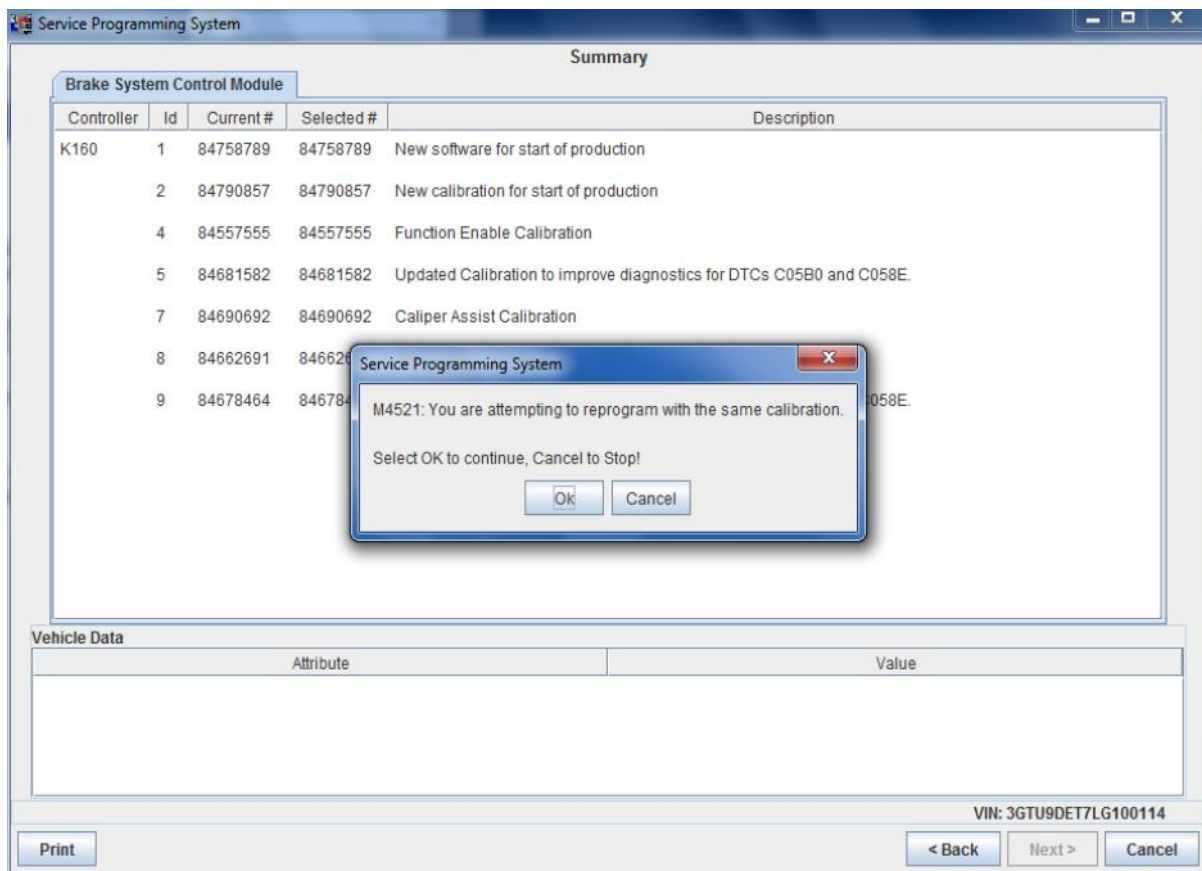
5431207

Note: If the Same Calibration/Software Warning is noted on the SPS screen, select OK and follow screen instructions. After a successful programming event, the WCC is located in the Service Programming System dialogue box of the SPS Summary screen. No further action is required. Refer to the Warranty section of the bulletin.

1. Reprogram the Engine Control Module. Refer to *K20 Engine Control Module: Programming and Setup* in SI.

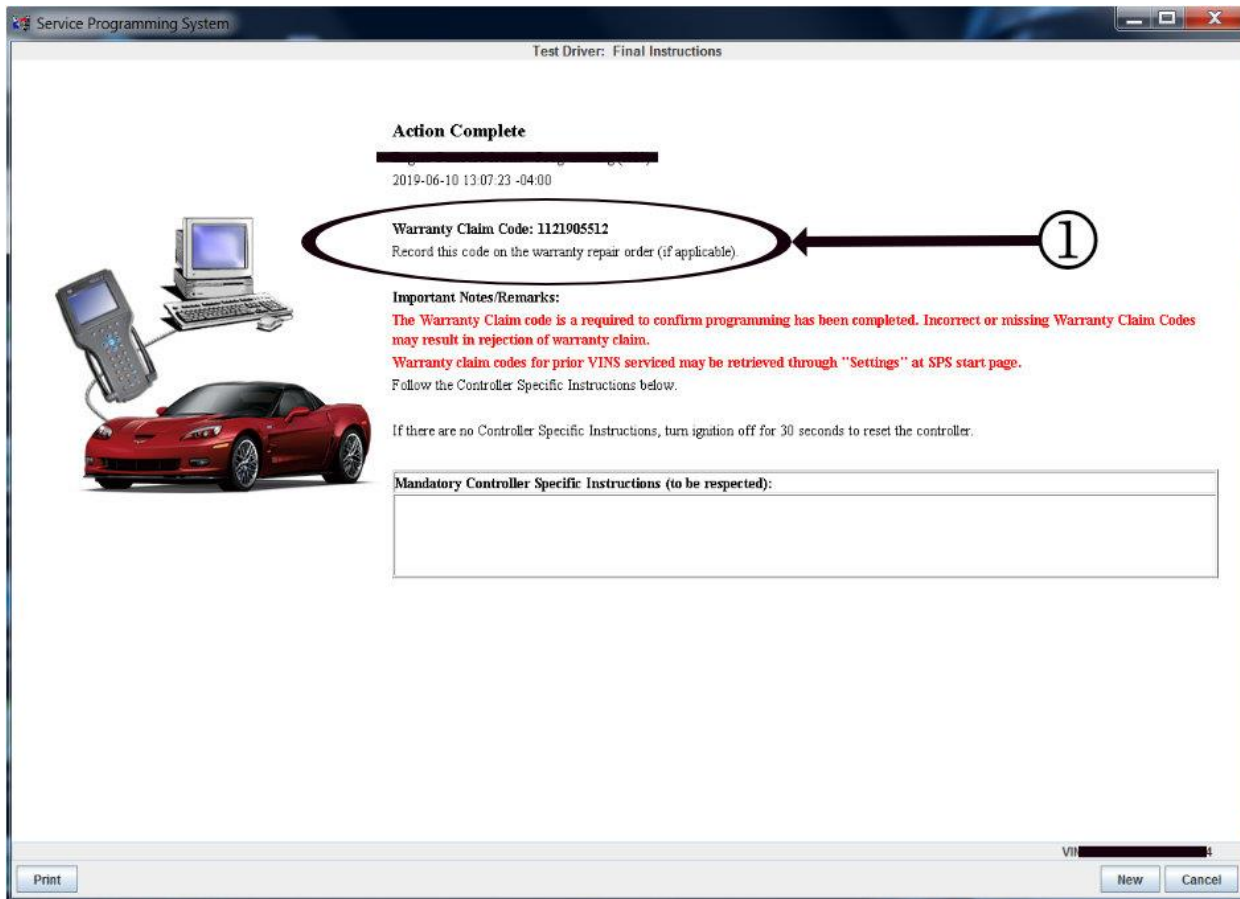
5431209

Note: To avoid warranty transaction rejections, you **MUST** record the warranty claim code provided on the SPS Warranty Claim Code (WCC) screen on the job card. Refer to callout 1 above for the location of the WCC on the SPS screen.

- Record SPS Warranty Claim Code on job card for warranty transaction submission.
