GLOBAL SAFETY FIELD INVESTIGATIONS
DCS5260
URGENT - DISTRIBUTE IMMEDIATELY

Subject: N192275630 - Customer Satisfaction Program
Brake Assist Feature

Models: 2019 Chevrolet Silverado 1500 (New Model)
2019 GMC Sierra 1500 (New Model)

N192275630 Brake Assist Feature

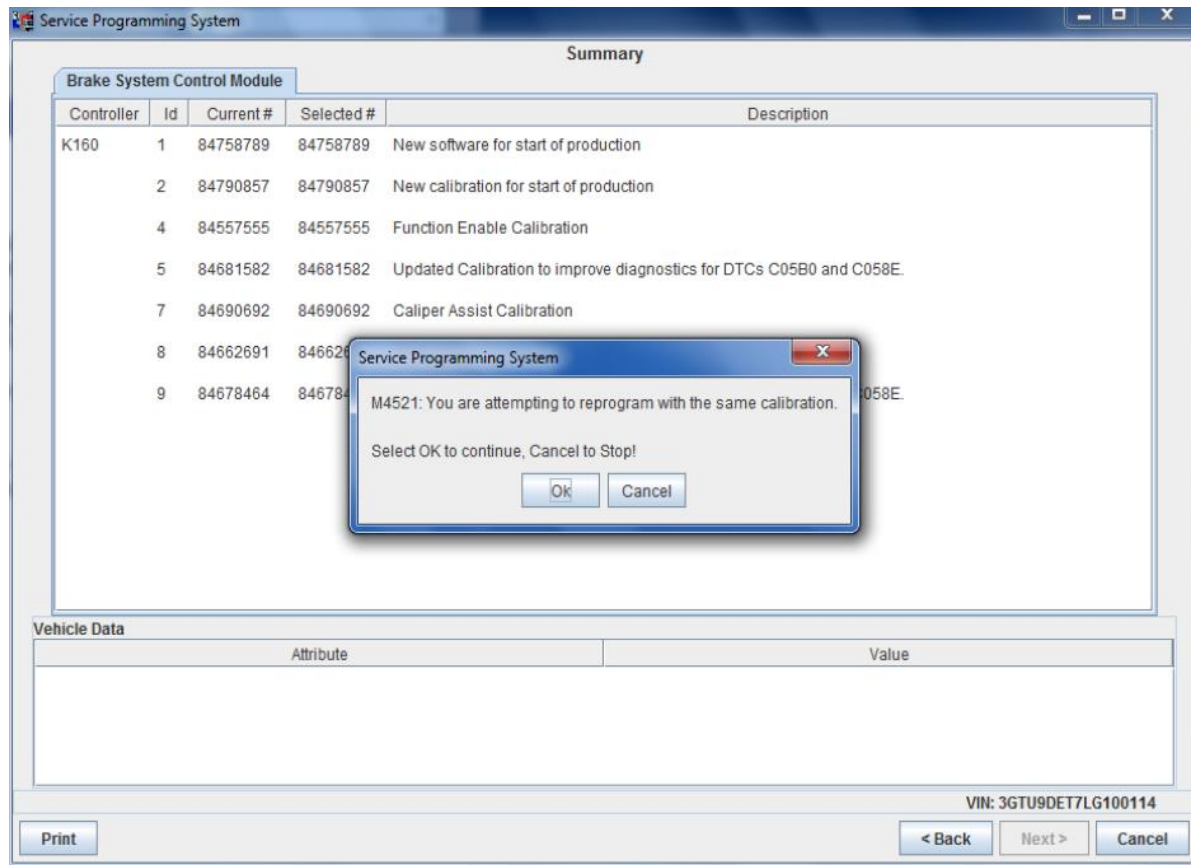
5431207

Note: If the Same Calibration/Software Warning is noted on the SPS screen, select OK and follow screen instructions. After a successful programming event, the WCC is located in the Service Programming System dialogue box of the SPS Summary screen. No further action is required. Refer to the Warranty section of the bulletin.

1. Reprogram the frontview camera. Refer to *B174W Frontview Camera - Windshield: Programming and Setup* in SI.

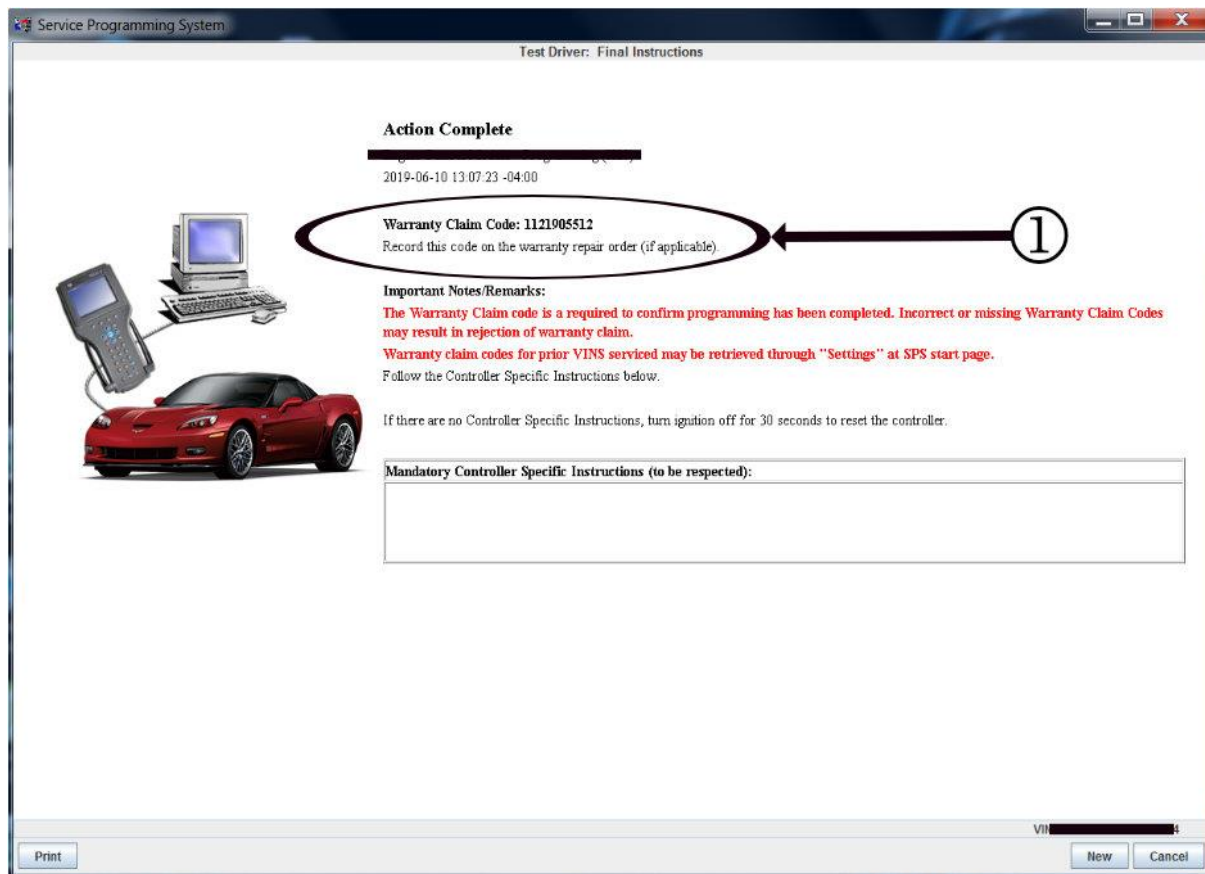
5431209

Note: To avoid warranty transaction rejections, you **MUST** record the warranty claim code provided on the SPS Warranty Claim Code (WCC) screen on the job card. Refer to callout 1 above for the location of the WCC on the SPS screen.

- Record SPS Warranty Claim Code on job card for warranty transaction submission.
